**AGÊNCIA NACIONAL DE AVIAÇÃO CIVIL - BRAZIL**

## **BRAZILIAN AIRWORTHINESS DIRECTIVE**

**AD No.: 2021-02-02**

**AD No. 2021-02-02 - YABORÃ / 39-1478.**

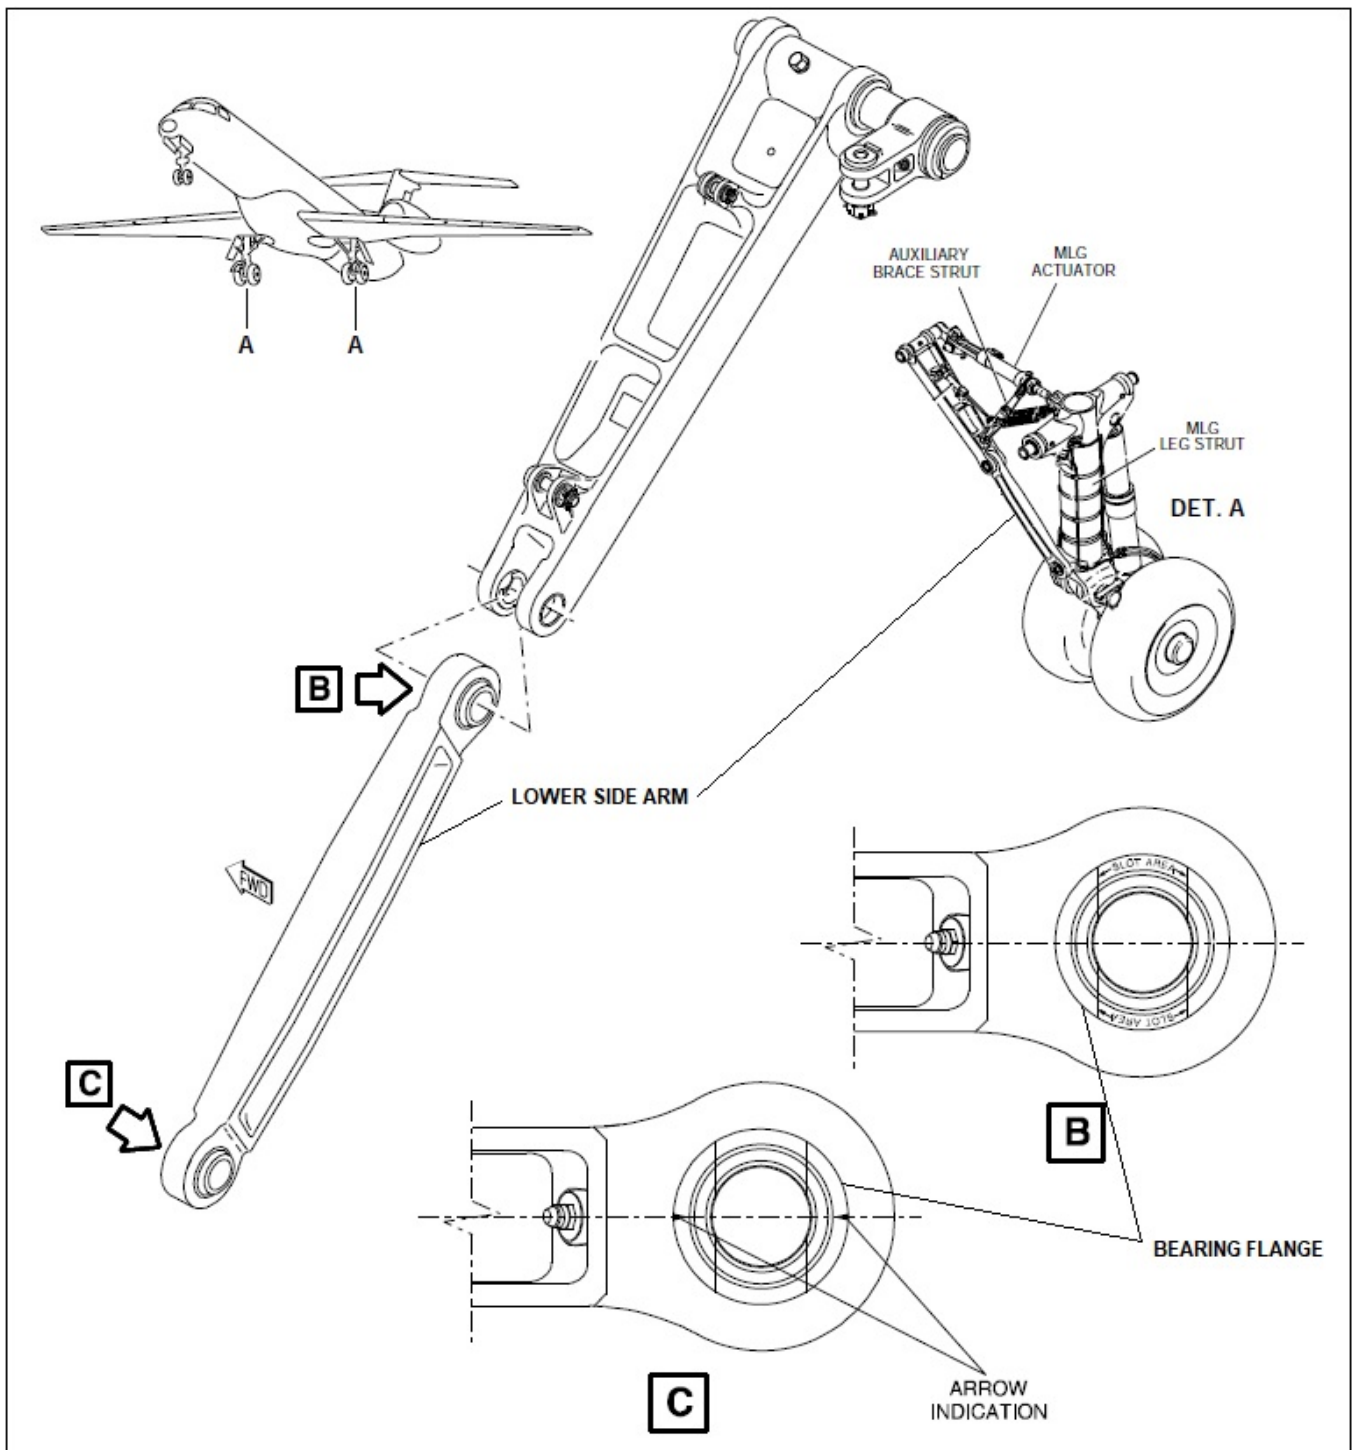
Figure 2: Correct installation of the Lower Side Arm Bearings

It was determined that the inverted installation of the MLG Side Arm Strut Bearing was a contributing factor to the disconnection of the Side Arm Strut from the Main Landing Gear.

2. Verify that the flanges of the 2 MLG Side Arm Bearings are both facing the flight direction (see Details B and C in Figure 2 below);

A one-time inspection, and reinstallation of the MLG Side Arm Strut, if necessary, as to the inverted installation of the Bearings (see Figure 2).

- i. If, during the inspection required by item (a)(2) above, it is found that either of the Bearing's flanges is installed inverted (flange facing opposite to the flight direction), before the next flight (see NOTE 2), remove the Lower side Arm and re-install the affected Bearing in the correct position (flange facing the flight direction). To comply with this paragraph, refer to procedure 32-10-03/400 (MAIN-LANDING-GEAR MAIN BRACE STRUT - REMOVAL/INSTALLATION) of the AMM applicable to the aircraft, and to the CMM (Component Maintenance Manual), procedure T.P. 145/1190\_32-10-03, as necessary.
3. Verify that there is no migration of both Bearings of the MLG Side Arm (see Details B and C in Figure 2) (both Flanges shall be flushed with the MLG Lower Side Arm face);
