## AIRWORTHINESS DIRECTIVE

### Bell Helicopter Textron UH-1 (All Variants) Series Helicopters

**AD/UH-1/20**                      **Tail Boom and Fin - Fretting and Cracking**                      **22/2019**  
**Amdt 2**

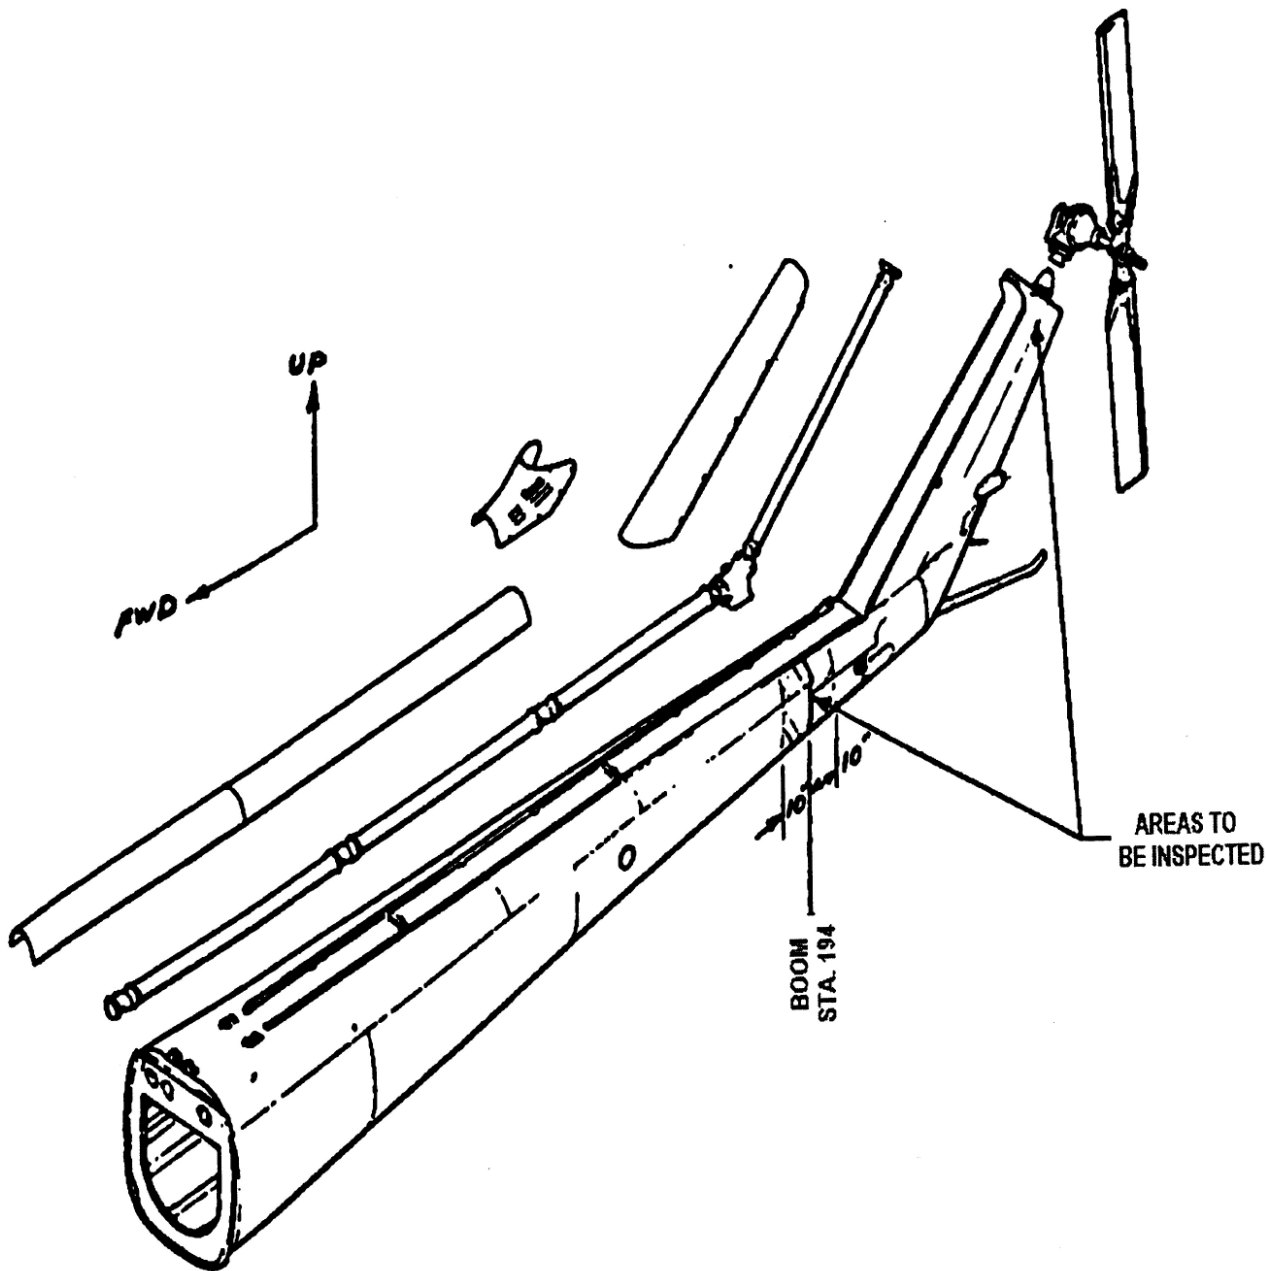
- Requirement:
1. Visually inspect the tail boom skin joint at tail boom Station 194 for fretting or cracking (inspect 10 inches forward and 10 inches aft of Station 194 as per Figures 1. and 2 below) .
  2. Visually inspect the vertical fin front spar cap at its intersection with the tail rotor gear box support fitting for cracks as per Figure 1.
  3. Conduct a radiographic inspection using a CASA approved procedure, or approved alternative procedure, of the tail boom skin at Station 194 splice joint. (inspect 10 inches forward and 10 inches aft of Station 194 as per Figures 1. and 2 below).
  4. Replace any cracked skin panels found while performing Requirement 1 or Requirement 3 inspections, with serviceable panels.
  5. Replace any cracked fin spar caps found while performing Requirement 2 inspection, with serviceable parts.

*Note 1: Federal Aviation Administration of the United States of America (FAA) Airworthiness Directive (AD) 83-03-03 Amdt 39-4556 (FAA AD) has been referenced as a source document for Figure 1.*

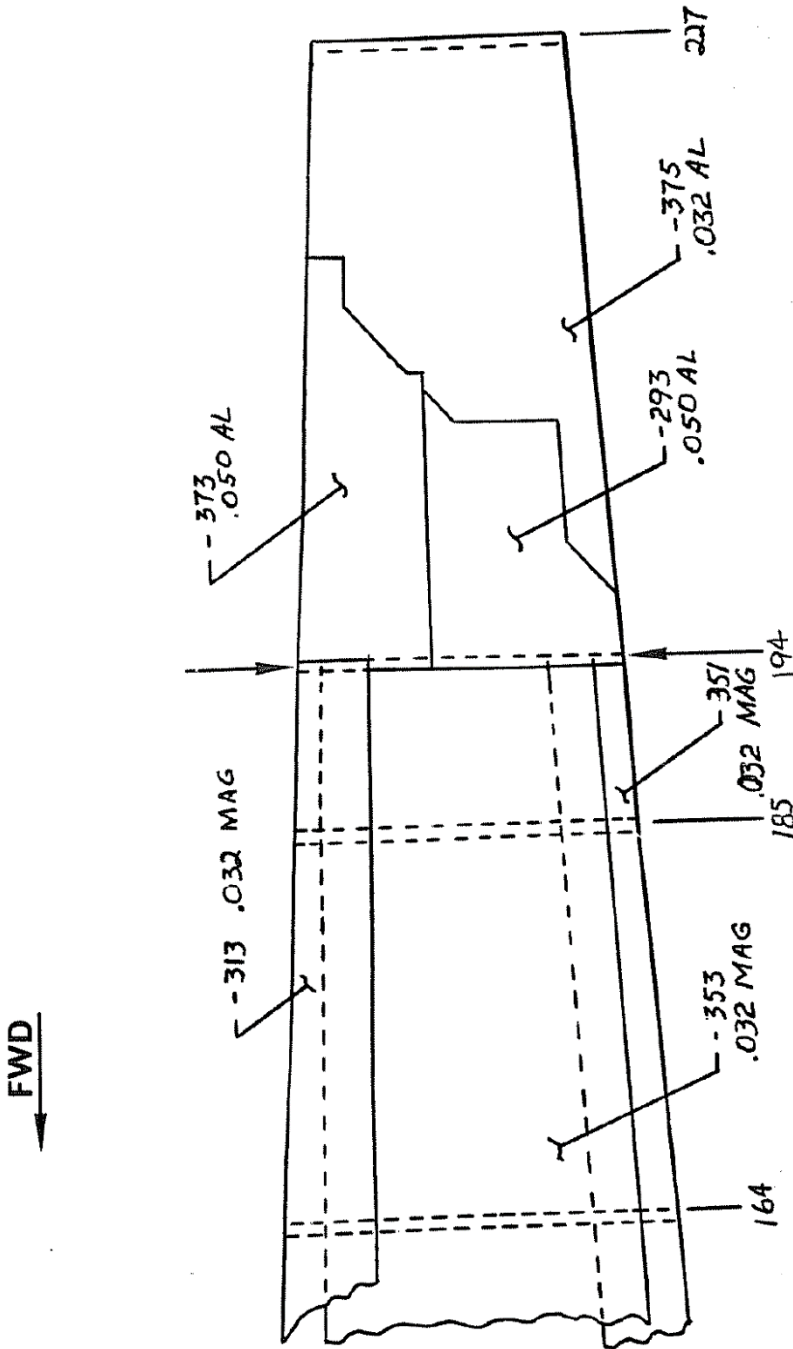
Figure 2.

*Note 2: National Transportation Safety Board of the United States of America (NTSB) Safety Recommendation(s) A-82-52 has been referenced as a source document for Figure 2.*

Background: FAA AD 83-03-03 Amdt 39-4556 with an effective date of 14 March 1983 was issued to detect cracks and prevent possible failure of the tail boom and fin. The FAA had determined that tail boom skin cracks occurred in a model UH-1B which crashed. A metallurgical examination revealed cracks to be due to structural fatigue.

Sketch of the skin panels on the left side of the tail boom of the UH-1B from station 164 to station 227. Part number, thickness and alloy of the various skin pieces are indicated. For example, "-353 .032 mag" indicates that this skin piece is P/N 204-030-800-369-353 and is a magnesium alloy sheet with an 0.032 inch thickness. Arrows indicate the station 194 fracture location.
