AIRWORTHINESS DIRECTIVE

AlliedSignal (Lycoming) Turbine Engines - ALF502 and LF507 Series

AD/ALF/21

High Pressure Compressor Discs

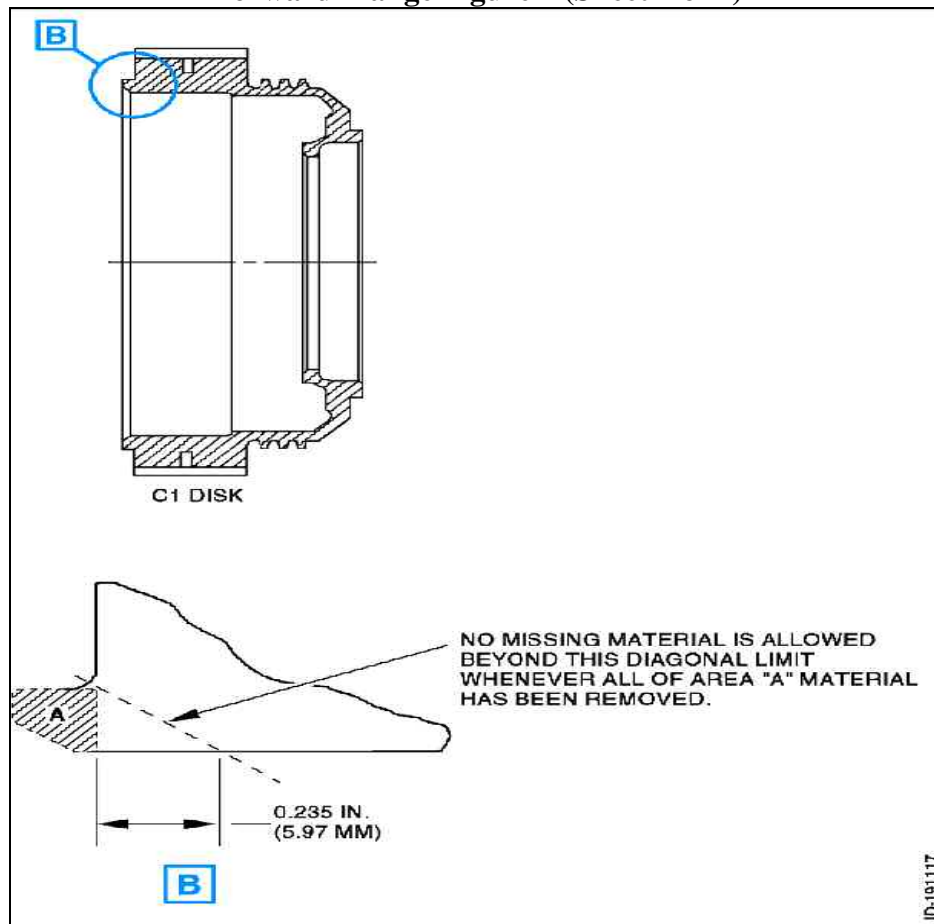
**Limits for Removed Balance Material, Disc
Forward Flange Figure 1 (Sheet 1 of 2)**

Requirement: 1. For discs with 5,000 or more cycles-since-new on the effective date of this AD, perform a dimensional inspection of the HPC first stage disc to determine if excessive disc balance material was removed. See the following Figure 1 for limits.

Background: This AD results from reports of discs found with excessive material removed from the balancing locations of the disc. The issuing of this AD is intended to prevent the discs from fracturing before reaching the currently published life limit. A disc fracture could result in an uncontained failure of the disc and damage to the aeroplane.

2. Replace the disc if excessive disc balance material was removed. See limits in Figure 1 of this AD.
3. If the removed balance material condition is acceptable, perform a magnetic particle inspection of the disc rim and slots for cracks using a 3 to 7 power magnification glass. The Engine Overhaul Manual, 72-34-11, Inspection/Check, contains information on the magnetic particle inspection procedure.
4. Replace the disc if any cracks are found.
