Cessna 170, 172, F172, FR172 and 175 Series Aeroplanes

**AD/CESSNA 170/47**                      **Crankcase Breather Tube and Oil Seal**                      **4/86**  
**Amdt 1**

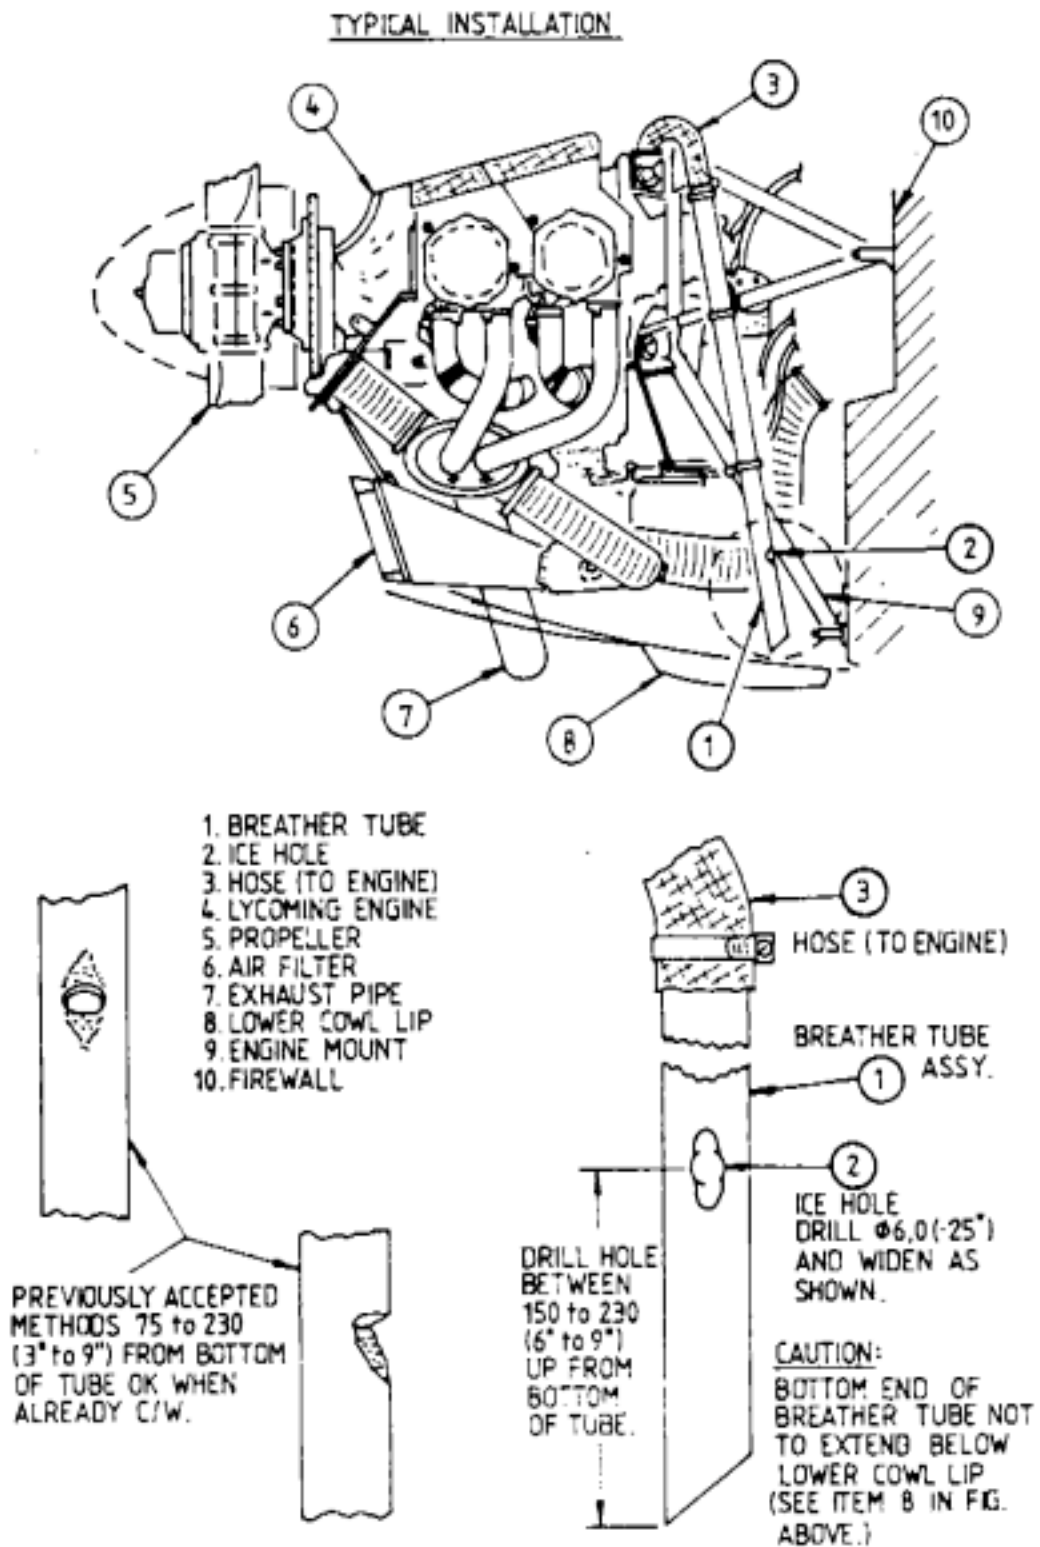
FIGURE 1.

- Requirement: To reduce the possibility of rapid loss of engine oil caused by ice obstruction of the engine crankcase breather, accomplish the following:

1. Visually examine the engine crankcase breather to determine if an alternate air outlet is drilled or cut in the tube as shown in Figure 1. If any of these provisions exist, make an appropriate entry in the aircraft maintenance records. No further action is necessary.

- Background: This AD has been amended to clarify the situation where the breather is still in close proximity to the exhaust outlet. Although this may currently prevent the breather from freezing, the exhaust system has been redesigned and the outlet moved to the opposite side. The original exhaust system is no longer available, and if a new exhaust is fitted the breather will then be unprotected. Therefore all breathers should be modified regardless of position.

2. If the hole or cutout shown in Figure 1 is not in the engine crankcase breather tube:
    - (a) Inspect the crankcase to crankshaft seal and ensure that the seal is secure. (This seal is located behind the starter ring gear in the forwardmost part of the crankcase). Reinstall or replace this seal if it is not flush with the forward face of the crankcase.

- (b) Drill the engine crankcase breather tube line to include an alternate air outlet as shown in Figure 1.
- Compliance: Unless already accomplished, within 100 hours time in service after 30 June 1982.
