## AIRWORTHINESS DIRECTIVE

### Cessna 170, 172, F172, FR172 & 175 Series Aeroplanes

**AD/CESSNA 170/57  
Amdt 4**

**Forward Door Post Bulkhead**

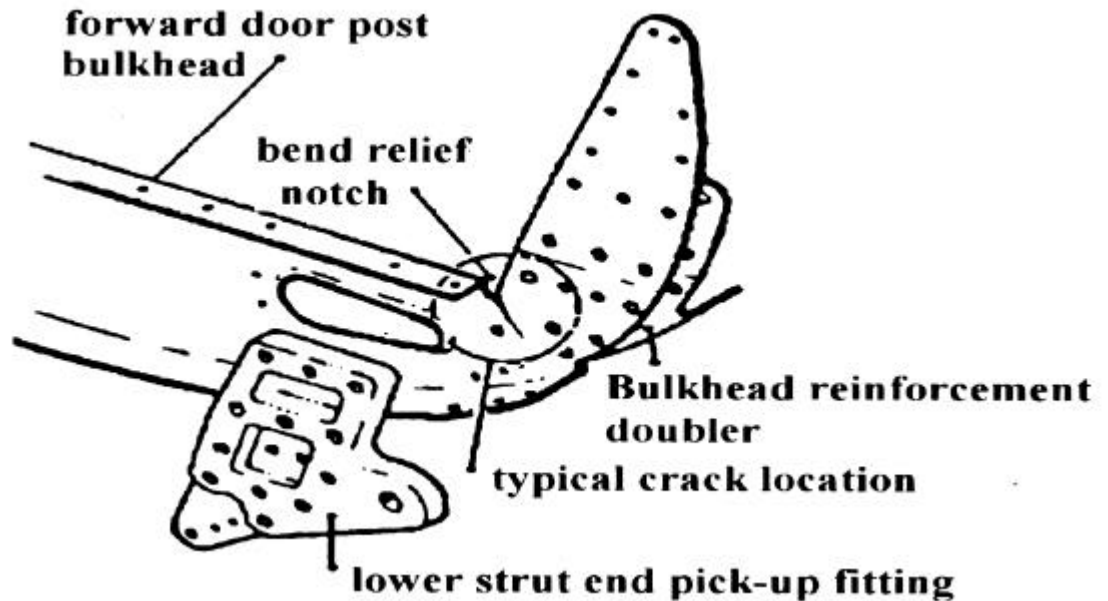
1. Visually inspect the wing strut lower attachment structure to determine the type of strut attachment used. Aircraft with the earlier embedded type strut attachment are not subject to any further action. Aircraft with strut attachment fittings of the type with the protruding lug, similar to that shown in the diagram below, must comply with Requirement paragraphs 2 and 3.

2. Visually inspect for cracks at the inside edge of the left hand and right hand bend relief notches of the forward door post bulkhead.
3. Visually inspect for loose or working fasteners securing the lower strut end pick-up fitting to the forward door post bulkhead. The inspection areas and typical crack location are shown in the diagram below.

The bend relief notch in the bulkhead serves as a stress concentration notch, causing fatigue cracks to propagate across the bulkhead web. The strut attachment area forms part of the wing's primary load path, and loss of strength in this area could be catastrophic. Although most of this area is covered by the strut attach fitting and a bulkhead reinforcement doubler, the inside edge of the bulkhead, where the cracks have been initiating, is visible without removing the lower strut attachment fitting.

**Compliance:** Inspect before exceeding 1000 hours aircraft time in service, or before 50 hours time in service after 20 July 1995, whichever occurs last. Thereafter inspect in accordance with Requirements 2 and 3, as applicable, at intervals not to exceed 500 hours time in service.
