AIRWORTHINESS DIRECTIVE

Cessna 180, 182 and Wren 460 Series Aeroplanes**AD/CESSNA 180/15
Amdt 4****Rear Spar****8/2004**

TECHNICAL MEMO NO. 12

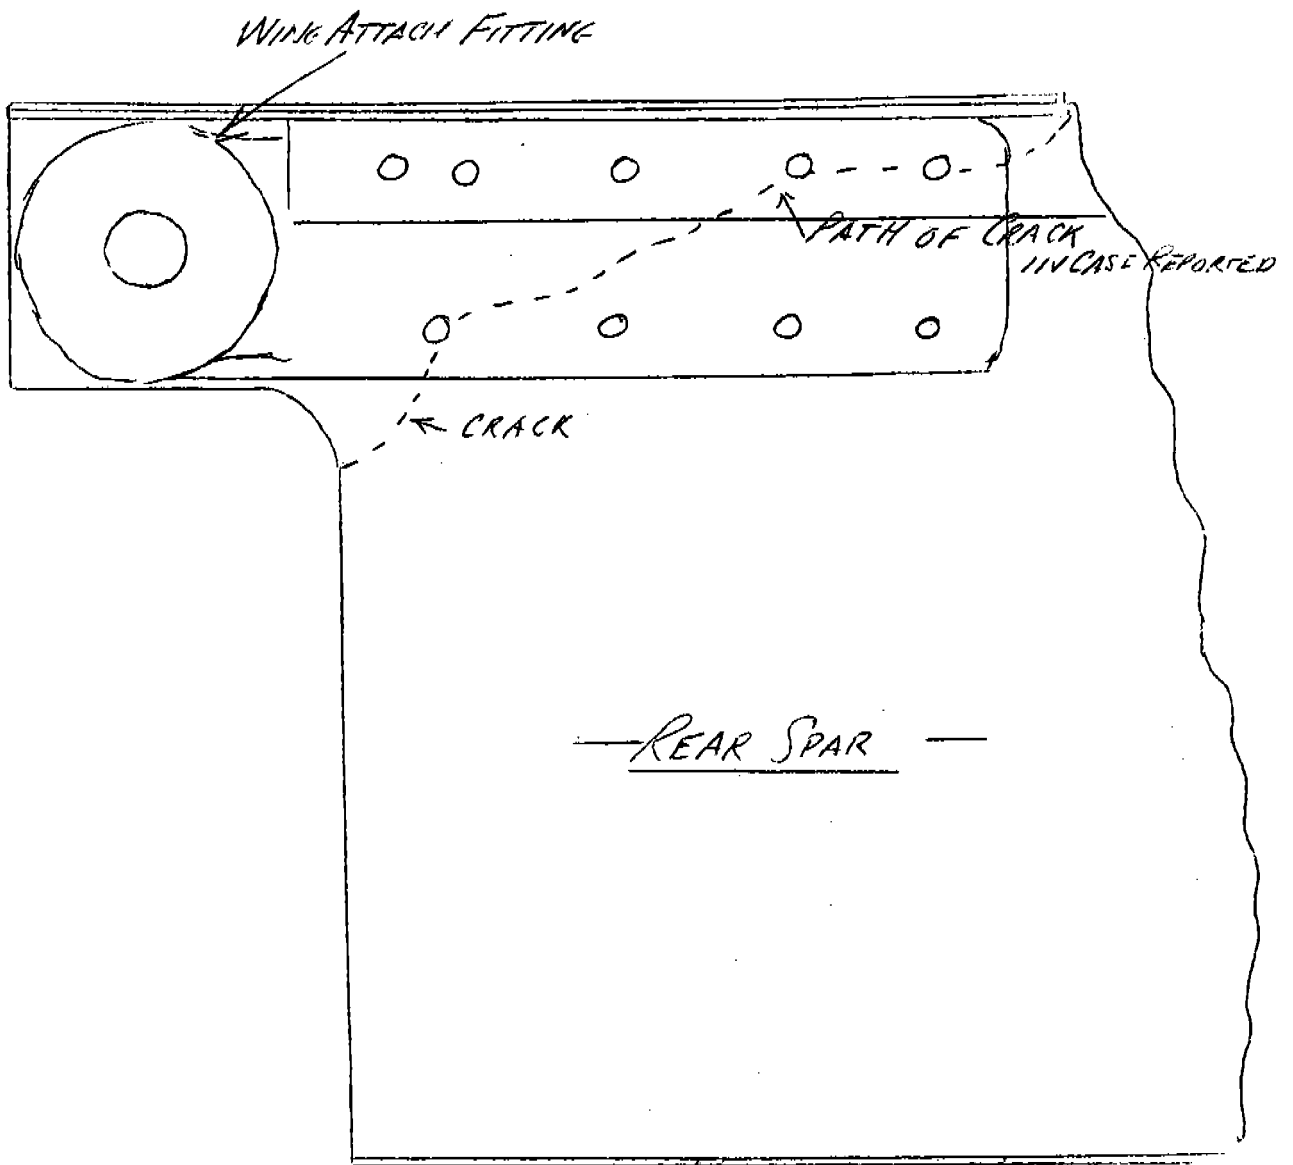
REAR SPAR ATTACHMENT FAILURE

A recent fatal accident occurring to a Cessna 180 Agricultural aircraft in New Zealand has been attributed to the failure of the mainplane rear spar attachment, as shown in the attached sketch.

The Civil Aviation Authorities in New Zealand, who investigated the accident, consider this failure may have been due to high inertial loads, such as would be imposed during unauthorised aerobatics or as a result of a ground loop wing damage,

Please note that any possible cracks in the spar web area below the fitting may be difficult to detect, as the trailing edge root end rib fit closely to the spar. Where any doubt exists the trailing edge root end rib should be removed for more detailed inspection. It is also necessary to inspect the upper flange of the spar itself at the outer ends of the attach fitting. This can be done through the flap bay inner inspection panel.

Any aircraft found cracked or otherwise defective in this area is to be reported to the Department of Civil Aviation and ourselves, and not to be flown until suitable modification or repair action is carried out. Please advise the results of all inspections.

An approved repair scheme is in course of preparation by our associate Company in New Zealand and will be made available to Australian operators if required.
