Cessna 180, 182 and Wren 460 Series Aeroplanes

AIRWORTHINESS DIRECTIVE

AD/CESSNA 180/75
Amdt 2

Forward Door Post Bulkhead

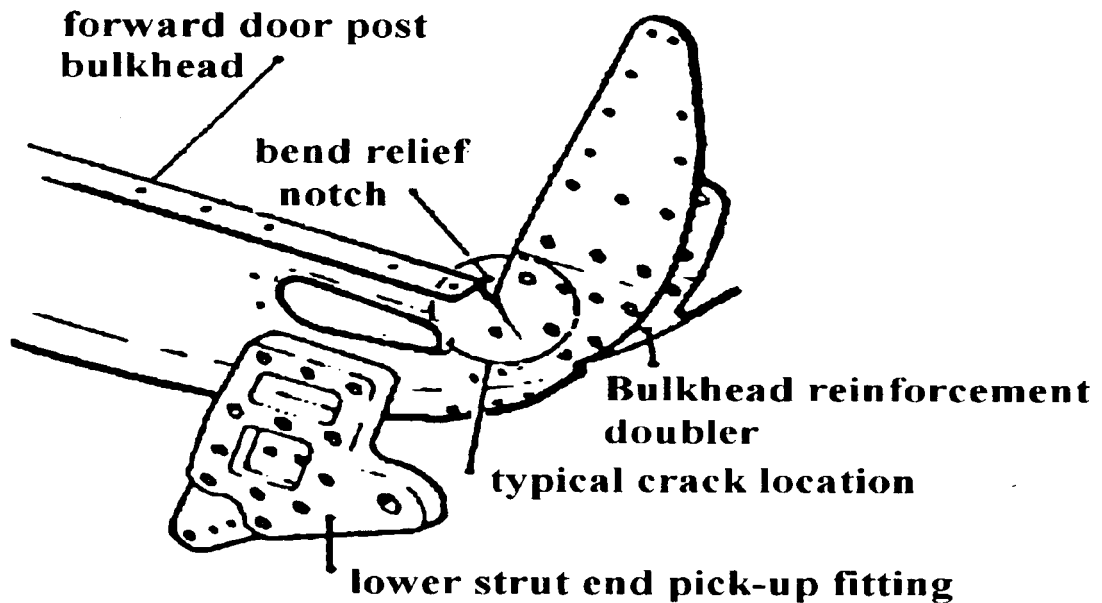
2. Visually inspect for cracks at the inside edge of the left hand and right hand bend relief notches of the forward door post bulkhead.
3. Visually inspect for loose or working fasteners securing the lower strut end pick-up fitting to the forward door post bulkhead. The inspection areas and typical crack location are shown in the diagram below.

Background: Numerous reports have been received of cracking in this area on Cessna models 206 and 182. The bend relief notch in the bulkhead serves as a stress concentration notch, causing fatigue cracks to propagate across the bulkhead web. The strut attachment area forms part of the wing's primary load path, and loss of strength in this area could be catastrophic. Although most of this area is covered by the strut attach fitting and a bulkhead reinforcement doubler, the inside edge of the bulkhead, where the cracks have been initiating, is visible without removing the lower strut attachment fitting.

Compliance: Inspect before exceeding 1000 hours aircraft time in service, before 50 hours time in service after 20 July 1995, or before 200 hours time in service since last inspected in accordance with this Directive, whichever occurs last.

Thereafter inspect in accordance with Requirements 2 and 3, as applicable, at intervals not to exceed 200 hours time in service.

Amendment 2 is issued to allow the installation of Cessna Service kit 182-115 as terminating action for the repetitive inspection requirement.
