AIRWORTHINESS DIRECTIVE

Cessna 205 (210-5) Series Aeroplanes

**AD/CESSNA 205/21
Amdt 2**

Forward Door Post Bulkhead

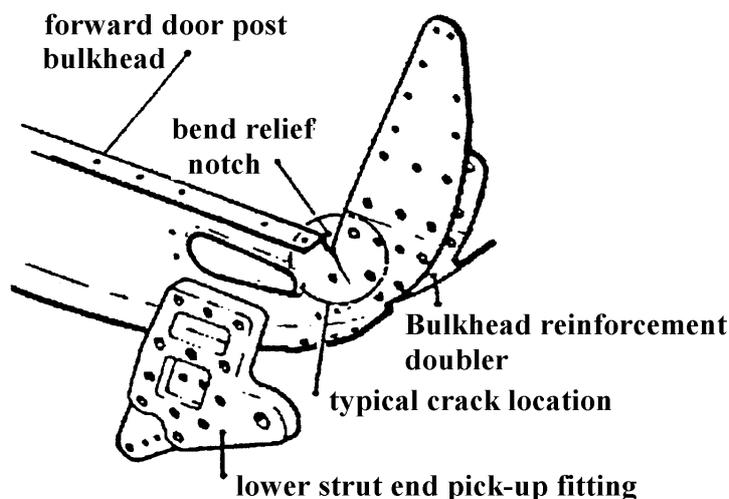
1. Visually inspect for cracks at the inside edge of the left hand and right hand bend relief notches of the forward door post bulkhead.
2. Visually inspect for loose or working fasteners securing the lower strut end pick-up fitting to the forward door post bulkhead. The inspection areas and typical crack location are shown in the diagram below.

Background: Numerous reports have been received of cracking in this area on Cessna models 182, 205 and 206. The bend relief notch in the bulkhead serves as a stress concentration notch, causing fatigue cracks to propagate across the bulkhead web. The strut attachment area forms part of the wing's primary load path, and loss of strength in this area could be catastrophic. Although most of this area is covered by the strut attach fitting and a bulkhead reinforcement doubler, the inside edge of the bulkhead, where the cracks have been initiating, is visible without removing the lower strut attachment fitting.

Amendment 2 of this Airworthiness Directive is issued to allow the installation of the appropriate Cessna Service Kit as terminating action for the repetitive inspection requirement.
