AIRWORTHINESS DIRECTIVE

Cessna 206 Series Aeroplanes

**AD/CESSNA 206/48
Amdt 2**

Forward Door Post Bulkhead

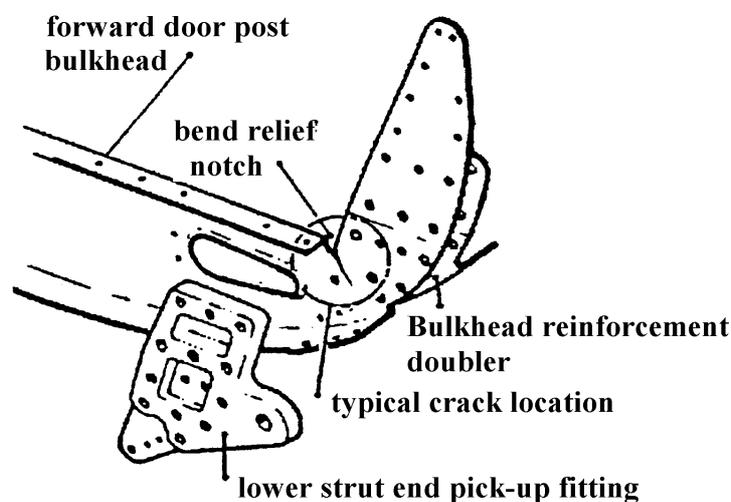
1. Visually inspect for cracks at the inside edge of the left hand and right hand bend relief notches of the forward door post bulkhead.
2. Visually inspect for loose or working fasteners securing the lower strut end pick-up fitting to the forward door post bulkhead. The inspection areas and typical crack location are shown in the diagram below.

Background: Numerous reports have been received of cracking in this area on Cessna models 206 and 182. The bend relief notch in the bulkhead serves as a stress concentration notch, causing fatigue cracks to propagate across the bulkhead web. The strut attachment area forms part of the wing's primary load path, and loss of strength in this area could be catastrophic. Although most of this area is covered by the strut attach fitting and a bulkhead reinforcement doubler, the inside edge of the bulkhead, where the cracks have been initiating, is visible without removing the lower strut attachment fitting.

Applicability: All models that do not have Cessna Service Kit SK206-42 or SK206-42A or SK206-42B or SK206-42C, as per Cessna SEB 93-5 Revision 1.

Amendment 2 of this Airworthiness Directive is issued to allow the installation of the appropriate Cessna Service Kit as terminating action for the repetitive inspection requirement.
