## AIRWORTHINESS DIRECTIVE

### Cessna 206 Series Aeroplanes

**AD/CESSNA 206/54**                      **Horizontal Stabilizer Front Spar**                      **9/2004**  
**Amdt 2**

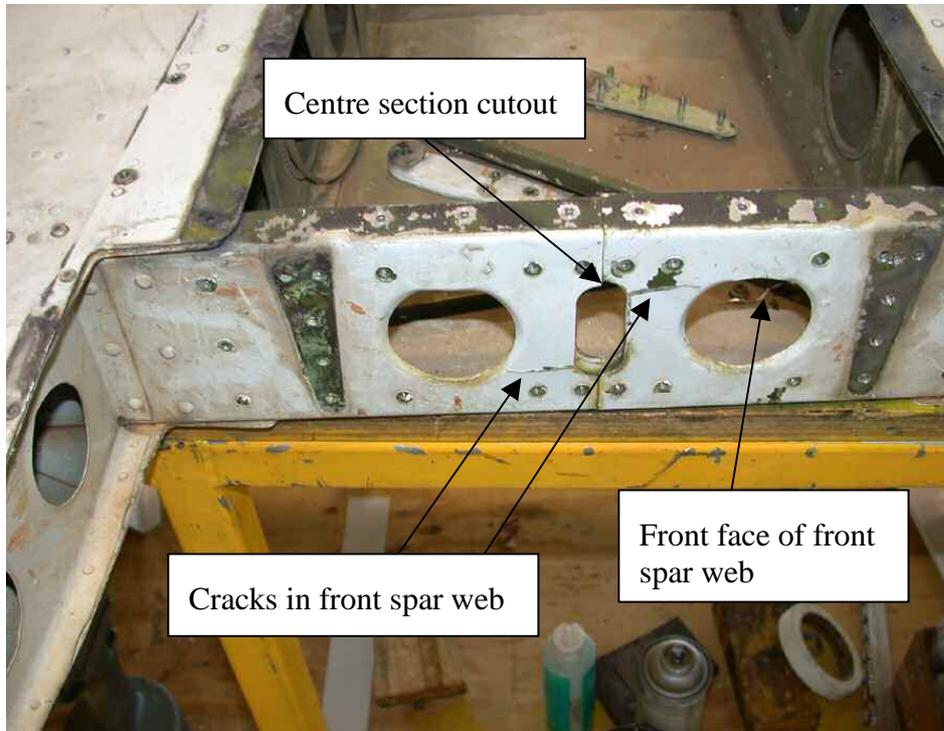
Requirement: Visually inspect the front and rear faces of horizontal stabilizer front spar assembly centre section for cracks around the cut-out in the front spar web. Refer to Figure 1 below.

It should be noted that for models manufactured from 1968 onwards the horizontal stabiliser front spar would be of a three-layer design. This means that the centre laminate will effectively be hidden by the two outer laminates, making inspection of the centre laminate almost impracticable. The centre laminate should be inspected as far as practicable without disassembly of the spar.

Background: Reports have been received of cracking of the horizontal stabilizer front spar on Australian registered Cessna 210s. Both front and rear spars must be serviceable for the horizontal stabilizer to carry ultimate load. The front spar forms part of the horizontal stabilizer's primary load path, and loss of strength in this area could be catastrophic.

Any cracks in the front spar web must be repaired before further flight, and a defect report must be submitted.
