AIRWORTHINESS DIRECTIVE

Cessna 207 Series Aeroplanes

**AD/CESSNA 207/32
Amdt 2**

Forward Door Post Bulkhead

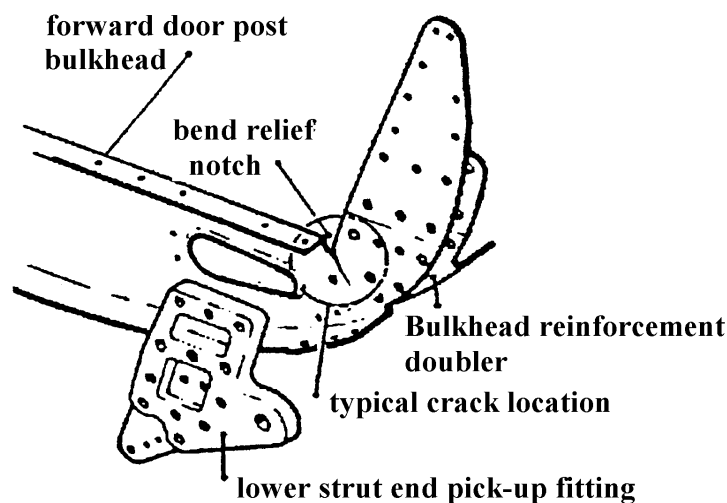
1. Visually inspect for cracks at the inside edge of the left hand and right hand bend relief notches of the forward door post bulkhead.
2. Visually inspect for loose or working fasteners securing the lower strut end pick-up fitting to the forward door post bulkhead. The inspection areas and typical crack location are shown in the diagram below.

Background: Numerous reports have been received of cracking in this area on Cessna models 206 and 182. The structure on the model 207 is similar. The bend relief notch in the bulkhead serves as a stress concentration notch, causing fatigue cracks to propagate across the bulkhead web. The strut attachment area forms part of the wing's primary load path, and loss of strength in this area could be catastrophic.

Although most of this area is covered by the strut attach fitting and a bulkhead reinforcement doubler, the inside edge of the bulkhead, where the cracks have been initiating, is visible without removing the lower strut attachment fitting.

Amendment 2 of this Airworthiness Directive is issued to allow the installation of the appropriate Cessna Service Kit as terminating action for the repetitive inspection requirement.
