AIRWORTHINESS DIRECTIVE

Cessna 207 Series Aeroplanes

AD/CESSNA 207/34 **Horizontal Stabilizer Front Spar** **9/2004**
Amdt 1

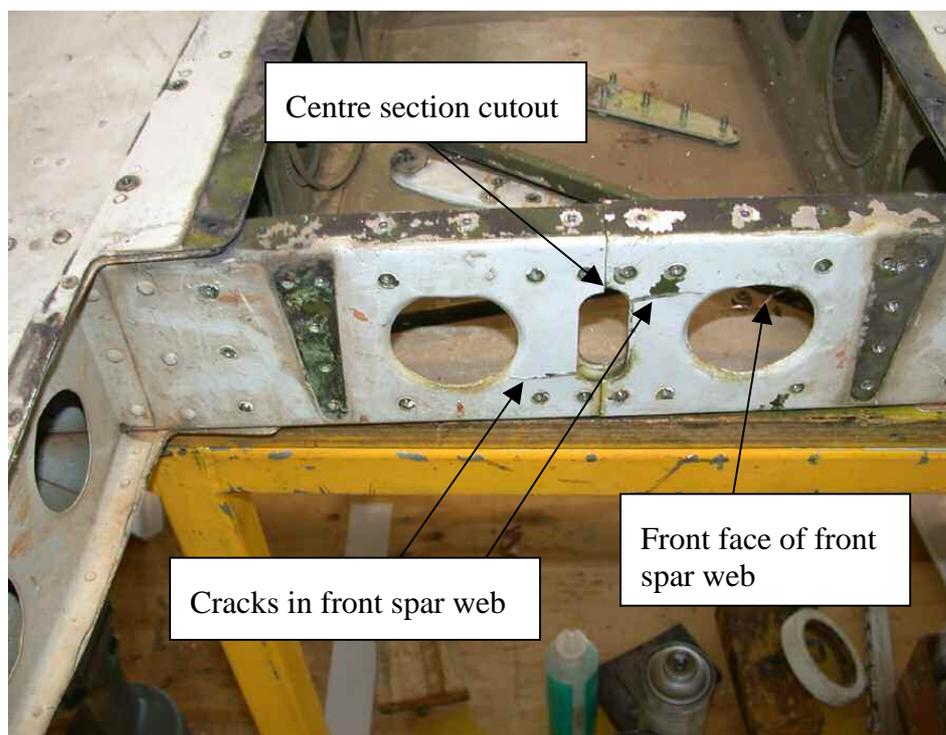
Requirement: Visually inspect the front and rear faces of horizontal stabilizer front spar assembly centre section for cracks around the cut-out in the front spar web. Refer to Figure 1 below. Any cracks in the front spar web must be repaired before further flight, and a defect report must be submitted.

Background: Reports have been received of cracking of the horizontal stabilizer front spar on Australian registered Cessna 210s. Both front and rear spars must be serviceable for the horizontal stabilizer to carry ultimate load. The front spar forms part of the horizontal stabilizer's primary load path, and loss of strength in this area could be catastrophic. As the 207 and 210 have similar horizontal stabilizer design, the same in service cracking may also occur on the Cessna 207 aircraft.
