## Airworthiness Directive

**AD No.:** 2018-0043

A380 aeroplanes

## ATA 71 – Power Plant – Rear Engine Mount Assembly – Inspection

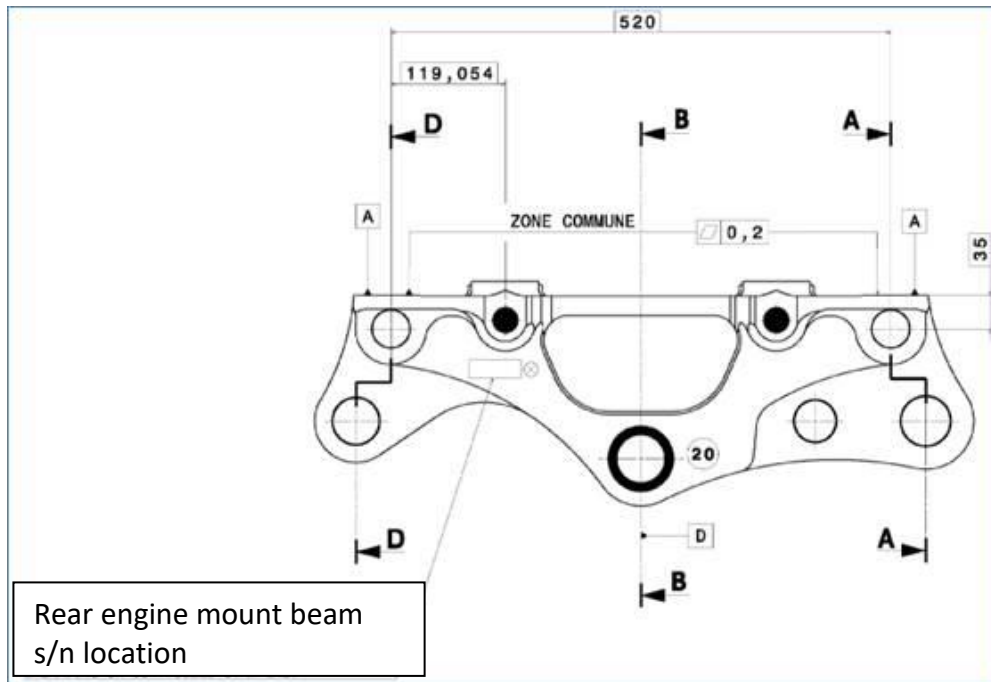
Figure 1 – Rear engine mount beam

Note 2: The s/n of the beam (in some cases with a prefix added by Airbus) is provided on the main body (back face) of the part, as shown in Figure 1 above.

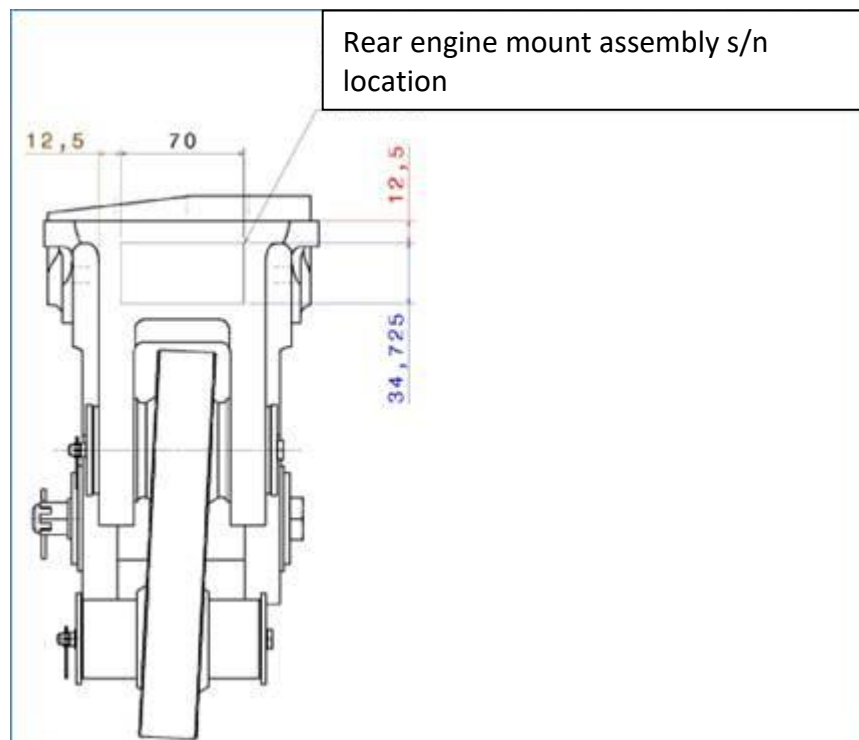
Figure 2 – Rear engine mount assembly

Note 3: The s/n of the rear engine mount assembly is provided on the left side of the part, as shown in Figure 2 above.
