Airworthiness Directive

AD No.: 2018-0043R1

A380 aeroplanes

ATA 71 – Power Plant – Rear Engine Mont Assembly – Inspection

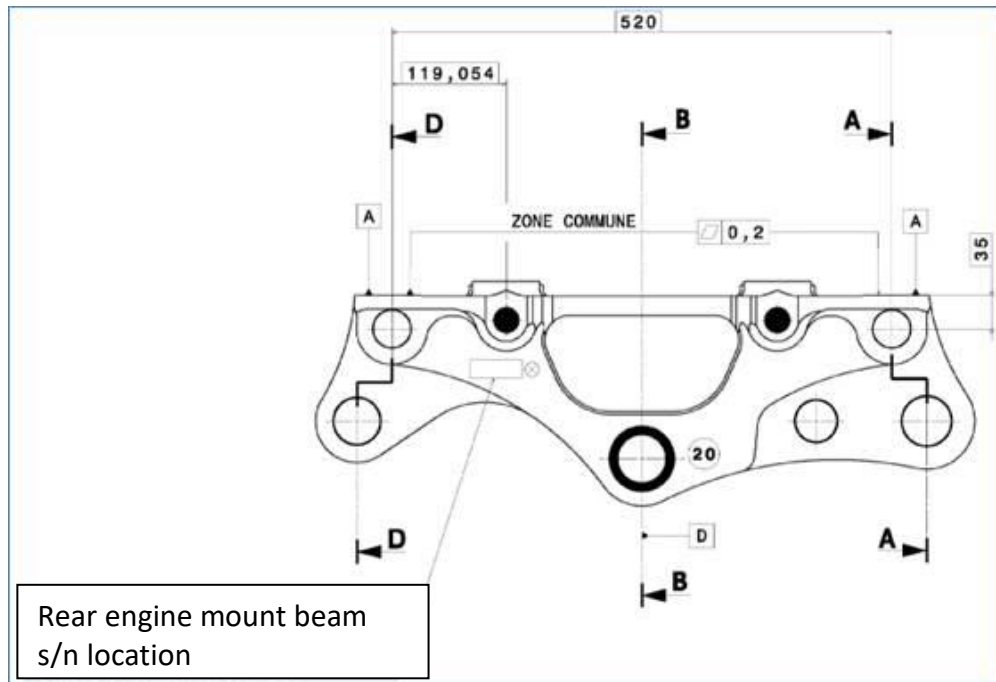
Figure 1 – Rear engine mount beam

Affected part: Rear engine mount beams, Part Number (P/N) L7121076120000, except those with a serial number (s/n) as listed in Appendix 1 of this AD. For the location of the s/n of the beam, see Figure 1 of Appendix 2 of this AD.

Note 2: The s/n of the beam (in some cases with a prefix added by Airbus) is provided on the main body (back face) of the part, as shown in Figure 1 above.

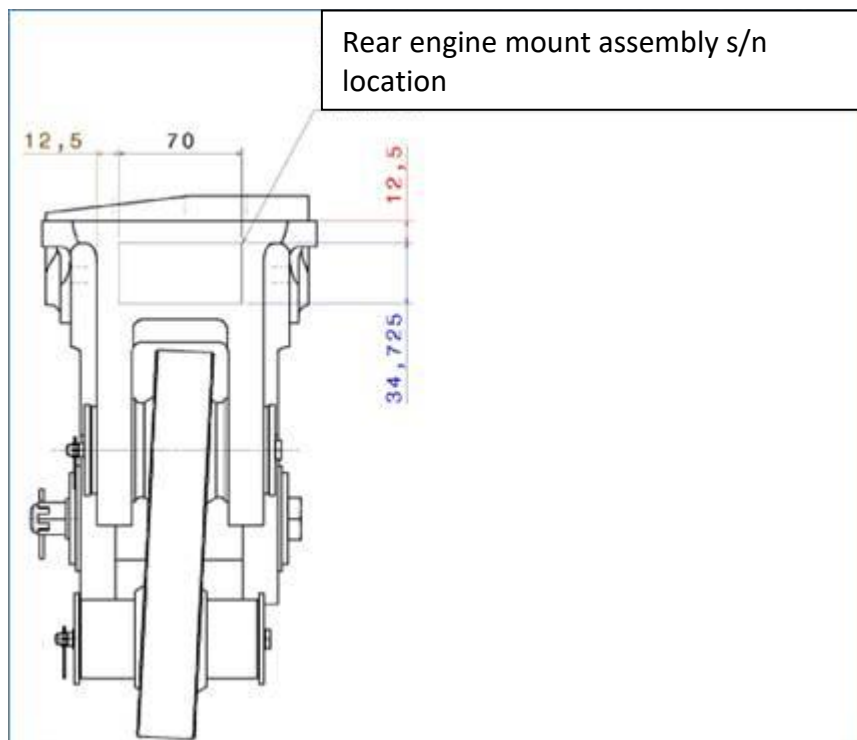
Figure 2 – Rear engine mount assembly

Affected assembly: Rear engine mount assemblies, P/N L7121016002000, P/N L7121016200000, and P/N L7121016500000 (where the number of zeros at the end of the P/N can vary), having an affected part installed, except those assemblies with a s/n as listed in Appendix 1 of this AD. For the location of the s/n of the assembly, see Figure 2 of Appendix 2 of this AD.

Note 3: The s/n of the rear engine mount assembly is provided on the left side of the part, as shown in Figure 2 above.
