<b>EASA</b>	<b>AIRWORTHINESS DIRECTIVE</b>

<p><b>AD No.: 2012-0064</b></p> <p><b>Date: 20 April 2012</b></p> <p>Note: This Airworthiness Directive (AD) is issued by EASA, acting in accordance with Regulation (EC) No 216/2008 on behalf of the European Community, its Member States and of the European third countries that participate in the activities of EASA under Article 66 of that Regulation.</p>
<p>This AD is issued in accordance with EC 1702/2003, Part 21A.3B. In accordance with EC 2042/2003 Annex I, Part M.A.301, the continuing airworthiness of an aircraft shall be ensured by accomplishing any applicable ADs. Consequently, no person may operate an aircraft to which an AD applies, except in accordance with the requirements of that AD unless otherwise specified by the Agency [EC 2042/2003 Annex I, Part M.A.303] or agreed with the Authority of the State of Registry [EC 216/2008, Article 14(4) exemption].</p>

<p><b>Type Approval Holder's Name :</b></p> <p>ATR-GIE Avions de Transport Régional</p>	<p><b>Type/Model designation(s) :</b></p> <p>ATR 42-500 and ATR 72-212A aeroplanes</p>
TCDS Number:	EASA.A.084
Foreign AD:	Not applicable
Supersedure:	This AD supersedes EASA Emergency AD

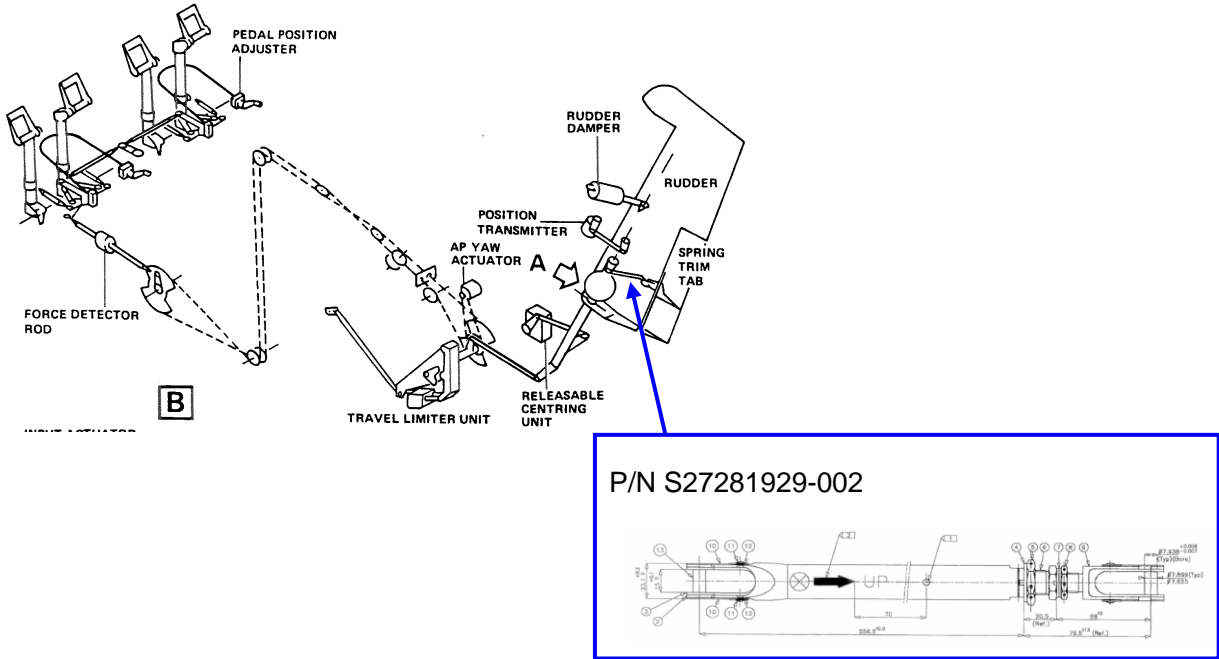
Appendix 1 - Rudder tab control rod location

- (5) In addition to the actions required by paragraphs (1), (2), (3) and/or (4) of this AD, as applicable, for aeroplanes (MSN) listed in the applicability paragraph of this AD, except MSN 671, 673 and 769 to 784 inclusive, within 24 months after the effective date of this AD, inspect the rudder tab control rod P/N S27281929-002 for batch number identification, in accordance with the instructions of the applicable ATR Aircraft Maintenance Manual / Job Instruction Card (AMM/JIC) 27-20-00 DVI 10000. Refer to Appendix 1 of this AD for rod location.

- (6) If, during the inspection as required by paragraph (5) of this AD, the rudder tab control rod is found belonging to batch number 2107267 or 2120855, or if the batch number is unreadable, before next flight, replace the rod with a serviceable one in accordance with the instructions provided in AMM/JIC 27-21-42 RAI 10000, and identify the removed rod as unserviceable component.
