<b>EASA</b>	<b>AIRWORTHINESS DIRECTIVE</b>

<p><b>AD No.: 2012-0192</b>  <b>[Correction: 24 September 2012]</b></p> <p><b>Date: 21 September 2012</b></p> <p>Note: This Airworthiness Directive (AD) is issued by EASA, acting in accordance with Regulation (EC) No 216/2008 on behalf of the European Community, its Member States and of the European third countries that participate in the activities of EASA under Article 66 of that Regulation.</p>	
<p>This AD is issued in accordance with EC 748/2012, Part 21.A.3B. In accordance with EC 2042/2003 Annex I, Part M.A.301, the continuing airworthiness of an aircraft shall be ensured by accomplishing any applicable ADs. Consequently, no person may operate an aircraft to which an AD applies, except in accordance with the requirements of that AD, unless otherwise specified by the Agency [EC 2042/2003 Annex I, Part M.A.303] or agreed with the Authority of the State of Registry [EC 216/2008, Article 14(4) exemption].</p>

<p><b>Design Approval Holder's Name:</b>  ATR-GIE Avions de Transport Régional</p>	<p><b>Type/Model designation(s):</b>  ATR 72-212A aeroplanes</p>	
<p>TCDS Number:</p>	<p>EASA A.084</p>	
<p>Foreign AD:</p>	<p>Not applicable</p>

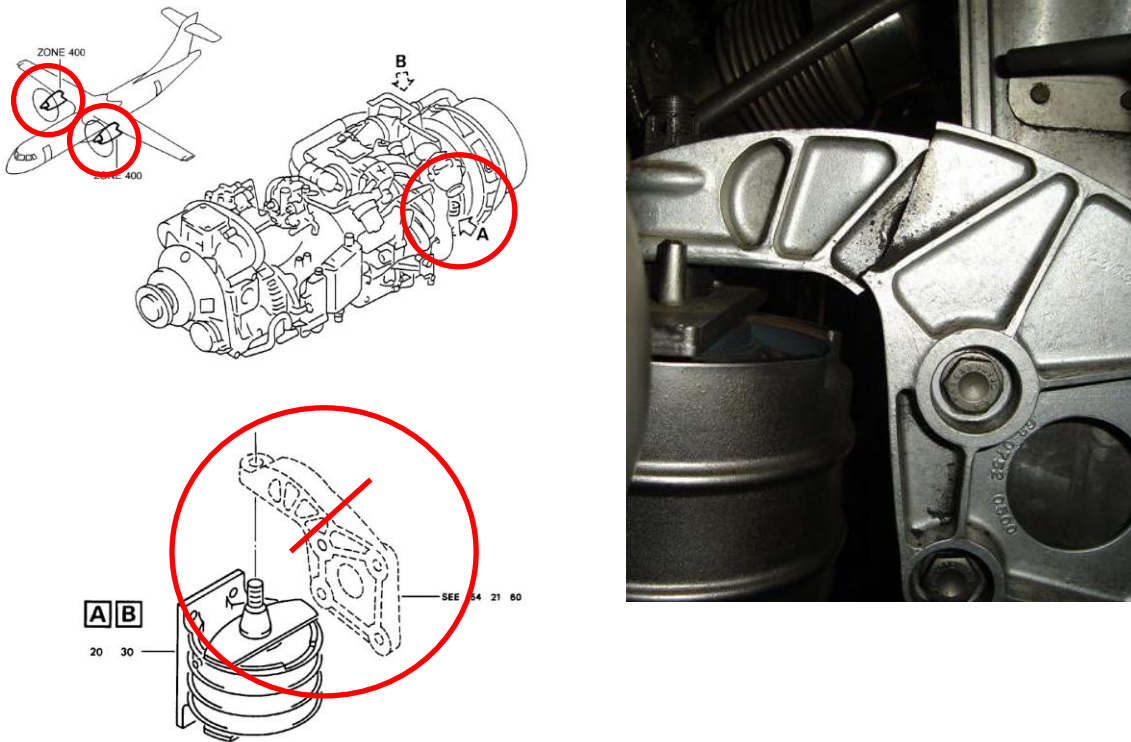
Figure 1: Shock mount pick-up fitting potential failure

<p>Required Action(s) and Compliance Time(s):</p>	<p>Required as indicated, unless already accomplished</p> <p>(1) Within 6 months after the effective date of this AD, accomplish the following actions concurrently:</p> <p>(1.1) Identify the s/n of the P/N S54210394200 (Barry Control P/N 94423-05) LH and RH shock mount pick-up fittings installed on both engine nacelles. Appendix 2 of this AD identifies the fitting P/N and s/n locations.</p> <p>A review of maintenance records is acceptable to determine the s/n of the LH and RH shock mount pick-up fitting, provided the s/n can be conclusively identified from this review.</p> <p>(1.2) Visually inspect both LH and RH aft side isolator pick-up fittings on both engines in accordance with the instructions of the applicable Aircraft Maintenance Manual (AMM) Job Instruction Card (JIC) 541161-DVI-10000 paragraph 004.1. Refer to Appendix 1 Figure 1 of this AD for potential crack location.</p> <p>(1.3) Visually inspect both LH and RH aft shock mount cone bolts on both engines in accordance with the instructions of the applicable AMM JIC 712000-DVI-10000 paragraph 006.3.A. Refer to Appendix 1 Figure 2 of this AD for potential crack location.</p> <p>(2) If, during any inspection as required by paragraphs (1.2) or (1.3) of this AD, cracks are detected, before next flight, replace defective component in accordance with approved ATR instructions.</p> <p>(3) If the s/n of the L/H shock mount pick-up fitting, identified as required by paragraph (1.1) of this AD, is lower than 2451 or unreadable, and no crack has been found, within 6 months after the inspection as required by paragraph (1.2) of this AD, replace LH shock mount pick-up fitting P/N S54210394200 with a serviceable LH shock mount pick-up fitting having a s/n equal to or higher than 2451, in accordance with ATR approved instructions.</p> <p>(4) Within 30 days after the inspections as required by paragraph 1 of this AD, report all findings (including none) to ATR, by using the reporting form provided in Appendix 3 of this AD.</p> <p>(5) From the effective date of this AD, do not install on any aeroplane a LH shock mount pick-up fitting P/N S54210394200, unless it has been determined to have a s/n equal to or higher than 2451.</p>

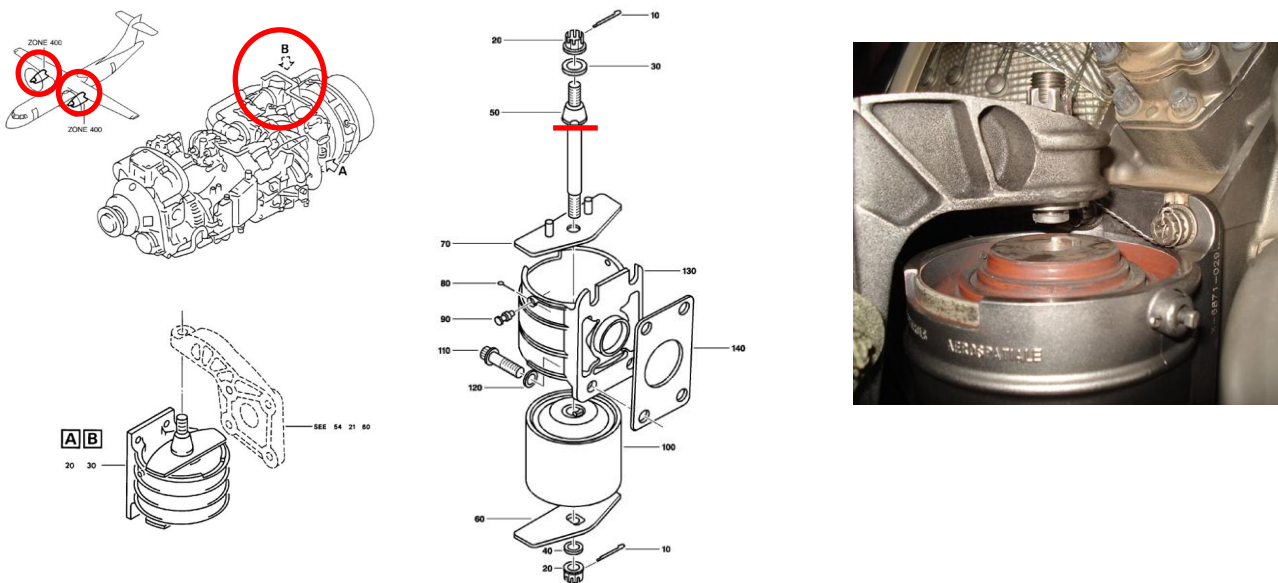
Figure 2: Shock mount cone bolt potential failure

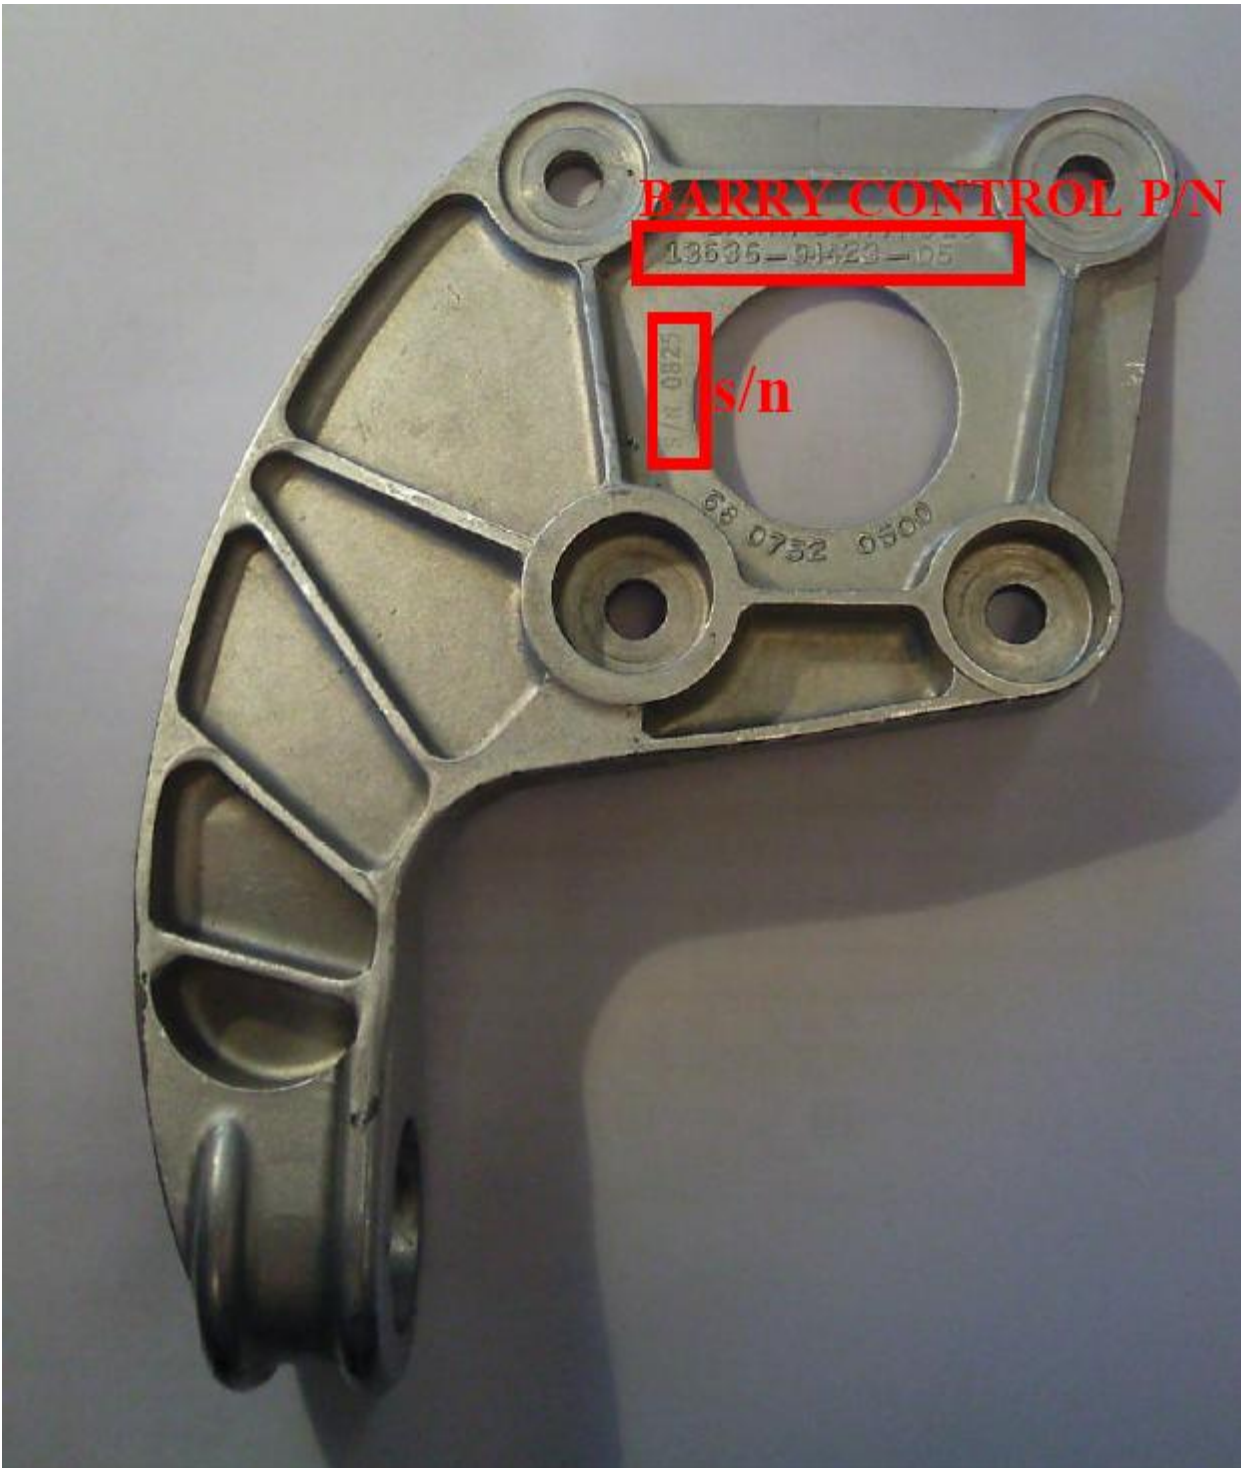
Figure 3: Location of Fitting P/N and s/n

Reminder: if pick-up fitting s/n is below 2451, the pick-up fitting must be replaced
