[Docket No. FAA-2015-7527; Directorate Identifier 2015-NM-094-AD; Amendment 39-18686; AD 2016-21-05]

Airworthiness Directives; The Boeing Company Airplanes

2016-21-05 The Boeing Company: Amendment 39-18686; Docket No. FAA-2015-7527; Directorate Identifier 2015-NM-094-AD.

Air Transport Association (ATA) of America Code 2822, Fuel Boost Pump.

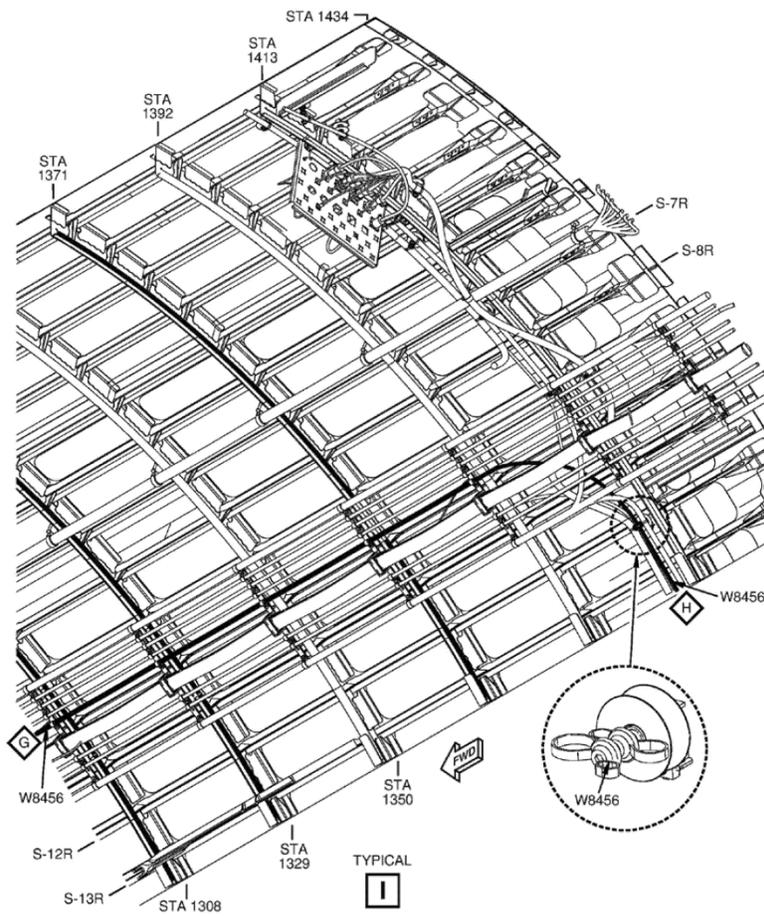
Figure 1 to paragraph (h) of this AD: Wiring Installation - Right Engine Fuel Spar Valve

We partially agree with the commenter's request. We cannot include Boeing Service Bulletin Information Notice 777-28-0061, IN 03, dated November 16, 2015, as an appropriate source of service information in this AD because it is not an FAA-approved document. However, we acknowledge that for certain airplanes, Figure 22, Sheet 9, of Boeing Special Attention Service Bulletin 777-28-0061, Revision 2, dated May 4, 2015, includes an editorial error, which shows incorrect wire routing. Boeing Service Bulletin Information Notice 777-28-0061, IN 03, dated November 16, 2015, allows for a modification of Group 2 airplanes that meets the requirements of the AD without an additional burden to operators. We have included a corrected figure in paragraph (h) of this AD to address this issue.

This AD was prompted by a report indicating that the manufacturer discovered locations where the control components and wiring of the left and right engine fuel spar valves do not have adequate physical separation to meet the redundant system separation requirements. We are issuing this AD to prevent loss of control of both the left and right engine fuel spar valves during a single event, such as local wire bundle damage or a wire bundle fire, which could cause both engines to shut down or result in the inability to control an engine fire.

(1) Where Boeing Special Attention Service Bulletin 777-28-0061, Revision 2, dated May 4, 2015, specifies to use Figure 22, Sheet 9, for the wiring installation of the right engine fuel spar valve, this AD requires using figure 1 to paragraph (h) of this AD.
