Propellers - Variable Pitch - Hartzell

**AD/PHZL/60**  
**Amdt 4**

**Three Bladed 'Y' Shank Aluminium Hubs**

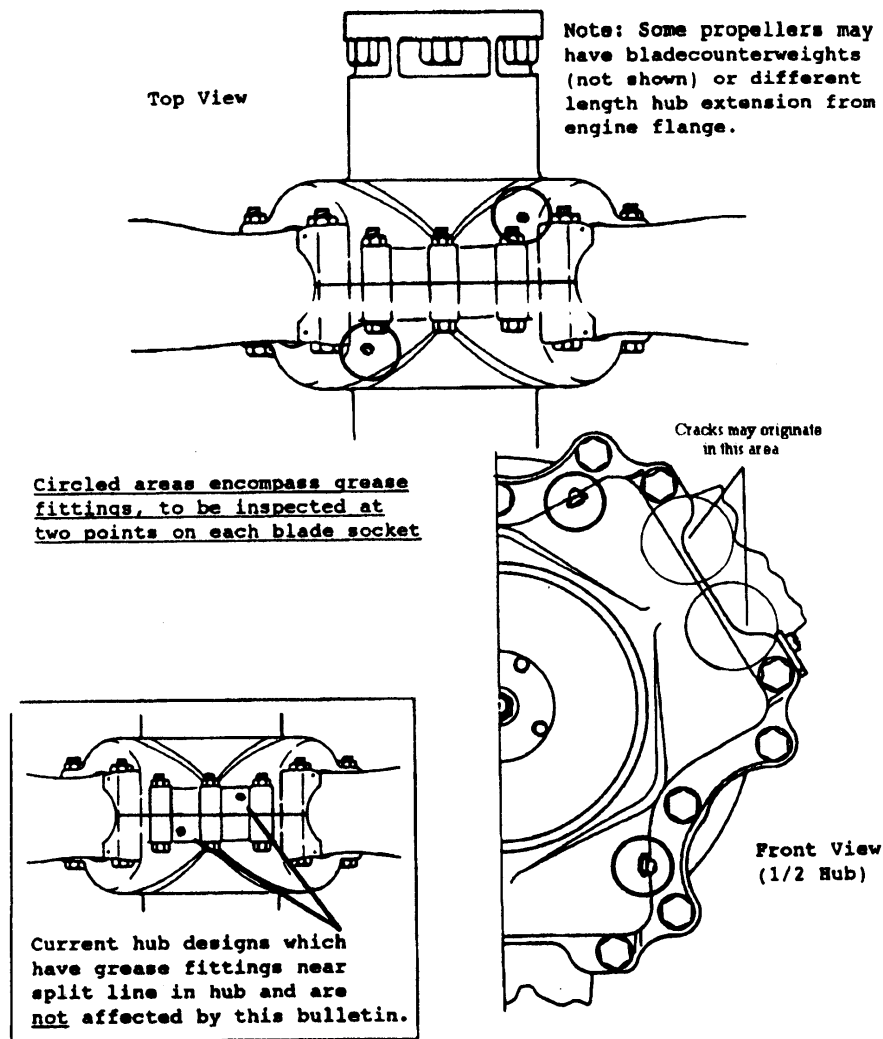
Background: There have been incidents of hub cracks in Hartzell three blade “compact” aluminium hub propellers. Cracks have originated in the threads of a grease fitting hole on the side of the hub and have also originated in the fillet radius area. The cracks are believed to be observable with careful visual examination using a 10X magnifying glass.

As the cracks propagate around the blade arm of the hub their progression accelerates and results in failure of one hub half which can then, potentially, progress to blade separation. Replacement with the later style hubs, post 83, provides terminating action for this Directive. The previous amendment reduces the repetitive inspection interval while this amendment, in line with the manufacturer’s SB, further reduces the inspection intervals, introduces an eddy current or fluorescent penetrant inspection requirement, allows chamfer modifications of the hub and for specific aircraft types mandates replacement of pre 83 hubs within a certain time frame.

- Requirement:
1. Carry out a visual inspection of the hub using a 10X glass looking for signs of cracking or grease leakage. Replace any hub found cracked prior to further flight. Perform an eddy current or dye penetrant inspection in accordance with the procedures specified in Hartzell SB 165E on any of the above specified model and S/N propellers installed on any agricultural aircraft or Piper PA-31-325 Navajo C/R, Piper PA-31-350 Navajo “Chieftain”, Piper T-1020 (same as PA-31-350), PA-60-700P or Aerostar 700P aircraft.

2. For all other aircraft types listed in this Directive carry out a visual inspection of the hub using a 10X glass looking for signs of cracking or grease leakage. Replace any hub found cracked prior to further flight. Perform an eddy current or dye penetrant inspection IAW the procedures specified in Hartzell SB 165E.
