AIRWORTHINESS DIRECTIVE

Restraint Equipment

**AD/RES/20
Amdt 1**

Eon Corporation E6000 Buckle Assemblies

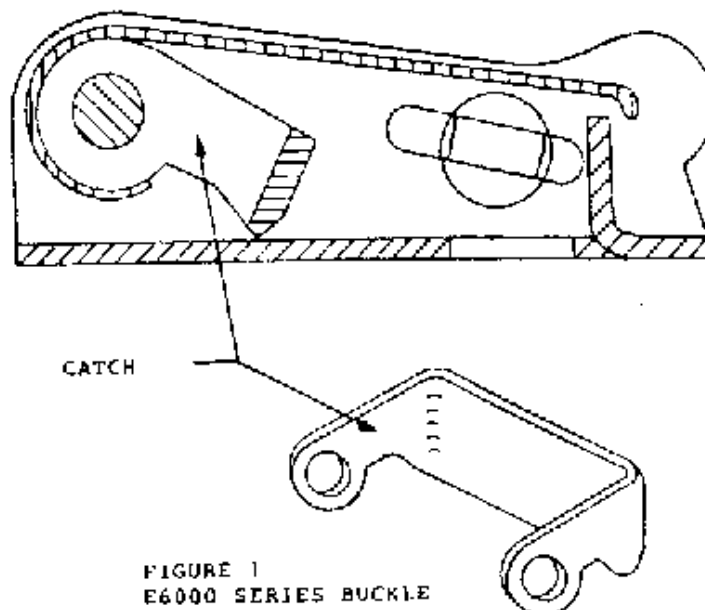
Note 1: An E6000 buckle assembly has a front cover plate which is pivoted at one end and is pulled at the other end through an arc to release the latch from the buckle. The E6000 buckle assemblies can be identified by the type of catch they use. Figure 1 shows the configuration of the catch and how it is located within the buckle assembly.

Background: This AD is prompted by reports of a buckle assembly that pulled apart under load and of other assemblies that could be pulled apart by manipulating the latch in the buckle. This could result in lack of restraint during either flight or crash loads.

- Requirement:
1. Inspect all seat belts to determine if they are marked as having been manufactured by the EON Corporation under “TSO-C22”. This includes all seat belts supplied under an airframe manufacturer’s part number.
 2. If the seat belt is marked as an EON Corporation seat belt manufactured under “TSO-C22”, determine if an E6000 buckle is fitted. If an E6000 buckle is fitted, remove the seat belt assembly and replace with another item approved in accordance with regulation 21.305 of CASR.
 3. The seat belts removed in compliance with this AD are to be destroyed or have the “TSO-C22” markings removed or totally obliterated.
 4. No E6000 buckle may be installed as a spare part after the effective date.
