DEPARTMENT OF TRANSPORTATION

Federal Aviation Administration

[Docket No. FAA-2022-0891; Project Identifier AD-2022-00585-A,E,R; Amendment 39-22432; AD 2023-09-09]

Airworthiness Directives; Various Airplanes, Helicopters, and Engines

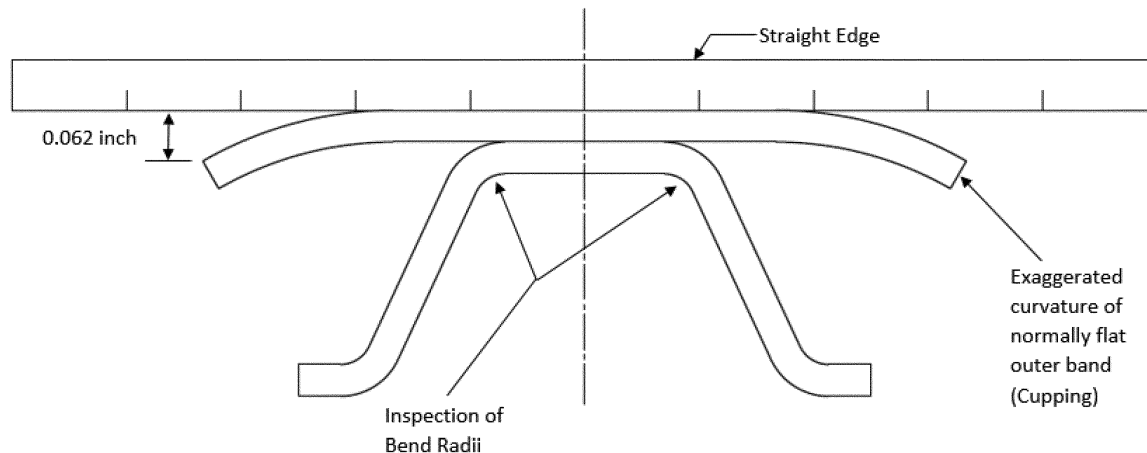
Figure 1 to paragraph (l)(1)(iii) – Inspection Depiction

(iii) Visually inspect the flatness of the outer band using a straight edge. Lay the straight edge across the width of the outer band as depicted in figure 1 to paragraph (l)(1)(iii) of this AD. If the gap between the outer band and the straight edge exceeds 0.062 inch, before further flight, remove the v-band coupling from service and install a new v-band coupling.

(v) Visually inspect the bend radii of the v-retainer coupling segments, throughout the length of the segment, as depicted in figure 1 to paragraph (l)(1)(iii) of this AD, for cracks. If there are any cracks, before further flight, remove the v-band coupling from service and install a new v-band coupling.
