Airworthiness Directive

AD No.: 2024-0221

Turbocharger exhaust systems

ATA 78 – Exhaust – Engine / Turbocharger Exhaust System / Components – Inspection

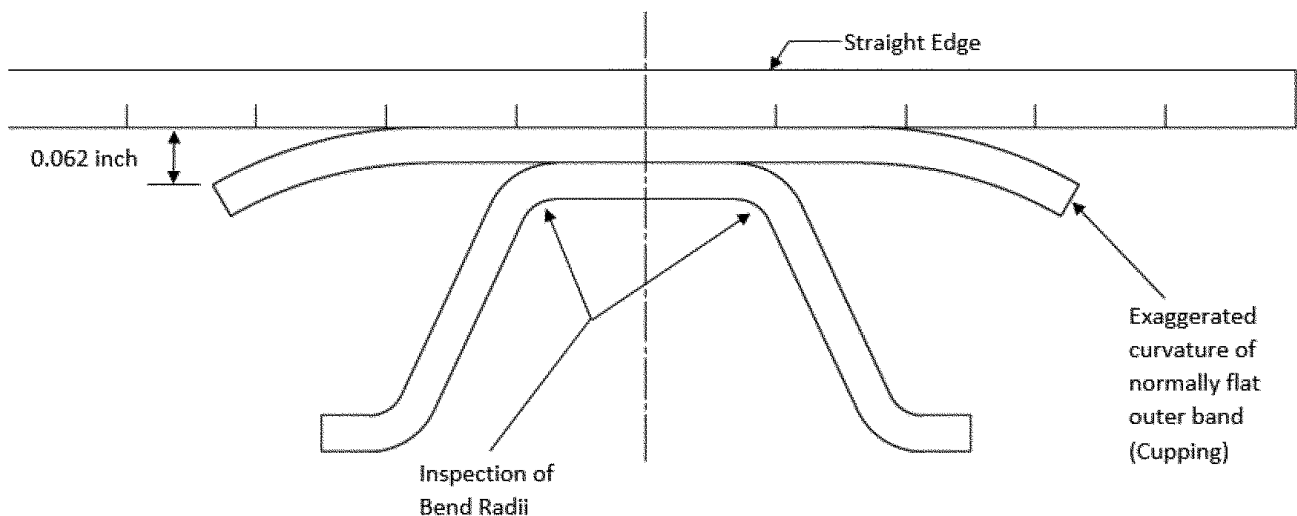
- (a.4) Visually inspect the affected part outer band for cupping, bowing, and crowning as depicted in Figure A3.1 of paragraph (b.4) of this Appendix. If there is any cupping, bowing, or crowning, before next flight, remove the affected part and, instead of the inspections in paragraphs (a.5) through (a.7) of this Appendix, do the inspections in paragraph (b) of this Appendix.

- (b.3) Using a 10X magnifying glass, visually inspect the outer band for cracks, paying particular attention to the spot weld areas. If there is a crack, before next flight, remove the affected part from service and install a serviceable part, as defined in this AD.
- (b.4) Visually inspect the flatness of the outer band using a straight edge. Lay the straight edge across the width of the outer band as depicted in Figure A3.1 of this paragraph. If the gap between the outer band and the straight edge exceeds 0.062 inch (1,575 mm) before next flight, remove the affected part from service and install a serviceable part, as defined in this AD.

- (b.6) Visually inspect the bend radii of the v-retainer coupling segments, throughout the length of the segment, as depicted in Figure A3.1 of paragraph (b.4) of this Appendix, for cracks. If there are any cracks, before next flight, remove the affected part from service and install a serviceable part, as defined in this AD.
- (b.7) Visually inspect the outer band opposite the t-bolt for damage (distortion, creases, bulging, or cracks) caused by excessive spreading of the coupling during installation or removal. If there is any damage, before next flight, remove the affected part from service and install a serviceable part, as defined in this AD.
- (b.8) If any affected part passes all inspections specified in paragraphs (b.2) through (b.7) of this Appendix, it may be re-installed.
