AD/TURBO/1

**Roto-Master (Rajay Industries, Inc.)
Turbochargers - Inspection and Replacement**

3/83

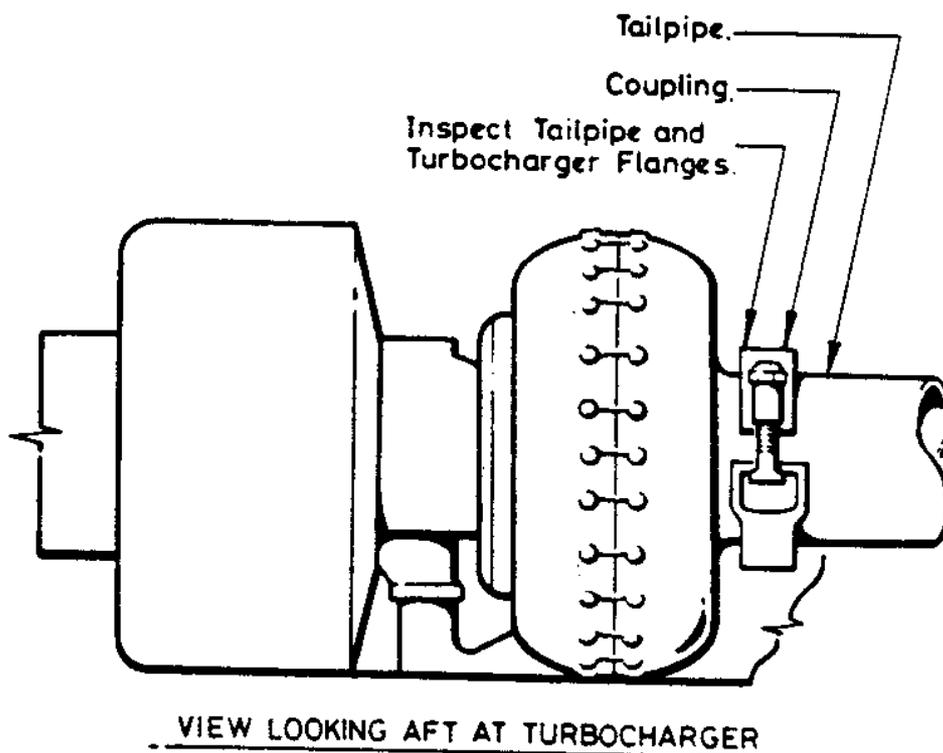
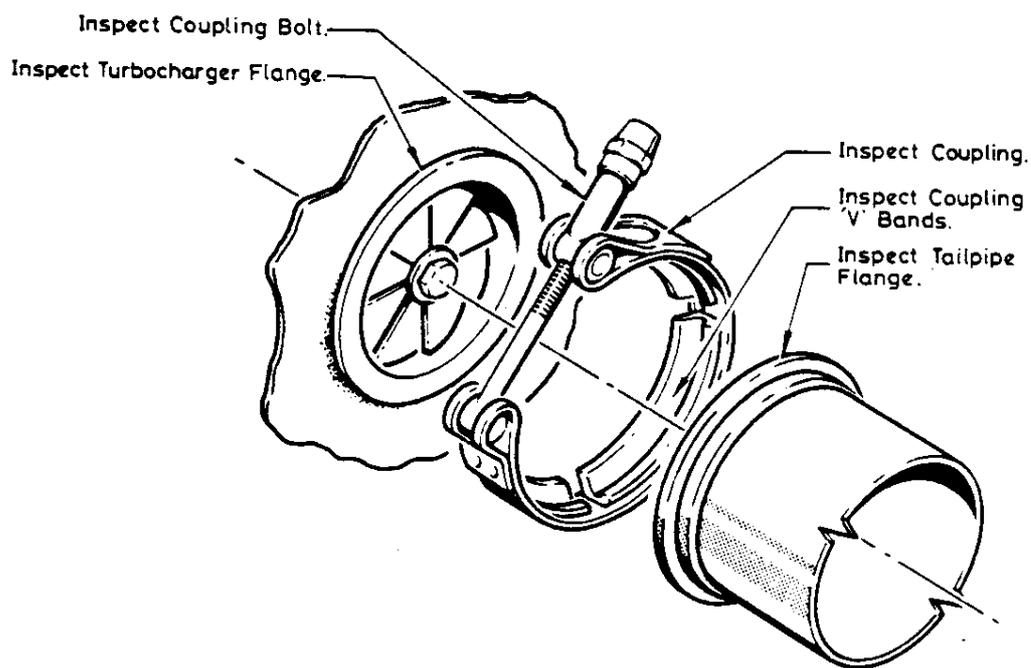
Figure 1.

- (a) Remove the turbocharger turbine housing exhaust coupling V-Band and tailpipes (see Figure 1).
- (b) Visually inspect the turbocharger turbine housing for cracks using a dye penetrant inspection method.

- (c) Inspect coupling V-Band clamp for cracks by spreading the band segments and checking for failed spot welds and for indication of exhaust flanges bottoming in coupling V-Band (see Figure 1) and clamp bolt for bending, overstress, thread damage, and cracks (see Figure 1).
- (d) Inspect turbochargers and tailpipe flanges for cracks and distortion (see Figure 1). Remove all carbon deposits from mating flanges before reassembly.
- (e) Inspect mating area of turbocharger exhaust flange to exhaust tailpipe connection for proper mating of surfaces.

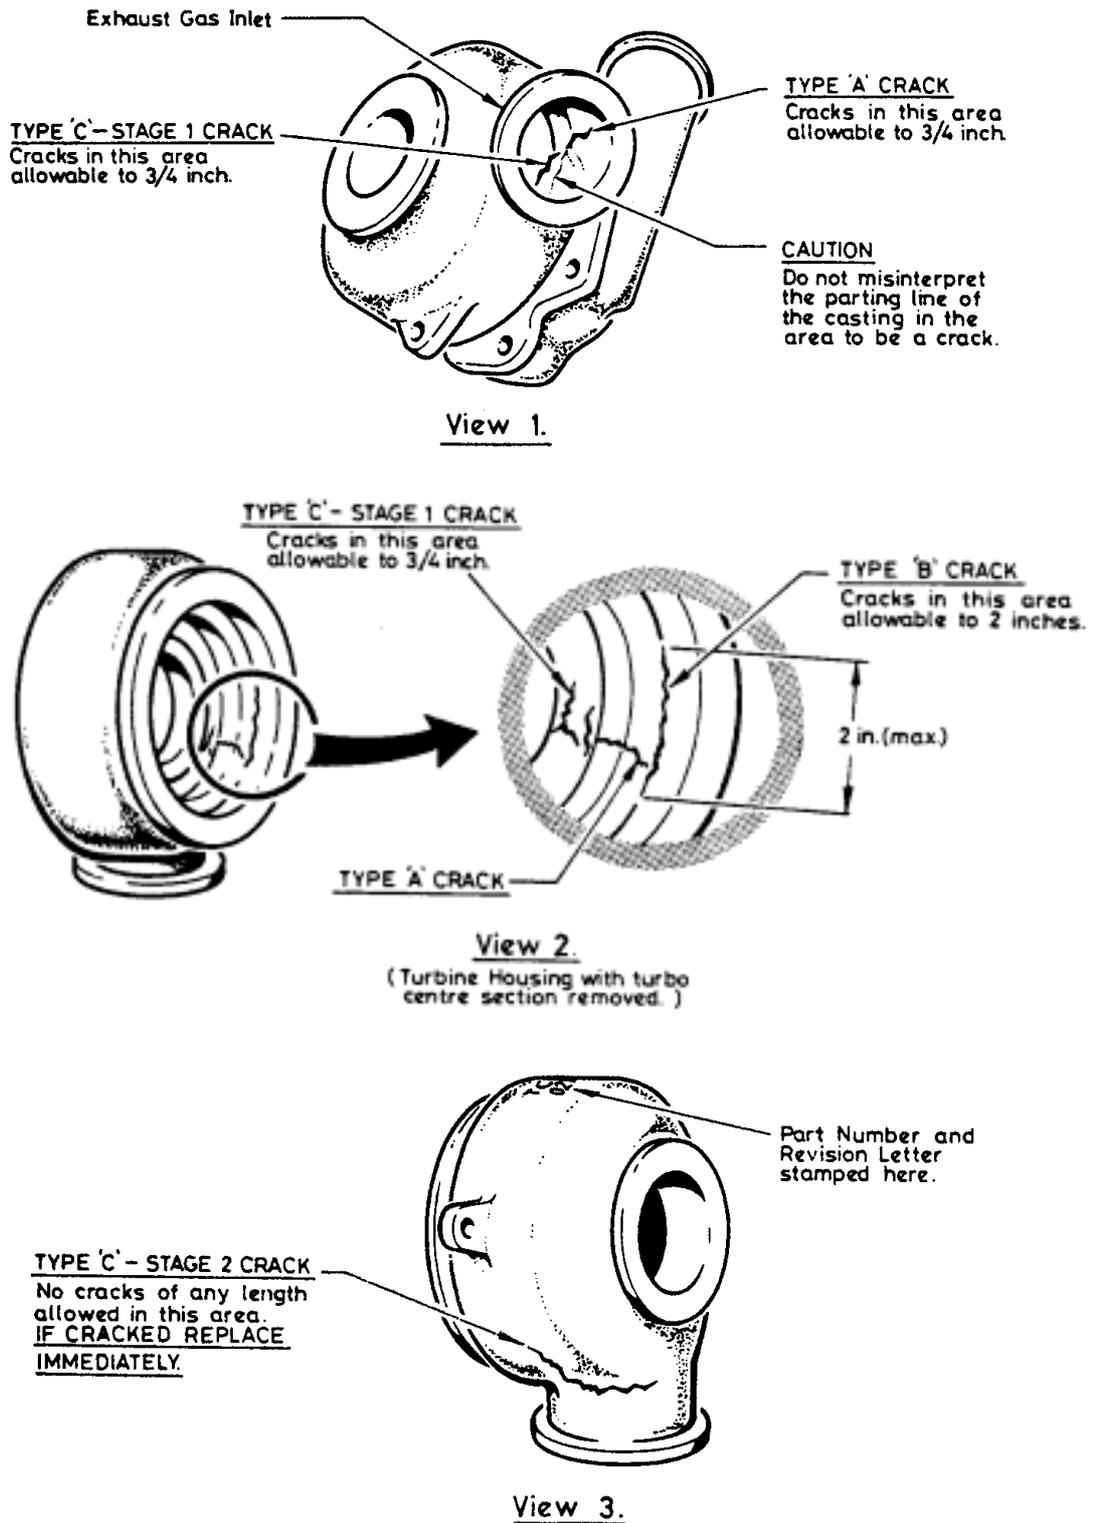
Note: The suspect area can be viewed through the exhaust port to ascertain possible presence of cracks penetrating through the outer wall as shown in Figure 2.

- (f) Inspect engine mount for indication of overheating, warpage, and corrosion, or rust. Repair as required.
- (g) If during inspection required by paragraph (b), an internal crack is found that either exceeds the limit shown in Figure 2, View 1 or 2, or a crack penetrates the outer wall of a turbine housing as shown in Figure 2, View 3, the existing turbine housing must be removed from service and replaced with a serviceable turbine housing prior to the next flight.
- (h) If during the inspections required by paragraphs (c) through (f), cracked, distorted, or otherwise damaged parts, components, or assemblies are found, before further flight repair or replace with serviceable parts, components and assemblies of the same part number.

Figure 2. - TURBINE HOUSING - INTERNAL CRACKS.
