## EMERGENCY AIRWORTHINESS DIRECTIVE

**Number: G-2024-0001-E**

Lindstrand Technologies Limited

## ATA - Hot Air Balloons - Envelopes with Polyester Filled Aramid (Kevlar) Load Tapes – Removal from Service

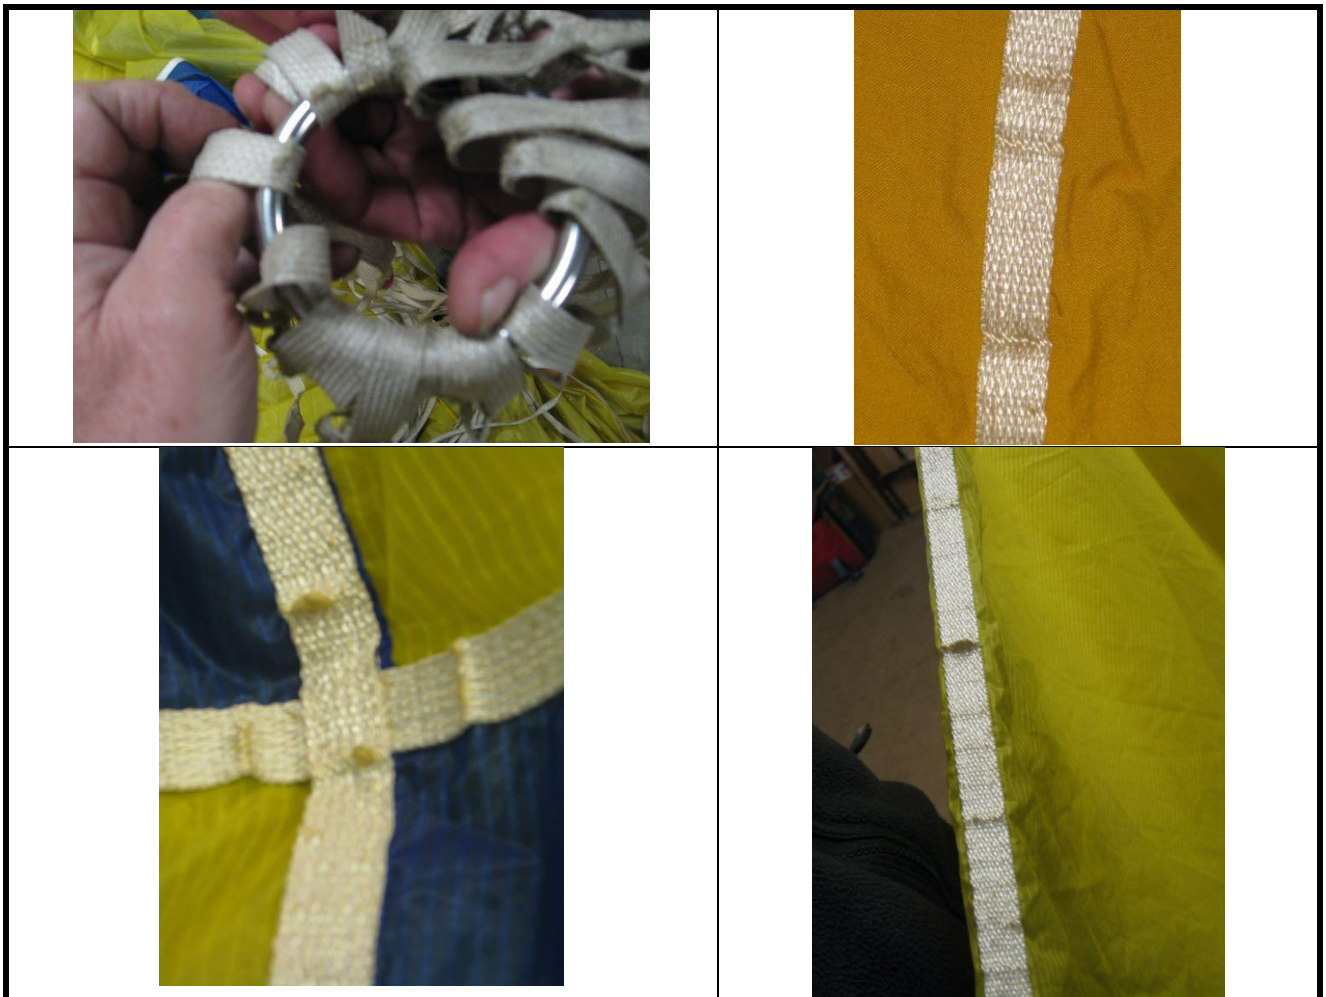
During a routine 100 hr/Annual inspection of an envelope, it's been discovered that the polyester filled aramid load tapes have degraded significantly (see Figure 1).

The damage has allowed the Kevlar core (coloured yellow) to become exposed which would degrade the strength of the tape due to ultraviolet exposure. Both horizontal and vertical tapes are affected and there is significant distortion to the horizontal tapes.

Additionally, in the area where the tape loops around the crown ring, the polyester has failed completely, and Kevlar is totally exposed. In other areas the load tapes have stretched and frayed.

The envelope that has been inspected has only completed 100 flying hours.

Although the maintenance manual states no damage to the load tapes is acceptable, an unsafe condition could exist as the rate of degradation is unknown and the residual strength of the tape, following exposure to UV, cannot be determined.

**Figure 1: Examples of load tape damage**

1. Before further flight from the effective date of this AD carry out a visual inspection to determine the date of manufacture (from the envelope data plate) and whether the envelope is fitted with Polyester Filled Aramid (Kevlar) load tapes.

2. If the date of manufacture is after March 2017 **and** the envelope has been found, by inspection, to be fitted with optional Polyester Filled Aramid (Kevlar) Load Tapes, the envelope must be considered as an **Affected Serial Number** for the purposes of this AD.
3. If the envelope is an **Affected Serial Number**, carry out a 100% visual inspection of the load tapes.
4. If damage is visible, no further flight is permitted until the damage has been rectified.
5. **If no damage is visible, amend the aircraft maintenance programme to include a 100% visual inspection of both the horizontal and vertical load tapes before each flight.**

Note: this visual inspection can be performed by the pilot/owner. In cases of doubt, the envelope should be inspected by a suitably qualified engineer.

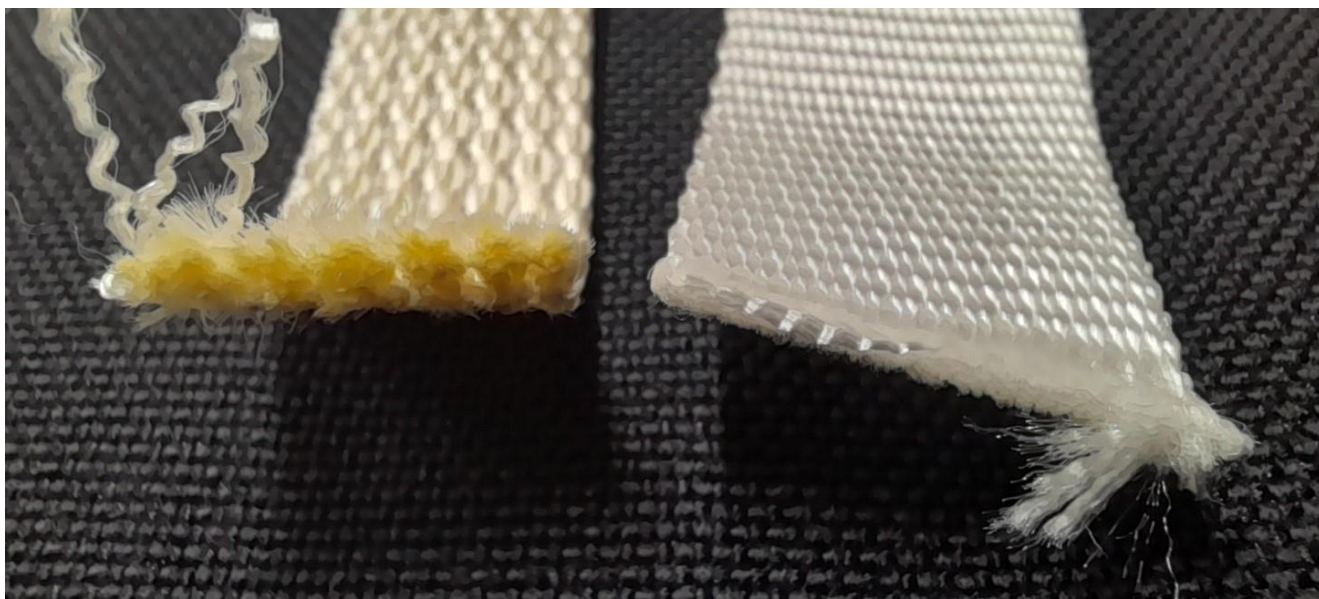
The Polyester Filled Aramid (Kevlar) load tapes (shown on left) have a distinctive yellow core which will become visible if damage has occurred.

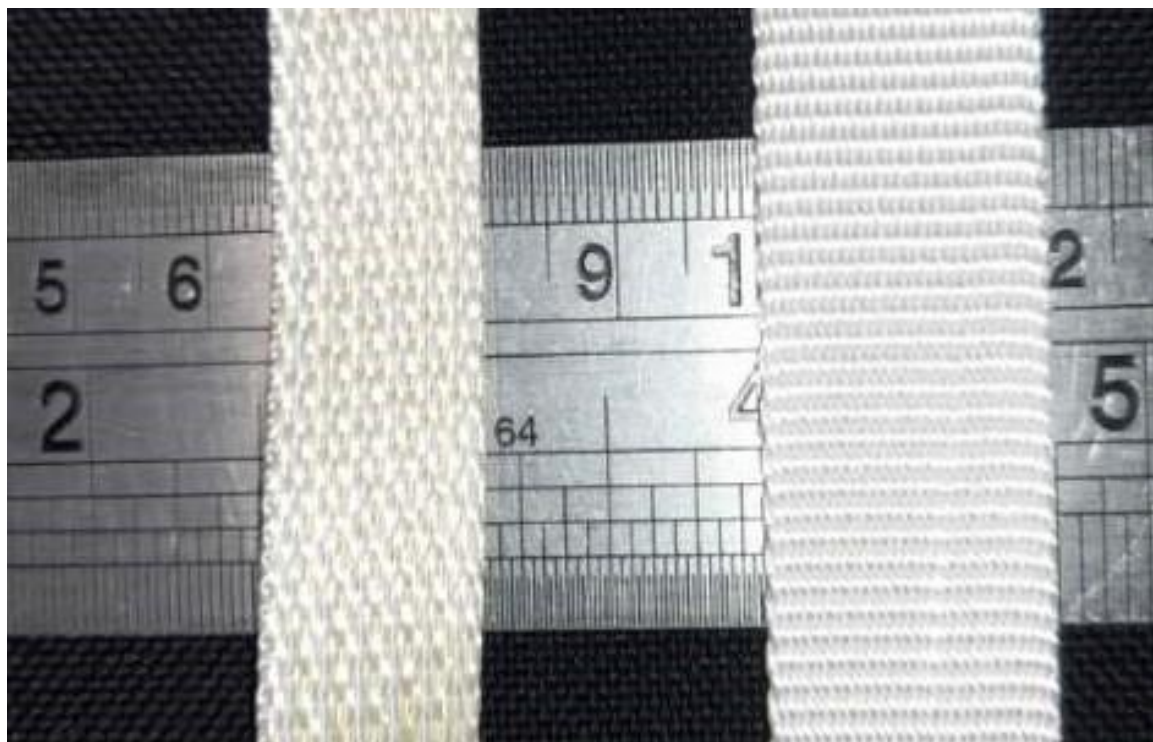
The Polyester Filled Aramid (Kevlar) load tapes (shown on left) is 15 mm wide; the standard polyester tape is 20 mm wide.
