Airworthiness Directive

AD No.: 2017-0060

A330 and A340 aeroplanes

ATA 57 – Wings – Slat Track Front Stop Attachment – Inspection

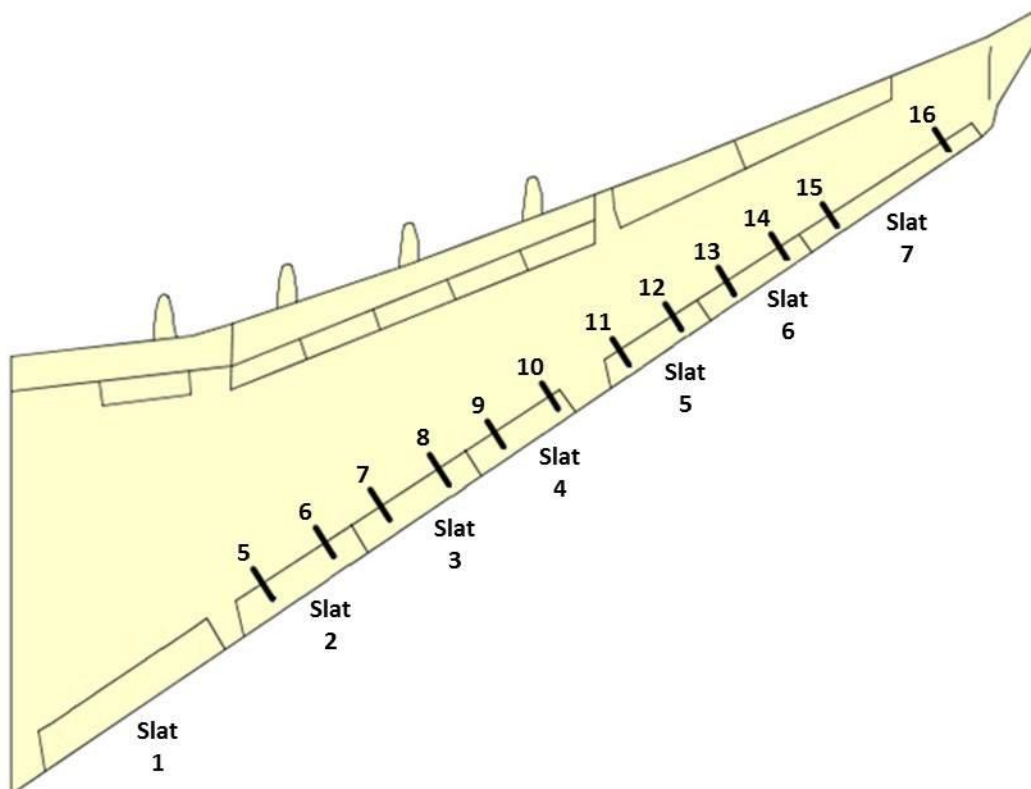
Figure 1 – Positions of Affected Slat Tracks

Several cases of cracked slat tracks at the location of front stop attachment to track have been reported by operators. Analysis of the affected slat tracks (Airbus pre-modification (mod) 45967 design) revealed that induced torque loads during normal installation of the front stop, in combination with an incorrect shaft length of the attachment bolts and geometry of the front stop, are the root cause.

Note 2: Pre-mod 45967 slat tracks, located at the wing positions as indicated in Figure 1 of this AD, and having a P/N as specified in Appendix 1 of this AD, are hereafter referred to as “affected slat track” in this AD.

- (1) For Group 1 aeroplanes: Within the thresholds specified in Table 1 of this AD, as applicable, accomplish a DET of the front stop lateral and aft surfaces, and an SDI of the front stop attachment areas of each affected slat track, both RH and LH wings (see Figure 1 of this AD), and, thereafter, depending on findings, at intervals not to exceed the values specified in Table 2 or Table 3 of this AD, as applicable, accomplish an SDI of the front stop attachment areas of each affected slat track, in accordance with the instructions of the applicable SB.

- (7) Replacement of an affected slat track at any position (see Figure 1 of this AD), as required by paragraph (3) or (5) of this AD, as applicable, with a post-mod 45967 slat track, constitutes terminating action for the repetitive inspections required by this AD for that slat track position.
- (8) Modification of all affected slat tracks on an aeroplane in accordance with the instructions of Airbus SB A330-57-3126, or SB A340-57-4133, as applicable, constitutes terminating action for the repetitive inspections required by this AD for that aeroplane, provided that, prior to modification, the affected slat tracks have passed an inspection (crack free) in accordance with the instructions of the applicable SB (see Note 1 of this AD).
