## Airworthiness Directive

**AD No.:** 2023-0136R1

A330 and A340 aeroplanes

## ATA 36 – Pneumatic – Overheat Detection System Sensing Elements – Inspection

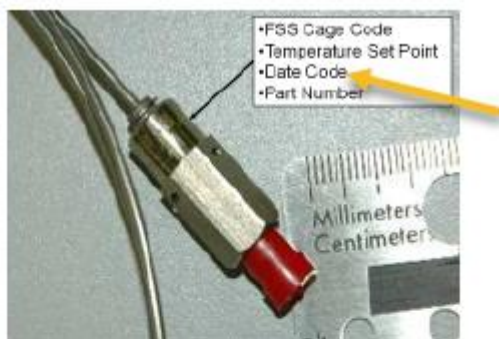
Figure 4-50. Identification Markings on Coaxial SE Male (Pin) Connector

Appendix 1 of this AD provides information how to identify affected parts (P/N and date code).
