## Airworthiness Directive

**AD No.:** 2022-0031

A350 aeroplanes

### ATA 36 – Pneumatic – Overheat Detection System Sensing Elements – Inspection – Master Minimum Equipment List – Temporary Operational Restrictions

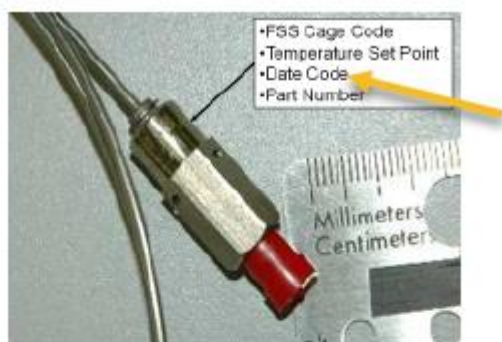
Figure 4-50. Identification Markings on Coaxial SE Male (Pin) Connector

**Affected part:** Overheat detection system (OHDS) sensing elements, also identified as 'Continuous Fire Detector', having a Part Number (P/N) and corresponding date code as listed in Section 1.A of the VSB, except those that passed an inspection (no discrepancies found; one face of the connector hex nut is marked) in accordance with the instructions of Section 3 of the VSB.
