## Airworthiness Directive

**AD No.:** 2025-0205R3

ATR 42 and ATR 72 aeroplanes

## ATA 53 – Fuselage – Passenger Seat Tracks – Inspection / Replacement

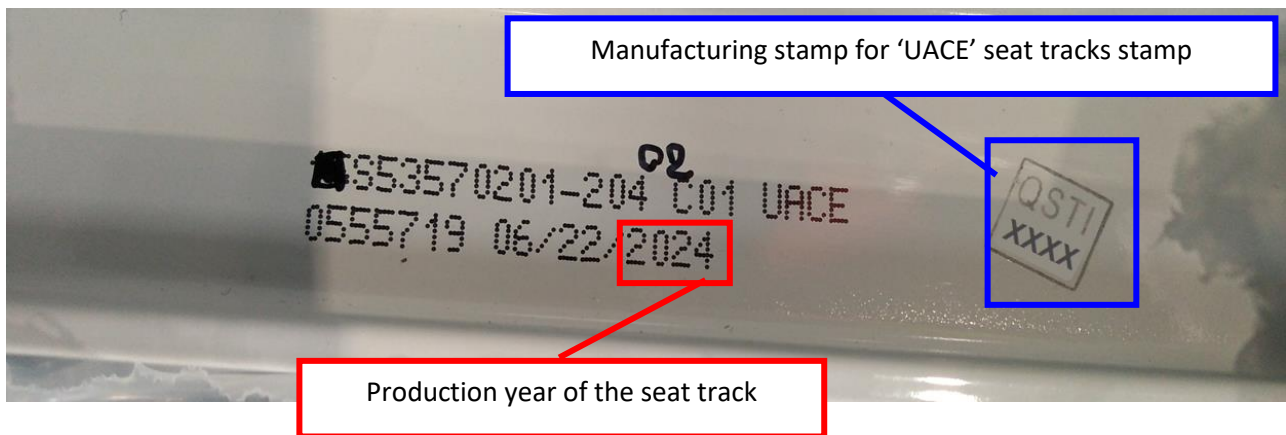
**Appendix 2-** Identification of 'UACE' seat tracks manufactured in or after 2024

The identification of the seat track is located on the lower face of the seat track.

The manufacturing stamp of the seat track on the illustration corresponds to 'UACE' manufacturer, where 'XXXX' represents any numerical sequence.

The production year of the seat track on the illustration is 2024.

All the seat tracks having this manufacturing stamp and a production year equal to or above 2024, do not have to be considered as affected parts.

All the seat tracks with the manufacturing stamp and/or production year not visible/legible, have to be considered as potential affected parts.
