**[Docket No. FAA-2023-1993; Project Identifier AD-2023-00129-T; Amendment 39-22940; AD 2025-02-07]**

### **Airworthiness Directives; The Boeing Company Airplanes**

**2025-02-07 The Boeing Company:** Amendment 39-22940; Docket No. FAA-2023-1993; Project Identifier AD-2023-00129-T.

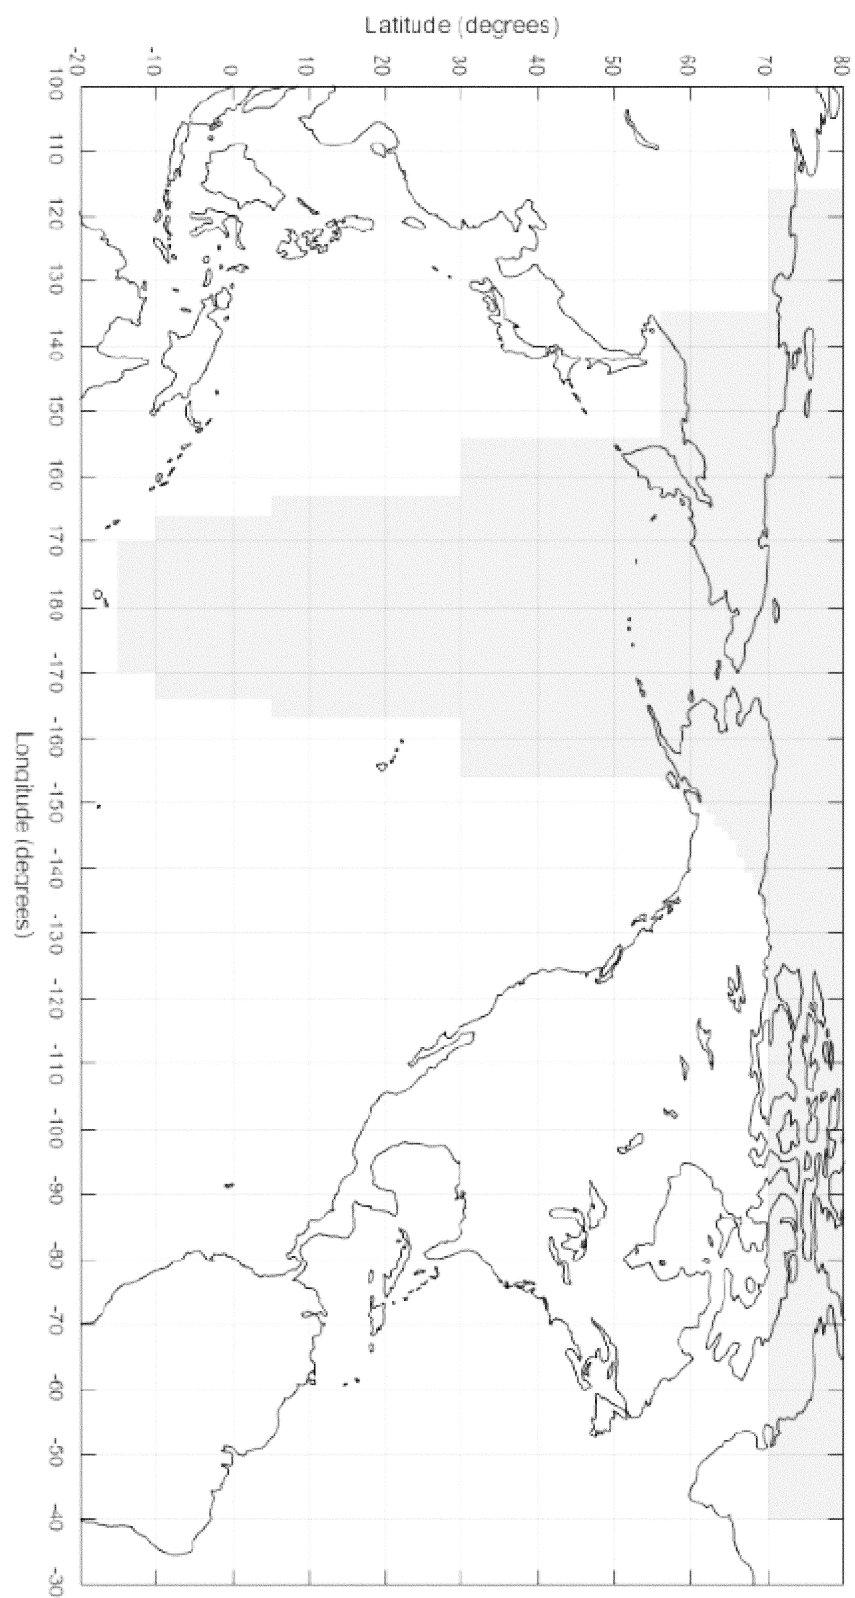
**Figure 2 to Paragraph (g)—AFM—Limitations or Certificate Limitations Continued**

Operations that require less than 0.3 RNP (For example, 0.1, 0.11, 0.15, etc.) in the region identified below are prohibited with GLU-2100 OPS software number COL4D-0087-0002, COL4E-0087-0001, COL48-0087-0700, or COL49-0087-0701 installed.

Exception: Anchorage (PANC) approach procedures that allow less than RNP 0.3 are authorized provided the instructions outlined in the Electronics – Global Landing Unit Section of Normal Procedures Chapter are followed.

Note: Currently, Fairbanks (PAFA) and Anchorage (PANC) are the only airports in the region with an RNP approach that requires better than 0.3 nmi performance.
