**[Docket No. FAA-2025-0618; Project Identifier AD-2024-00637-T; Amendment 39-23280; AD 2026-05-07]**

### **Airworthiness Directives; The Boeing Company Airplanes**

**2026-05-07 The Boeing Company:** Amendment 39-23280; Docket No. FAA-2025-0618; Project Identifier AD-2024-00637-T.

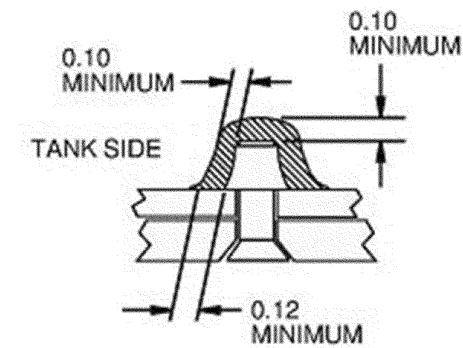
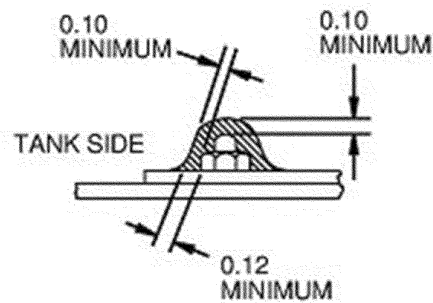
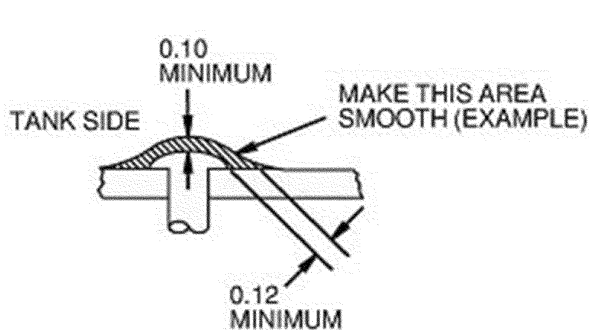
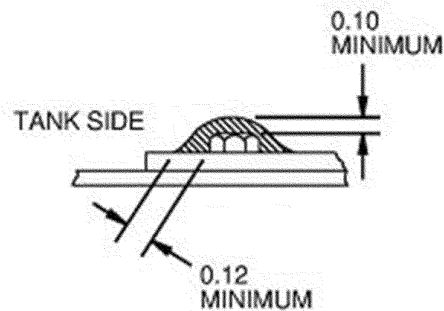
**Figure 1 to Paragraph (h)(4)—Cap Seal Minimum Thickness (All Dimensions in Inches)**

The FAA agrees that the cap sealing requirement of paragraph (h)(4) of this AD (corresponding to paragraph (h)(3) of the proposed AD) does not apply to fasteners outside the fuel tank. Accordingly, the FAA has revised paragraph (h)(4) of this AD to clarify the requirement applies only to fasteners, fastener heads, and fastener threads and collars inside the fuel tank.

The FAA disagrees with Boeing's request to remove the exception or add a note to refer to 767 AMM 28-11-00 as an acceptable procedure for the cap sealing required for in-tank fasteners. Boeing Alert Requirements Bulletin 767-57A0148 RB, dated October 10, 2024, already refers to 767 AMM 28-11-00 as an acceptable procedure, so including such a note in this AD is unnecessary. Further, referencing material as an accepted procedure does not make the actions in the material mandatory. Therefore, the FAA has determined that the exception in paragraph (h)(4) is necessary to ensure the cap sealing procedures are enforceable.

As stated previously, the FAA agrees that the cap sealing requirement does not apply to fasteners outside the fuel tank and has revised paragraph (h)(4) of this AD accordingly. However, the FAA disagrees with the commenter's request to require that the cap sealing for in-tank fasteners be done in accordance with 767 SRM 51-20-05 because the SRM refers to 767 AMM 28-11-00 for sealing of fuel tank repairs. Referring to 767 AMM 28-11-00 does not make the actions in that material mandatory, and the FAA has determined that the requirements in paragraph (h)(4) of this AD must be accomplished. Further, the FAA disagrees that the exception will result in multiple requirements for cap sealing of fasteners internal to the fuel tank because the 767 AMM 28-11-00 contains the same procedures as the requirements of figure 1 to paragraph (h)(4) of this AD. The FAA has not changed the AD in this regard.

(4) During application of any cap seal to a fastener, fastener head, and fastener threads and collars inside the tank, as required by this AD, the cap seal must be applied with a thickness equal to or greater than the dimensions specified in figure 1 to paragraph (h)(4) of this AD.
