[Docket No. FAA-2023-1814; Project Identifier AD-2023-00773-T; Amendment 39-22541; AD 2023-17-14]

### Airworthiness Directives; The Boeing Company Airplanes

**2023–17–14 The Boeing Company:** Amendment 39–22541; Docket No. FAA–2023–1814; Project Identifier AD–2023–00773–T.

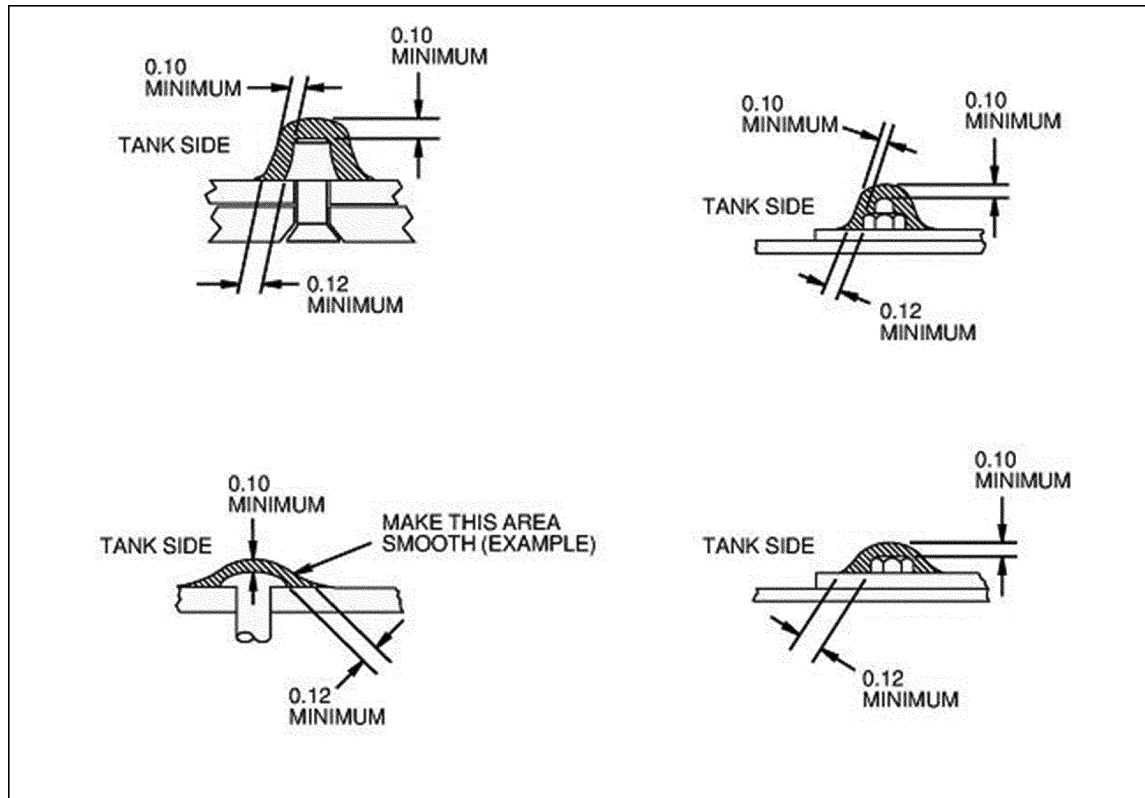
**Figure 1 to paragraph (h)(4) – Cap seal minimum thickness (all dimensions in inches)**

required by the requirements bulletin. A cap seal of insufficient thickness may fail to contain a spark resulting from a lightning strike, similarly compromising the fault tolerance of the fuel tank lightning protection. This AD specifies the minimum thickness and sealant type for an applied cap seal, and requires replacement of any seal that was previously applied using a procedure that specifies an inadequate thickness.

(4) During application of any cap seal to a fastener, fastener head, and fastener threads and collars, as required by this AD, the cap seal must be applied with a thickness equal to or greater than the dimensions specified in figure 1 to paragraph (h)(4) of this AD.

(ii) All cap seals were applied using procedures with thickness dimensions greater than or equal to those given in figure 1 to paragraph (h)(4) of this AD.

(2) If any cap seal was applied using procedures with thickness dimensions less than those given in figure 1 to paragraph (h)(4) of this AD, or if the maintenance records do not definitively specify the procedures used: At the applicable time specified in paragraph (i)(2)(i) or (ii) of this AD, replace the cap seal in accordance with the Accomplishment Instructions of Boeing Alert Requirements Bulletin 777-57A0122 RB, dated October 8, 2021, using a cap sealing procedure with thickness greater than or equal to the dimensions given in figure 1 to paragraph (h)(4) of this AD.

(3) For any cap seal that was not applied, or for any cap seal that was removed for inspections and not replaced, or if the maintenance records do not definitively specify the procedures used: At the applicable time specified in paragraph (i)(3)(i) or (ii) of this AD, apply a cap seal of BMS 5-45 sealant using an accepted method with thickness greater than or equal to the dimensions given in figure 1 to paragraph (h)(4) of this AD.
