**[Docket No. FAA-2024-0769; Project Identifier AD-2023-00556-T; Amendment 39-22815; AD 2024-16-09]**

### **Airworthiness Directives; The Boeing Company Airplanes**

**2024-16-09 The Boeing Company:** Amendment 39-22815; Docket No. FAA-2024-0769; Project Identifier AD-2023-00556-T.

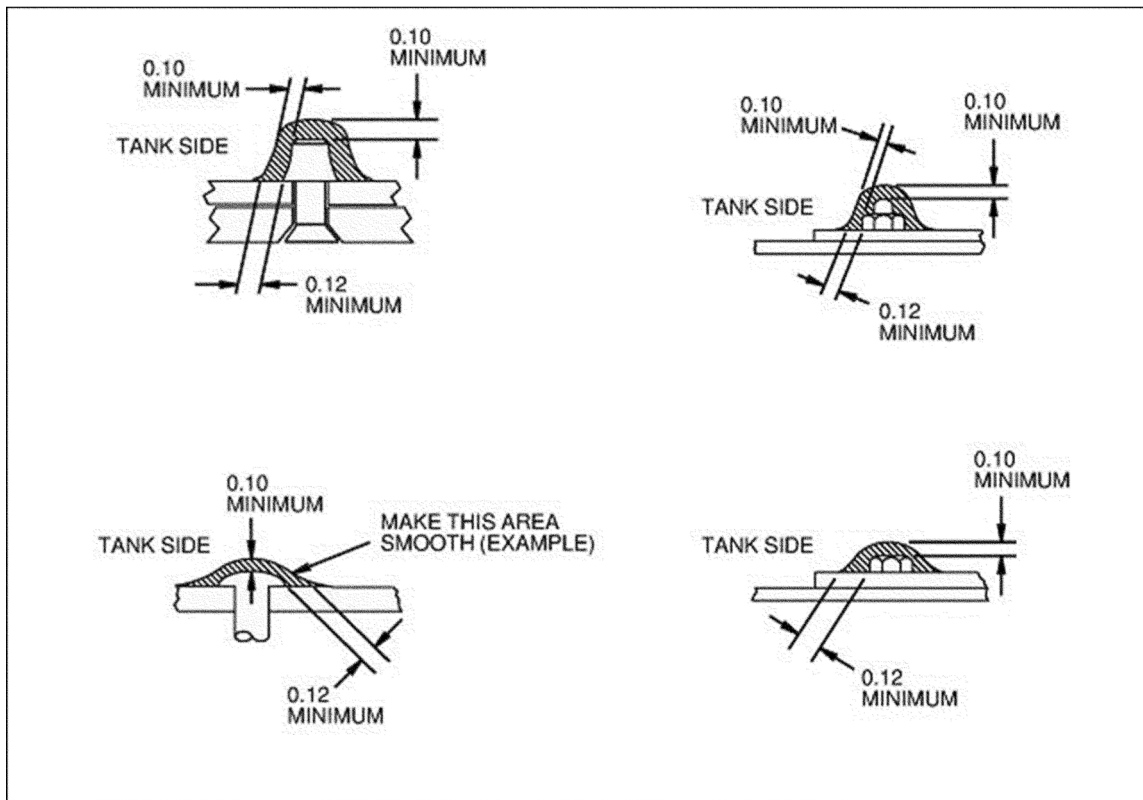
**Figure 1 to Paragraph (h)(3)—Cap Sealing Dimensions (all Dimensions are in Inches)**

Boeing concluded that only the cap seals on the interior side of the fuel tank require the dimensions specified in Figure 1 of paragraph (h)(3) of the proposed AD to perform their intended function, which is consistent with the labels shown in Figure 1 of paragraph (h)(3) of the proposed AD. Boeing recommended replacing the text “applying a cap seal (sealant) to a fastener, fastener head, and fastener threads and collars, for this AD, during application of any cap seal to a fastener, fastener head, or fastener threads and collars” with the text “applying a cap seal (sealant) to a fastener location that penetrates the fuel tank boundary, for this AD, during application of any cap seal to a fastener, fastener head, or fastener threads and collars inside the fuel tank.”

The FAA agrees to clarify paragraph (h)(3) of this AD for the reasons provided by the commenter. Locations that do not penetrate the fuel tank boundary do not require the same sealant application procedures. The FAA has added the text “inside the fuel tank” to paragraph (h)(3) of this AD. However, the FAA did not replace the text “to a fastener, fastener head, and fastener threads and collars” with the text “to a fastener location that penetrates the fuel tank boundary,” as recommended by the commenter, because the text “to a fastener, fastener head, and fastener threads and collars inside the fuel tank” better aligns with the language within the service information.

(3) Where any service information referenced in Boeing Alert Requirements Bulletin 777-53A0100 RB, dated March 16, 2023, specifies applying a cap seal (sealant) to a fastener, fastener head, and fastener threads and collars inside the fuel tank, for this AD, during application of any cap seal to a fastener, fastener head, or fastener threads and collars inside the fuel tank, the cap seal must be applied using a cap sealing procedure with thickness greater than or equal to the dimensions given in Figure 1 to paragraph (h)(3) of this AD.

The FAA agrees. Boeing 777 AMM 28-11-00 meets the sealant requirements of Figure 1 to paragraph (h)(3) of this AD. As such, it would be an acceptable procedure to follow when sealing inside the fuel tank in accordance with paragraph (h)(3) of this AD. The FAA has added a note to paragraph (h)(3) of this AD accordingly.

**Note 4 to paragraph (h)(3):** Guidance on an acceptable cap sealing procedure for accomplishing the actions required by paragraph (h)(3) of this AD can be found in Boeing Model 777 Aircraft Maintenance Manual (AMM) section 28-11-00.
