**[Docket No. FAA-2023-1055; Project Identifier AD-2023-00583-T; Amendment 39-22445; AD 2023-10-09]**

### **Airworthiness Directives; The Boeing Company Airplanes**

The FAA is adopting a new airworthiness directive (AD) for all The Boeing Company Model 787-8, 787-9, and 787-10 airplanes. This AD was prompted by reports of damaged decompression panels from operators. This AD requires repetitive inspections for damaged fastener holes on the vertical and bottom edges of the inward and outward blowing decompression panels installed on the forward and aft cargo compartment vertical sidewall linings and applicable on-condition actions. The FAA is issuing this AD to address the unsafe condition on these products.

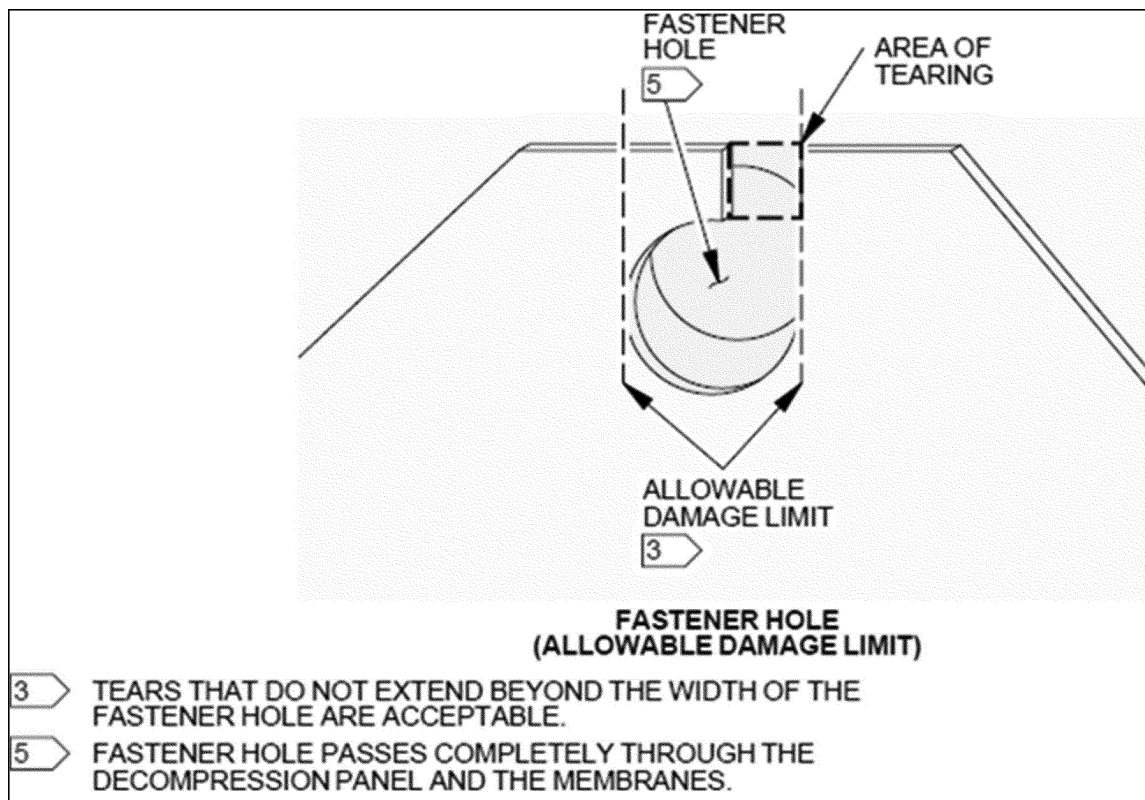
**Figure 1 to paragraph (g)(3)(i)** – Allowable damage not extending beyond fastener hole width

(i) If the damage is on the fastener hole, the damage must not extend beyond the width of the fastener hole. Refer to figure 1 to paragraph (g)(3)(i) of this AD. Where figure 1 to paragraph (g)(3)(i) of this AD refers to tears or tearing, this includes all types of damage as defined in paragraph (g)(2) of this AD.

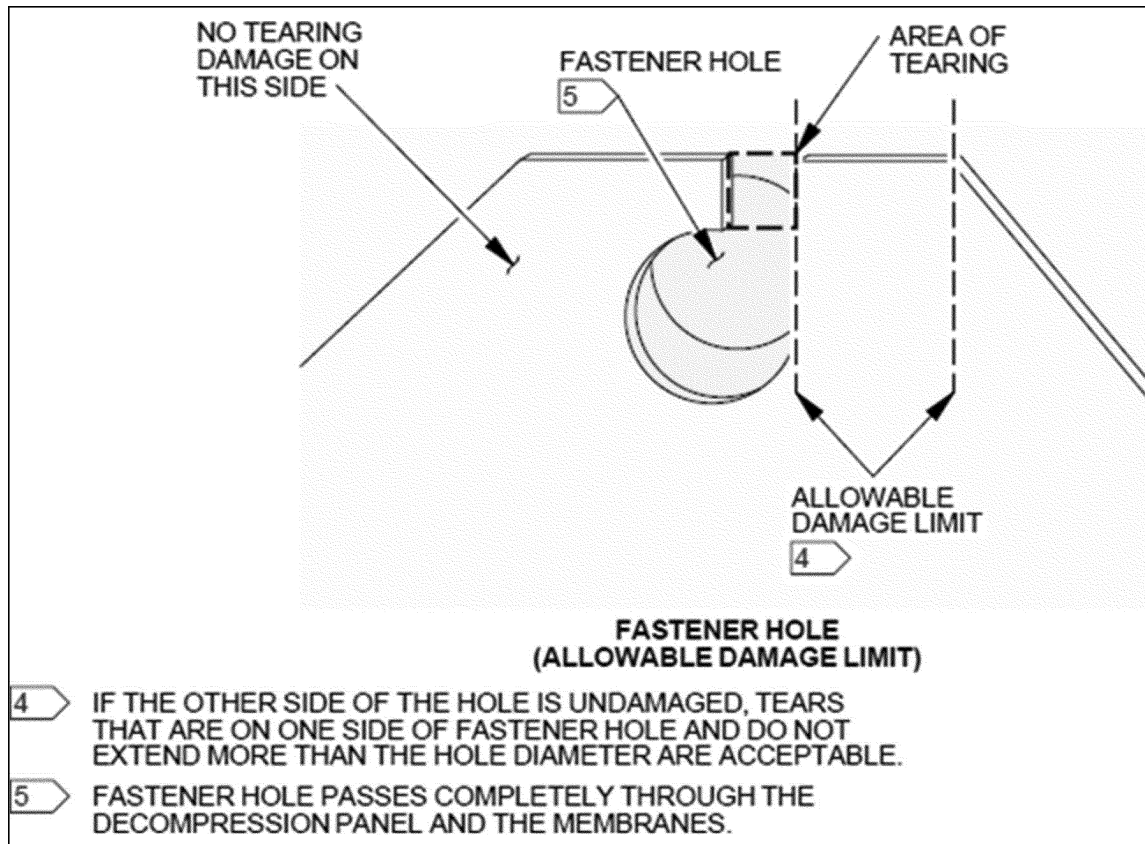
**Figure 2 to paragraph (g)(3)(ii)** – Allowable damage not extending more than fastener hole diameter

(ii) If the damage is on one side of the fastener hole and the other side of the fastener hole has no damage, the damage must not extend more than the diameter of the fastener hole. Refer to figure 2 to

paragraph (g)(3)(ii) of this AD. Where figure 2 to paragraph (g)(3)(ii) of this AD refers to tears, tearing, or tearing damage, this includes all types of damage as defined in paragraph (g)(2) of this AD.
