Lycoming Piston Engines

**AD/LYC/101**  
**Amdt 1**

**Superior Cylinders**

**3/97**

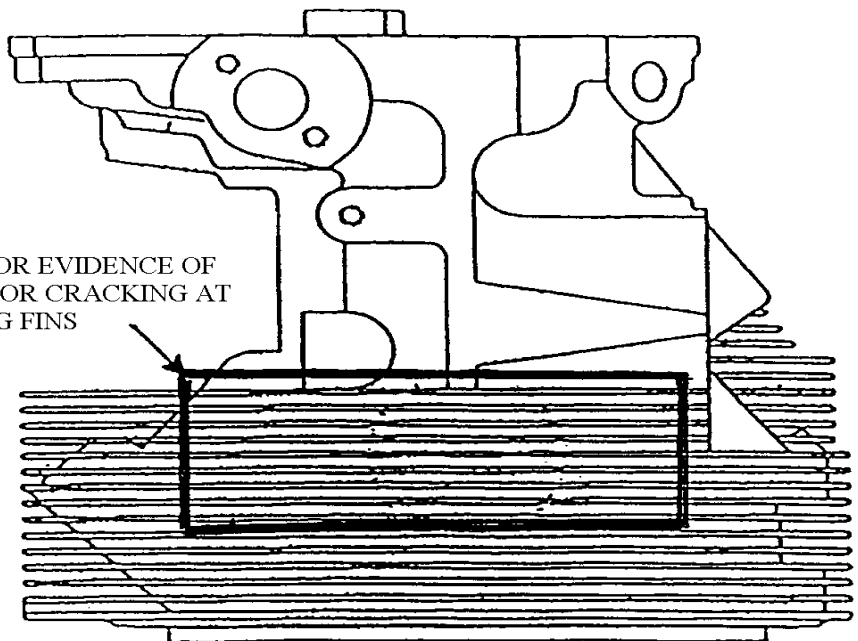
FIGURE 1

- Requirement:
1. To prevent the possible loss of a cylinder head, the subsequent loss of engine power and a possible engine fire, carry out:
    - a. A visual inspection of applicable cylinder assemblies for evidence of combustion leaks and/or cracking in the area adjacent to the location of the inlet valve seat as detailed in Figure 1, and
    - b. An 80psi pressure “wet” leak check of the cylinder assemblies paying particular attention to the area detailed in Figure 1.

INSPECT MARKED AREA FOR EVIDENCE OF COMBUSTION LEAKS AND/OR CRACKING AT THE BASE OF THE COOLING FINS

Remove from service before further flight, any cylinder showing either combustion gas leakage or cracks.

2. Remove applicable cylinders from service.
