[Docket No. FAA-2012-0704; Directorate Identifier 2012-SW-040-AD; Amendment 39-17113; AD 2012-13-11]

Airworthiness Directives; Eurocopter Deutschland GmbH Helicopters

SUMMARY: We are adopting a new airworthiness directive (AD) for Eurocopter Deutschland GmbH (ECD) Model MBB-BK 117 (all versions) and BO-105LS A-3 helicopters. This AD requires inspecting the tail rotor pitch link spherical bearing for proper swaging. This AD is prompted by a report of a tail rotor pitch link with a spherical bearing that had migrated out of the bearing bore. The actions specified by this AD are intended to prevent failure of the tail rotor pitch link and subsequent loss of control of the helicopter.

2012-13-11 Eurocopter Deutschland GmbH Helicopters: Amendment 39-17113; Docket No. FAA-2012-0704; Directorate Identifier 2012-SW-040-AD.

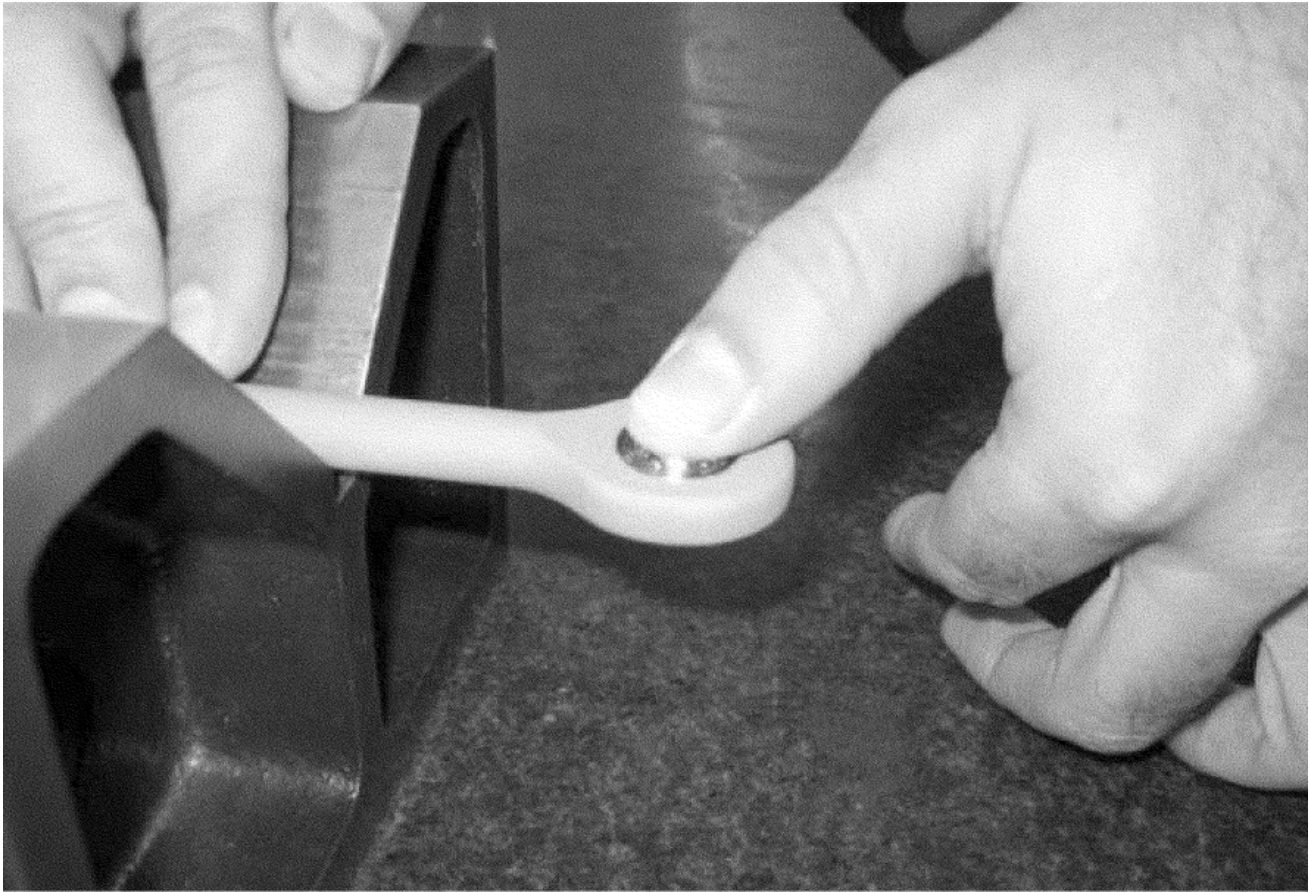
- (1) Remove the pitch link.
- (2) Clean the area around the spherical bearings and pitch link bearing bore chamfer.
- (3) Apply axial hand pressure to the faces of both spherical bearings as shown in Figure 1 to Paragraph (e) of this AD.

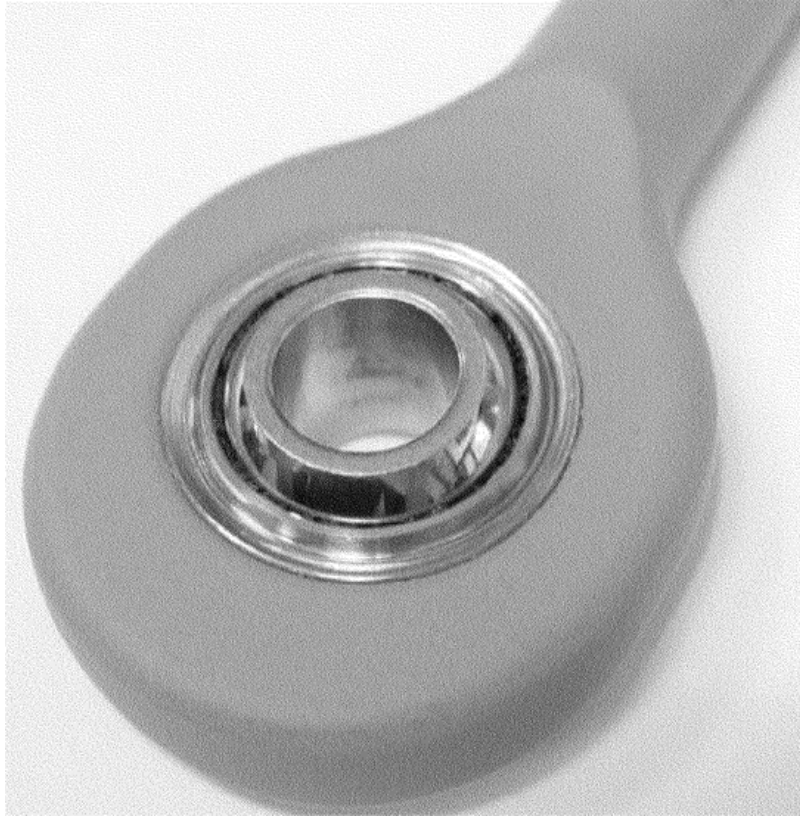
(4) Using an 8X or higher power magnifying glass, inspect the boundaries between the bearing and the bearing bore chamfer surface. Determine that the bearings have been completely swaged and there is no gap between the edge of the bearing and the chamfer as shown in Figure 2 to Paragraph (e) of this AD.
