AIRWORTHINESS DIRECTIVE

Schweizer (Hughes) 269 Series Helicopters

**AD/HU 269/57
Amdt 4**

Centre Frame Aft Cluster Fitting

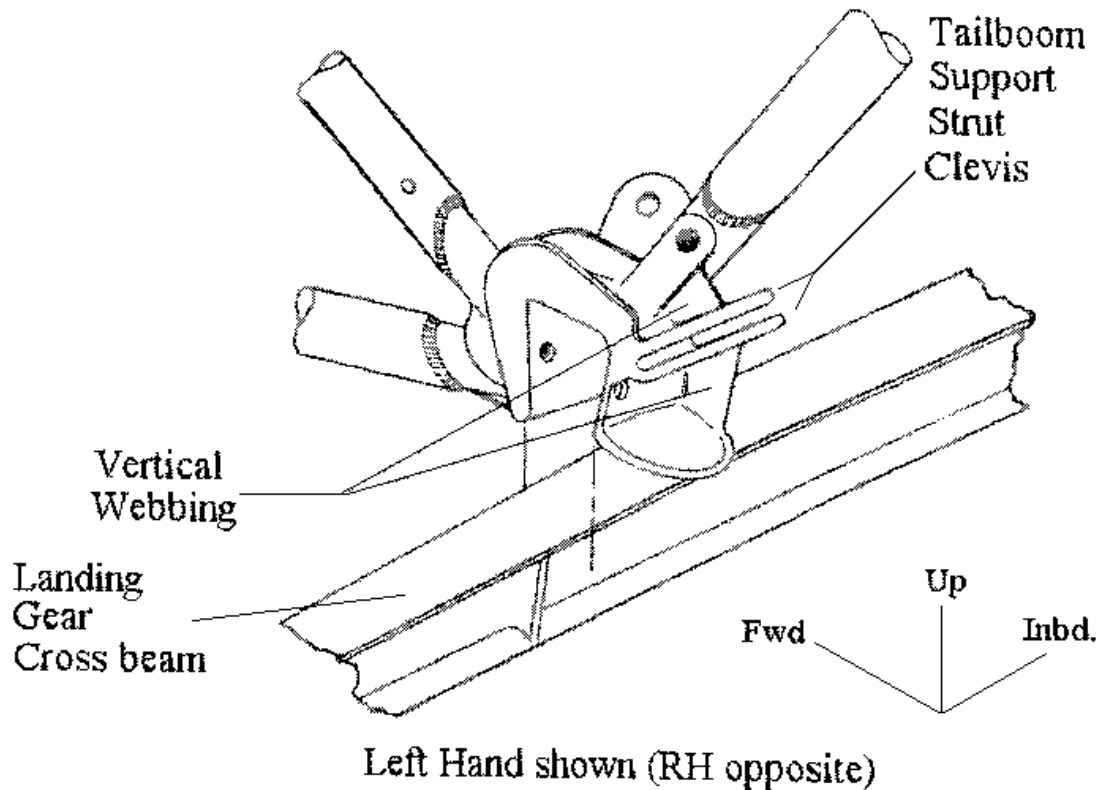
- Requirement:**
1. Accomplish the following:
 - a. Chemically remove paint from the clevis lugs on each centre frame aft cluster fitting. Wash with water and dry.
 - b. Dye-penetrant inspect the clevis lugs on each aft cluster fitting.
 - c. If a crack is found, before further flight, replace the cracked aft cluster fitting with a serviceable part number 269A2234-3 or 269A2235-3 aft cluster fitting, as applicable.
 - d. If no cracking is found, clean the aft cluster fitting and repaint.
 2. Replace each aft cluster part number 269A2234 and part number 269A2235 not modified in accordance with Kit part number SA-269K-106-1 with part number 269A2234 and 269A2235 aft cluster fittings modified in accordance with Kit part number SA-269K-106-1; or with aft cluster fittings part number 269A2234-3 and 269A2235-3.

Note 1: Installation of Aft Cluster Fitting Modification Kit, part number SA-269K-0106-1, constitutes terminating action for the repetitive inspection requirements of this Directive.
