McDonnell Douglas (Hughes) and Kawasaki 369 Series Helicopters

AD/HU 369/96
Amdt 1

Engine Control and Warning Systems

SCHEDULE OF AIRWORTHINESS DIRECTIVES

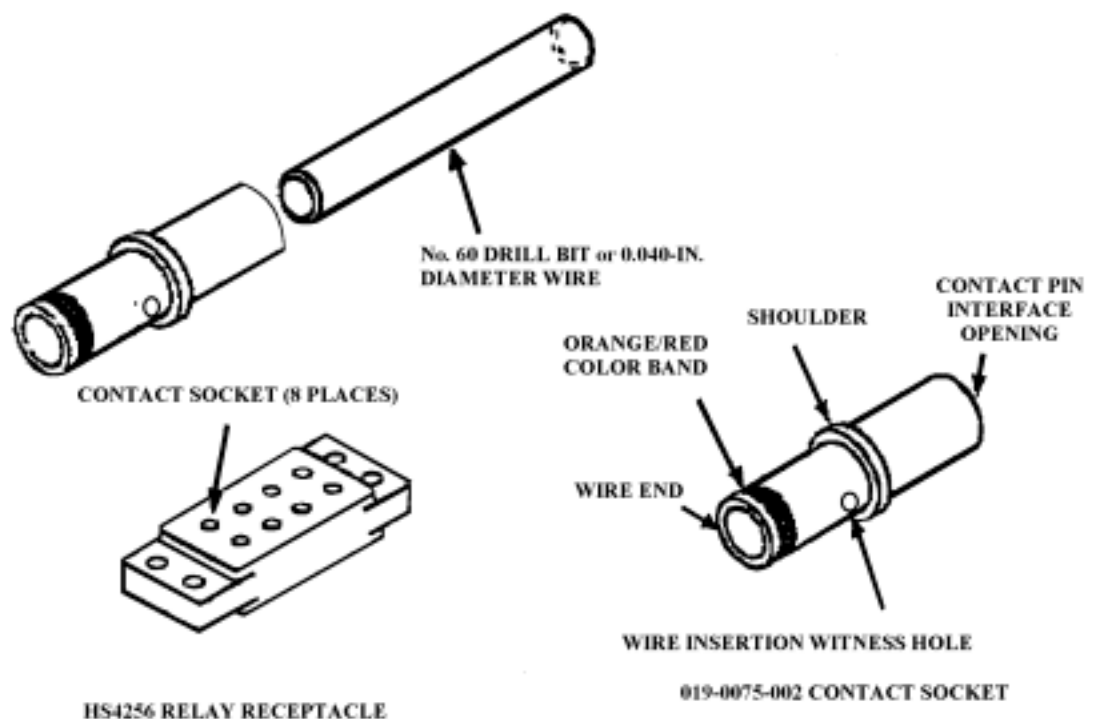
Figure 1. Contact Socket Inspection

Background: The FAA has received a report of an incident involving a MDHS 600N helicopter where the engine control unit (ECU) fail light illuminated, even though the ECU continued to automatically control the engine. The helicopter manufacturer has also reported two additional similar incidents on other model 600N helicopters. The cause of the ECU malfunction indication was determined to be contact sockets of a relay receptacle that did not correctly fit the corresponding pins of a relay. This directive requires the inspection of the contact sockets of each affected relay receptacle to ensure that the sockets are the correct size.

- Requirement: 1. If not previously accomplished, carry out the following:
- Access relays K1, K2, K3, K5, K104, and K200 (relay part number (P/N) HS4240).
 - Remove each relay specified in sub-paragraph (a) from its receptacle (P/N HS4256-1).
 - Using a No. 60 drill bit or a 0.40 inch diameter wire as a gauge, attempt to insert the gauge into every contact socket of each relay receptacle, see Figure 1. (To prevent damage to the receptacle and contact socket, ensure the gauge is inserted perpendicular to the face of the receptacle.) If the gauge can be inserted into the contact socket, the socket must be replaced with a new socket P/N 019-0075-002.
