AIRWORTHINESS DIRECTIVE

McDonnell Douglas (Hughes) and Kawasaki 369 Series Helicopters**AD/HU 369/109****Tail Rotor Gearbox Attachment****10/2002**

Applicability: MD Helicopters Inc. Model 369D, 369E, 369F, and 369FF helicopters, modified in accordance with Aerometals Supplemental Type Certificate (STC) SH5055NM or SH4801NM.

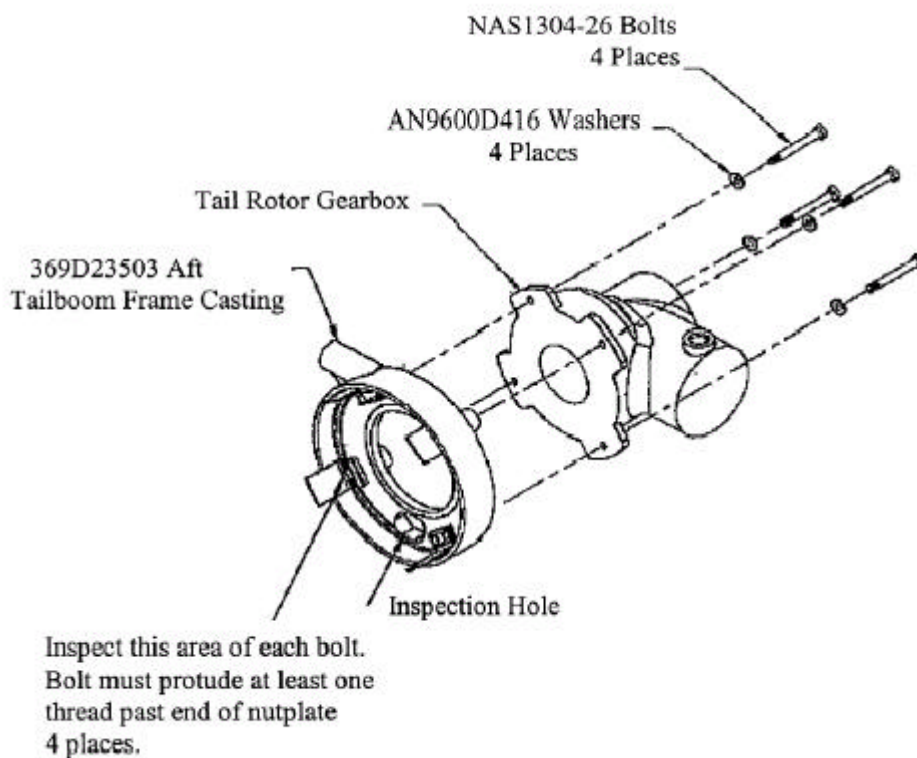
Figure 1 – Inspection Location

- d. Remove the tailboom control rod and determine the number of threads protruding from each nutplate on the internal surface of the aft tailboom frame casing, P/N 369D23503, as shown in Figure 1 of this Directive. At least one thread must protrude. If more than four threads protrude, add an additional washer, P/N AN960D416, under the bolt head.

Background: The bolts that attach the tail rotor gearbox have been found to be of inadequate grip length. This Directive introduces an inspection and possible replacement of the bolts to ensure the integrity of the gearbox for safe operation of the helicopter.

- b. If the part number cannot be determined or if the bolt is not P/N NAS1304-26, replace the bolt with bolt, P/N NAS1304-26.
 - c. Torque the bolt to 100-110 in-lbs and apply slippage mark.

- e. Torque the bolt to 100-110 in-lbs and re apply slippage mark.
 - 2. Repetitive Inspection:**
 - a. Re check the attachment bolts for correct torque and re-torque if necessary.
