AIRWORTHINESS DIRECTIVE

McDonnell Douglas (Hughes) and Kawasaki 369 Series Helicopters**AD/HU 369/116****Lateral Mixer Output Link Assembly****4/2007**

Applicability: Model MD600N helicopters, with a lateral mixer output link assembly part number 600N7636-1, -3, -9 or -11, installed.

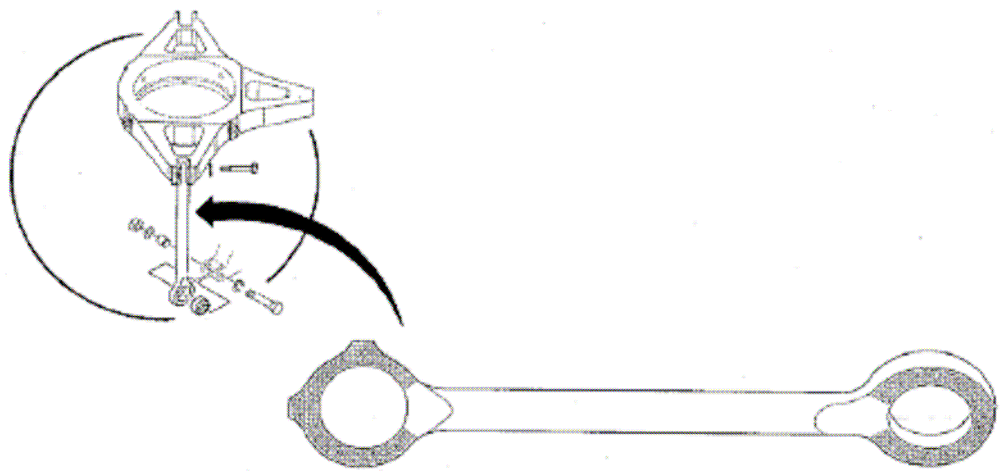
Figure 1

Requirement: 1. Remove each lateral mixer output link assembly (mixer link) and visually inspect, with a bright light and a 10x or higher magnifying glass, for cracks in the shaded areas around the bearing bore as depicted in the following Figure 1:

Background: The FAA received a report of a cracked lateral mixer output link assembly part number 600N7636-1, on an in-service MDHI Model MD600N helicopter. Cracks were also detected on two additional mixer links part number 600N7636-3, which were being held as spares. The cracks on all three mixer links run through the bearing end area of the mixer link and emanate from staking marks in the mixer link. Undetected cracks in the mixer link could result in failure of the mixer link and subsequent loss of control of the helicopter.

2. Perform an eddy current inspection of each mixer link in the bearing end areas.

Replace any cracked mixer link with a serviceable mixer link on which an eddy current inspection has been performed.

Perform an eddy current inspection on each mixer link before installation on any helicopter.
