Robinson R22 Series Helicopters

AIRWORTHINESS DIRECTIVE

**AD/R22/49 Main Rotor Drive Shaft Yoke Half Assembly 12/2000
TX**

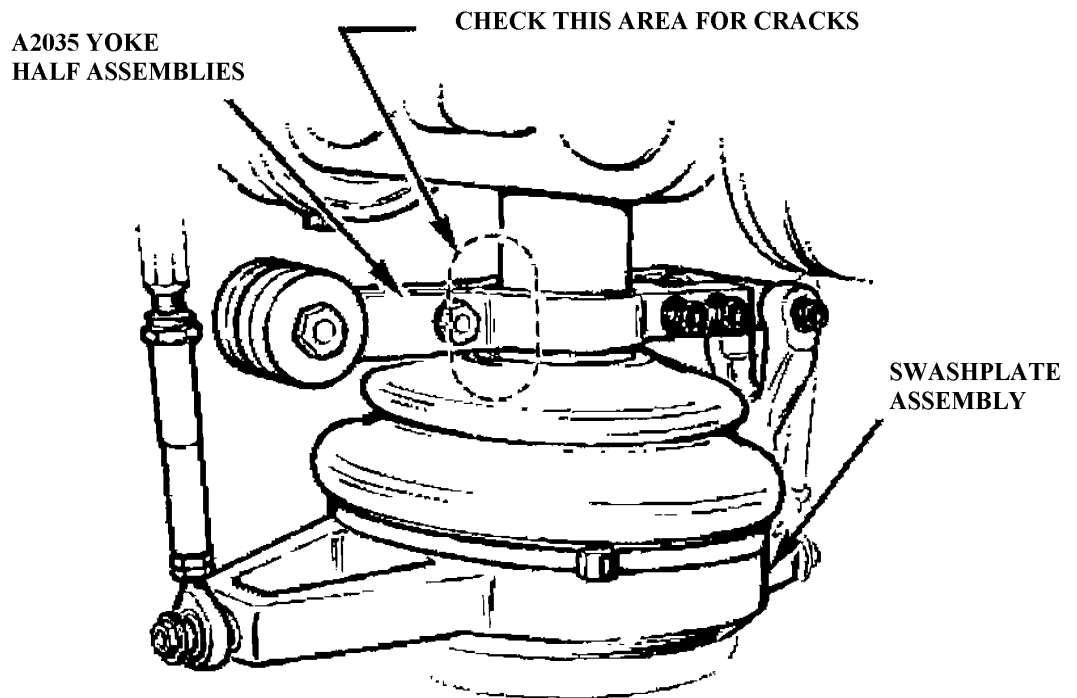
Figure A

Requirement: 1. Inspect each yoke for evidence of cracking, refer to Figure A.

- Background:
- The FAA received several reports of cracks in the yoke half assembly during pre-flight inspections. The cracked yokes were still in service and functioned for an unknown duration. This condition, if not corrected, could result in separation of the yokes from the main rotor drive shaft and subsequent loss of control of the helicopter.

If a yoke is cracked, before further flight, replace the yokes with serviceable yokes, part number A203-7. Both yokes must be replaced with yokes part number A203-7.
