AIRWORTHINESS DIRECTIVE

Robinson R22 Series Helicopters

AD/R22/52

Door and Window Assembly

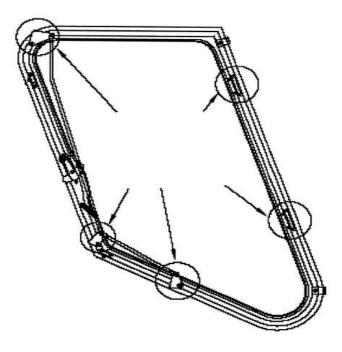
Door Assembly (left-hand shown) View Looking Outboard Figure 1

Visually inspect each pilot and co-pilot door assembly integral frame for a crack in the locations depicted in Figure 1 of this Directive. If a crack is found, before further flight, replace the cracked door assembly, part number (P/N) R-22-101-51 or P/N R-22-101-53 (left-hand door assembly), or P/N R-22-101-52 or P/N R-22-101-54 (right-hand door assembly), with a serviceable door assembly. If the above part number door assemblies are used as the replacement, then accomplish the replacement in accordance with Tech-Tool Plastics, Inc., Installation Instructions TTP-1R, Revision A, dated 21 November 1997, and with the sections titled "Door Weather Seal Installation" and "Cotter Pin Installation" in Tech-Tool Plastics, Inc., Service Bulletin (SB) No. TTP2005-01 Revision A, dated 1 February 2005.
