[Docket No. FAA-2025-0011; Project Identifier AD-2024-00618-R; Amendment 39-23053; AD 2025-11-07]

Airworthiness Directives; Robinson Helicopter Company Helicopters

Final rule.

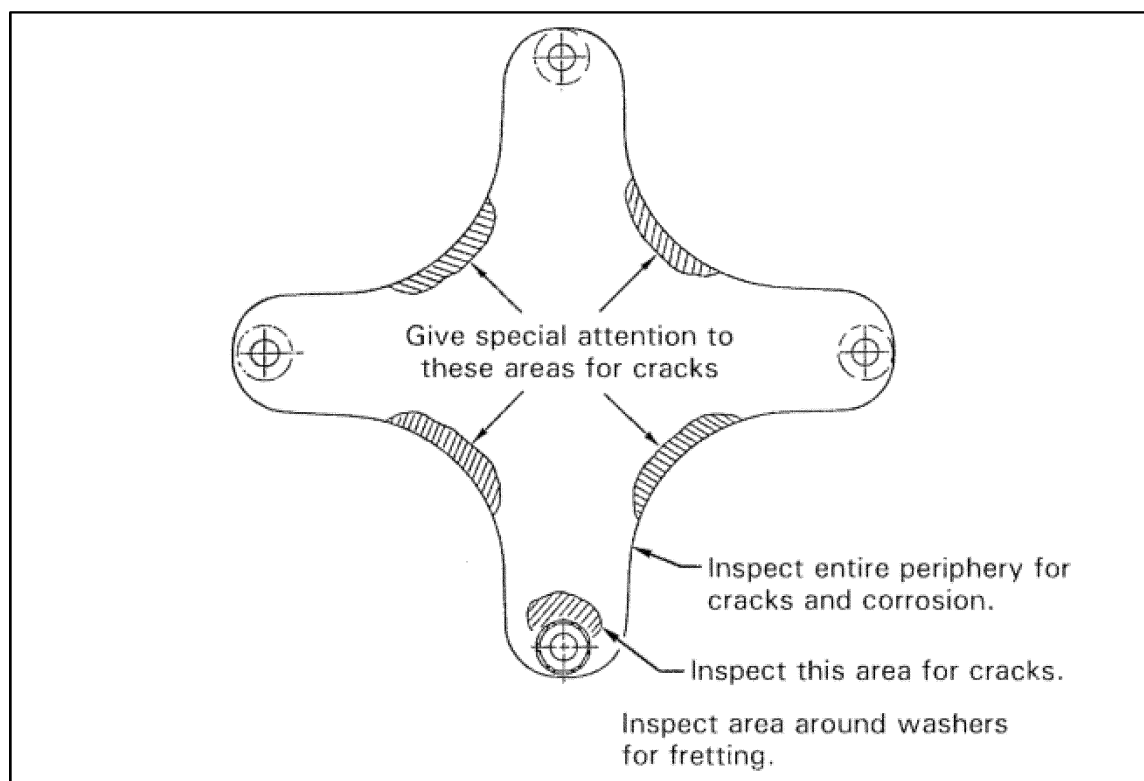
Figure 1 to Paragraph (g)(1)(i) - Flex Plate Inspection

This AD was prompted by reports of a fractured clutch shaft forward yoke (yoke) on the main rotor (M/R) drive due to fatigue cracking. The FAA is issuing this AD to detect fatigue cracking on the yoke. The unsafe condition, if not addressed, could result in loss of M/R drive and consequent loss of control of the helicopter.

(i) Visually inspect forward flex plate assembly part number (P/N) C947-1 (flex plate) for any loose fasteners, cracks, fretting, corrosion, wear, and to ensure that the washers are bonded to both sides of each flex plate arm, in the areas depicted in Figure 1 to paragraph (g)(1)(i) of this AD. If there is any loose fastener (can be moved by hand), crack, fretting, corrosion, or wear that consists of the washers not securely bonded to both sides of each flex plate arm, before further flight, remove the flex plate from service and replace it with an airworthy flex plate.
