Robinson R44 Series Helicopters

AD/R44/10
Amdt 1

Main Rotor Blade

14/98
DM

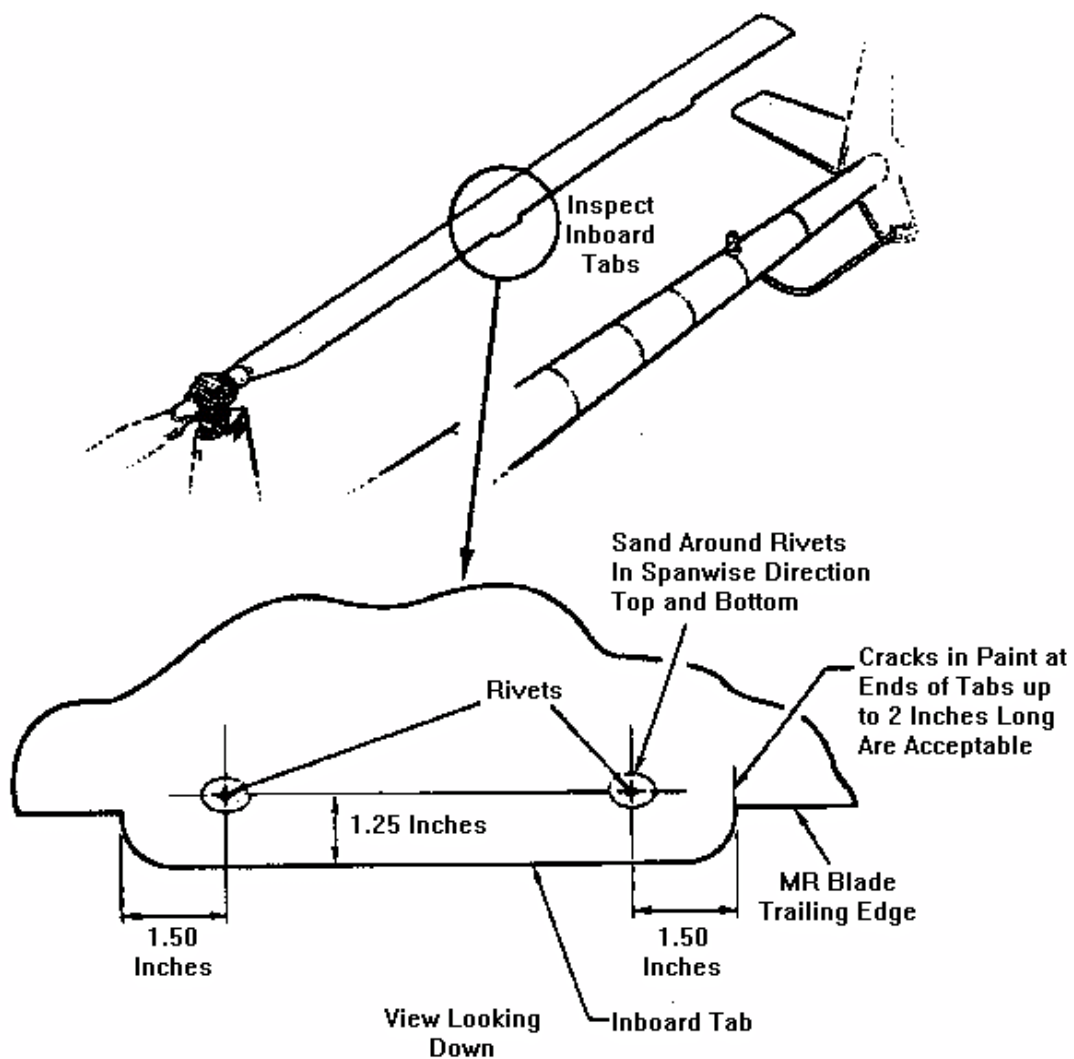
- Requirement:
1. Inspect the main rotor blade skin around both inboard trim tab alignment rivets as follows, referring to Figure 1 of this Directive:
 - (a) Remove all paint around both rivets, exposing an area of approximately $\frac{3}{4}$ inch in diameter, at the inboard trim tab on the top and bottom of each blade (four places per blade). Use 180 grit or finer abrasive paper, followed by 600 grit or finer paper to eliminate coarse sanding marks. Sand only in a spanwise direction. Do not use chemical paint strippers.
 - (b) Inspect the blade skin around the rivets on the blade upper and lower surfaces (four locations) using a dye penetrant method.

Note 1: Chordwise cracks in the paint up to 2 inches long which are located along either inboard or outboard edge of the trim tab are acceptable.

Background: The FAA received a report of an incident in which a pilot heard a loud noise and felt severe vibrations while hovering, resulting in a forced landing. Upon inspection, a crack was found in a main rotor blade that started at the mid-span inboard trim tab and ran chordwise to the spar where it turned along the spar for about an inch. The crack originated from a trim tab alignment rivet hole in the blade skin.

Subsequent investigations revealed that the manufacturing process utilised to drill the trim tab alignment rivet holes in the main rotor blade skin can allow a fatigue crack to originate at these holes and propagate in the skin. This condition, if not corrected, could result in failure of the main rotor blade and subsequent loss of control of the helicopter.

2. Thereafter, using a 5-power or higher magnifying glass, visually inspect the upper and lower blade skin surfaces around the inboard trim tab rivets (four locations) for cracks.
3. Replace main rotor blades P/N C016-1 with main rotor blades P/N C016-2.

- Compliance:
1. Unless already accomplished, within 5 hours time in service after November 4 1998.
 2. Before the first flight of each day, or at intervals not to exceed 5 hours time in service, whichever occurs first.
 3. Replace the main rotor blade before further flight if a crack, other than as described by Note 1, is found when inspected as per requirement 1 or 2, otherwise replace before 1 December 1998.
