Robinson R44 Series Helicopters

## AIRWORTHINESS DIRECTIVE

**AD/R44/14**

**Wire Harness and Fuel Line Chafing**

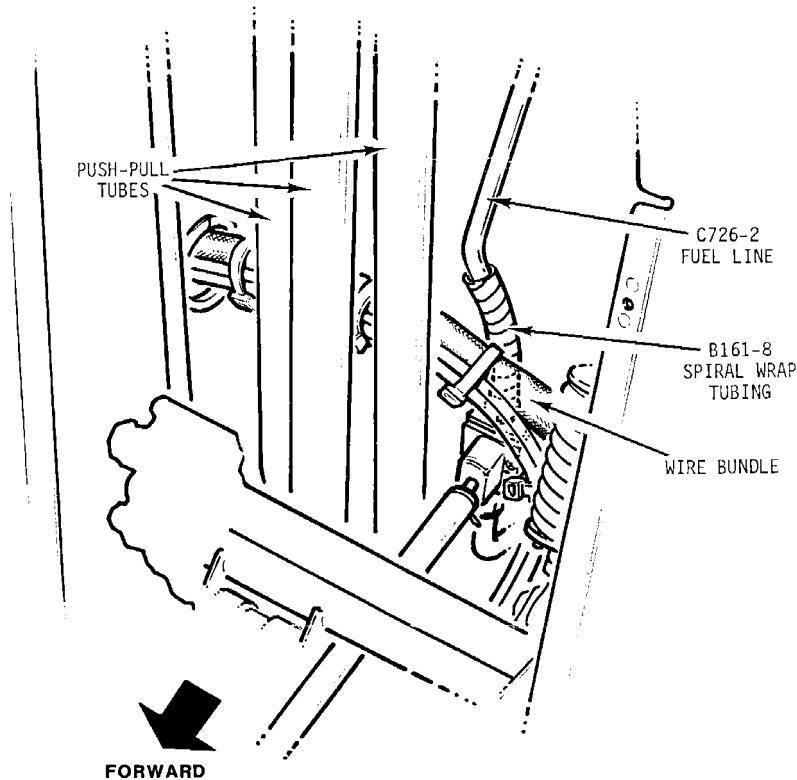
**Figure 1**

Background: The FAA has received reports of four incidents of contact between the wire harness and the fuel line assembly. This Directive requires inspection of the wire harness for contact with the fuel line assembly, removal and replacement of the fuel line assembly if chafing has occurred, and installing spiral wrap tubing on the fuel line assembly. These actions are intended to prevent contact between the wire harness and the fuel line, which could result in chafing of the wire harness and a potential fire hazard.

- Requirement:
1. Accomplish the following actions to prevent contact between the wire harness and the fuel line assembly:
    - a. Remove the cover, part number (P/N) C474-1, from between the rear seatbacks.
    - b. Inspect the wire harness, P/N C059, and the fuel line assembly, P/N C726-2, above the fuel shutoff valve for contact. If the wire harness contacts the fuel line assembly, inspect for chafing.
    - c. If chafing has occurred between the wire harness and the fuel line assembly, replace the fuel line with an airworthy fuel line assembly. Torque the fuel line nuts to 12.4-14.7 Nm (110-130 in-lbs). Verify that clearance exists between the fuel line assembly and the wire harness.
    - d. Install a 75 mm (3 in) section of spiral wrap tubing, P/N B161-8, on the fuel line assembly as shown in Figure 1. Push the spiral wrap tubing down until it is against the fuel line fitting.
