AIRWORTHINESS DIRECTIVE

Robinson R44 Series Helicopters

AD/R44/20 **Main Rotor Swashplate and Tail Rotor Bolts** **1/2004**
TX

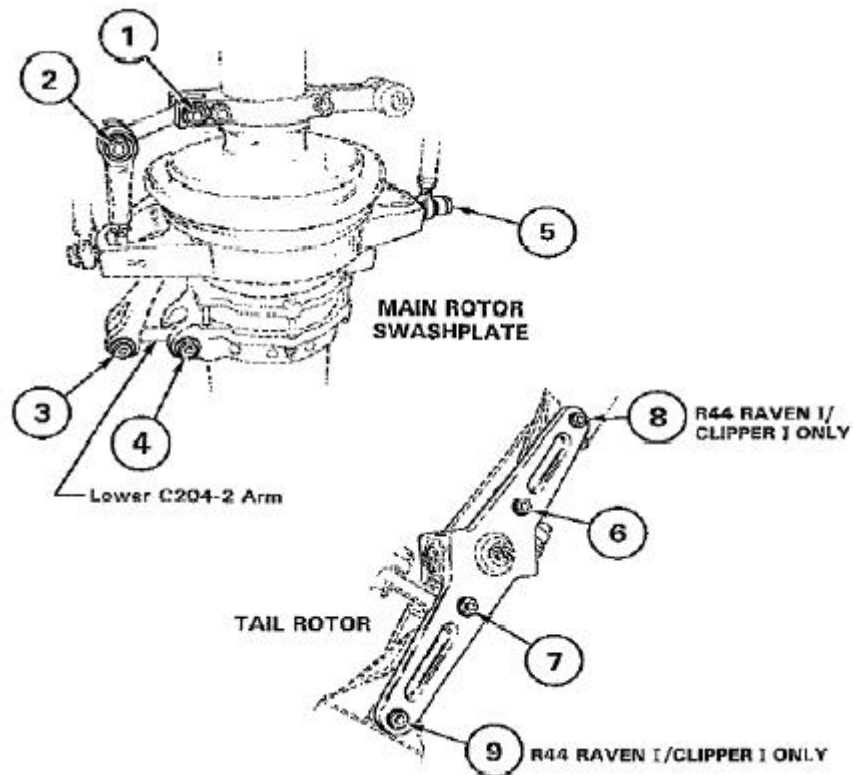
- Requirement: 1. For all R44 and R44 II helicopters except those serial numbers specified in Requirement 2 of this Directive:
- a. Determine if maintenance has been performed after 7 February 2003 on the areas specified in Figure 1 of this Directive, and determine if any bolt, part number NAS6605-31, shown on Figure 1 has been replaced for any reason.

- b. If any bolt has been replaced, or if it is uncertain whether any bolt has been replaced after 7 February 2003, remove the paint from the bolt head to reveal the vendor identification marking. Determine if the bolt vendor identification is 01DO.

3. For the helicopters affected by Requirements 1.b.(i) and 2. of this Directive, accomplish the following:
- a. Visually inspect each bolt for fretting residue under the bolt head, which indicates a loose, potentially cracked bolt.

Background: The FAA received a report of the failure of the bolt that secures parts of the main rotor swashplate and attaches the tail rotor blade. Investigation revealed that the bolt failed due to hydrogen embrittlement. Hydrogen embrittlement is suspected to have occurred during the cadmium plating process of an entire batch of bolts, which makes the batch suspect.

- b. Apply 10-15 ft-lb (13-20 Nm) torque to each bolt head and verify no rotation. See Figure 1 of this Directive.
 - c. If residue or rotation of the bolt is found, replace each affected bolt with a serviceable bolt that does not have a vendor identification marking of 01DO.

4. For the helicopters affected by Requirements 1.b.(i) and 2 of this Directive, replace each bolt, part number NAS6605-31, that has vendor identification marking 01DO on the bolt head, with a serviceable bolt, part number NAS6605-31, that has an alternative vendor identification marking.
