[Docket No. FAA-2023-2232; Project Identifier AD-2023-00943-R; Amendment 39-22681; AD 2024-04-02]

Airworthiness Directives; Robinson Helicopter Company Helicopters

Final rule.

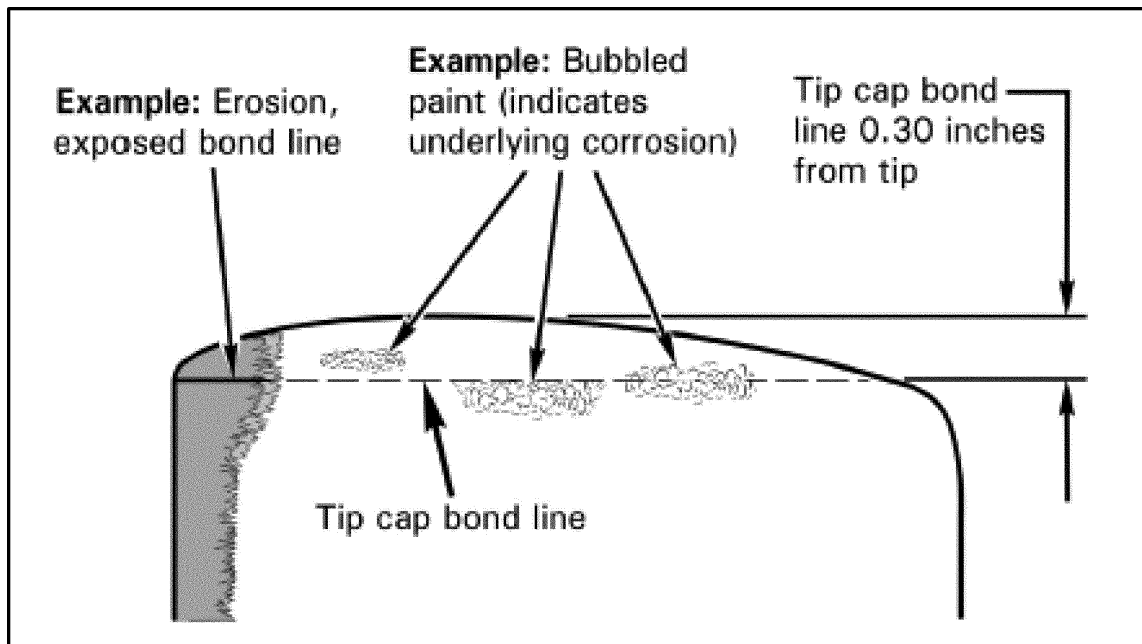
Figure 1 to Paragraph (g)(1)—TRB Tip Cap Check/Inspection

A debonded TRB tip cap can cause severe vibration and possible failure of the tail rotor gearbox housing. This condition, if not addressed, could result in increased vibrations, reduced controllability, and subsequent loss of control of the helicopter. The FAA is issuing this AD to address the unsafe condition on these products.

(1) Within 10 hours time-in-service (TIS) after the effective date of this AD and thereafter before the first flight of each day, visually check each TRB tip cap area (at and adjacent to the tip cap bond line on each surface and edge of the TRB) for an exposed tip cap bond line or bubbled paint, as depicted in Figure 1 to paragraph (g)(1) of this AD. These items may indicate evidence of corrosion. The owner/operator (pilot) holding at least a private pilot certificate may accomplish this TRB tip cap check and must enter compliance with this paragraph of the AD into the helicopter maintenance records in accordance with [14 CFR 43.9\(a\)](#) and [91.417\(a\)\(2\)\(v\)](#). The record must be maintained as required by [14 CFR 91.417](#), [121.380](#), or [135.439](#).

(2) Within 100 hours TIS or during the next 100 hour or annual inspection after the effective date of this AD, whichever occurs first, and thereafter at intervals not to exceed 100 hours TIS or during the next 100 hour or annual inspection, whichever occurs first, visually inspect each TRB tip cap area (at and adjacent to the tip cap bond line on each surface and edge of the TRB) for evidence of corrosion, which may be indicated by an exposed tip cap bond line or bubbled paint, as depicted in Figure 1 to paragraph (g)(1) of this AD.

(3) As a result of the actions required by either paragraph (g)(1) or (2) of this AD, if there is evidence of corrosion, an exposed tip cap bond line, or bubbled paint, before further flight, remove all of the

(4) Within 10 months of the effective date of this AD, remove all TRBs identified in paragraph (c) of this AD from service.
