AIRWORTHINESS DIRECTIVE

Sikorsky S- 76 Series Helicopters

AD/S-76/71

Rotor Brake Disc

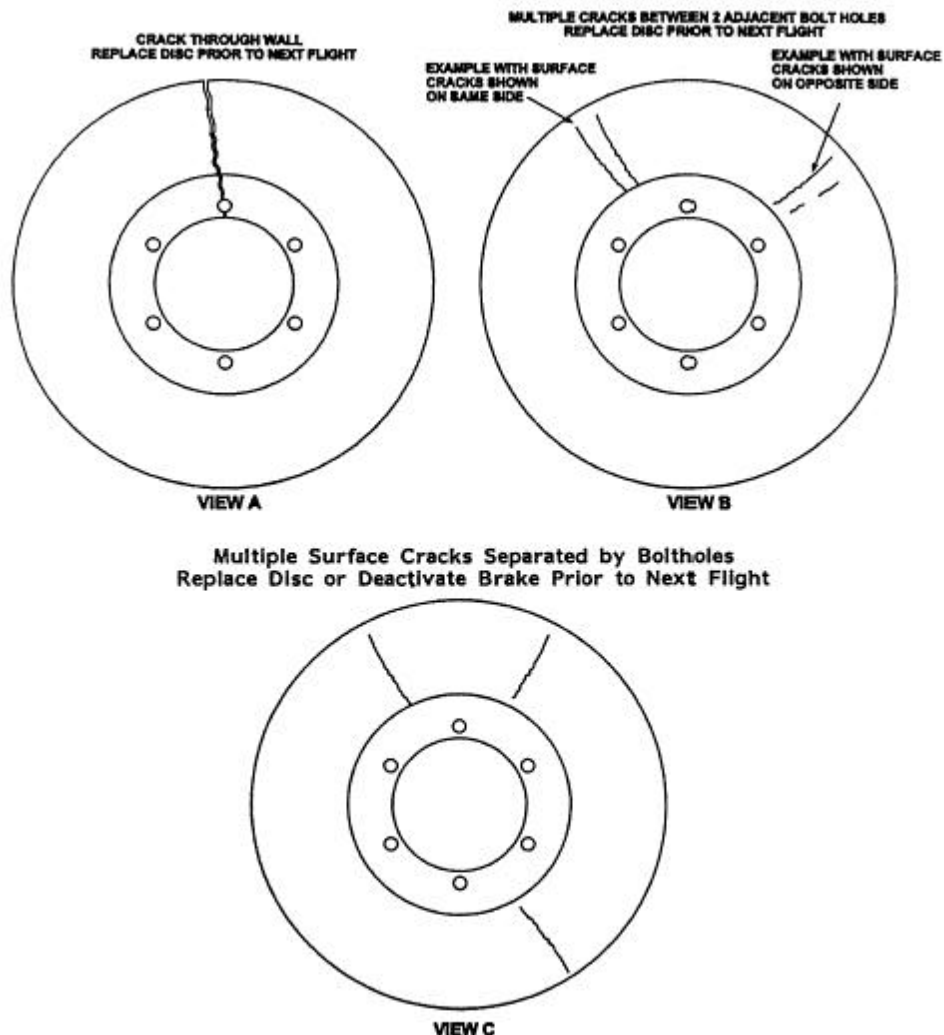
Figure 1 RBD Inspection Limits.

2. For RBD's with P/N 76363-0103-104, inspect the RBD for cracks as detailed in Figure 1.
 - a. If a crack is found extending through the entire RBD thickness as detailed in Figure 1, View A, replace the RBD with a serviceable RBD other than P/N 76363-09103-104.

- b. If 2 or more surface cracks are found located between adjacent boltholes as shown in Figure 1, View B, replace the RBD with a serviceable RBD other than P/N 76363-09103-104.

- c. If a surface crack, or surface cracks are found separated by boltholes as shown in Figure 1, View C, replace the RBD with a serviceable RBD other than P/N 76363-09103-104, or deactivate the RBD before further flight.

Note 1: Short "glazing" cracks are not a cause for rejection.

Background: Certain rotor brake discs were found to be manufactured using an incorrect heat treatment process of the disc. This can lead to premature cracking and subsequent failure of the discs. This directive requires identifying certain discs, inspection of these discs and eventual replacement of these discs. Failure of the disc could cause damage to the rotor blades, nearby hydraulic and fuel lines, and subsequent loss of control of the helicopter.

- 3. Replace the PHC RBD, P/N 76363-09103-104 with a serviceable RBD other than P/N 76363-09103-104.
