[Docket No. FAA-2007-0096; Directorate Identifier 2007-NE-39-AD; Amendment 39-16141; AD 2009-26-06]

Airworthiness Directives; Honeywell International Inc. ALF502 Series and LF507 Series Turbofan Engines

ACTION: Final rule.

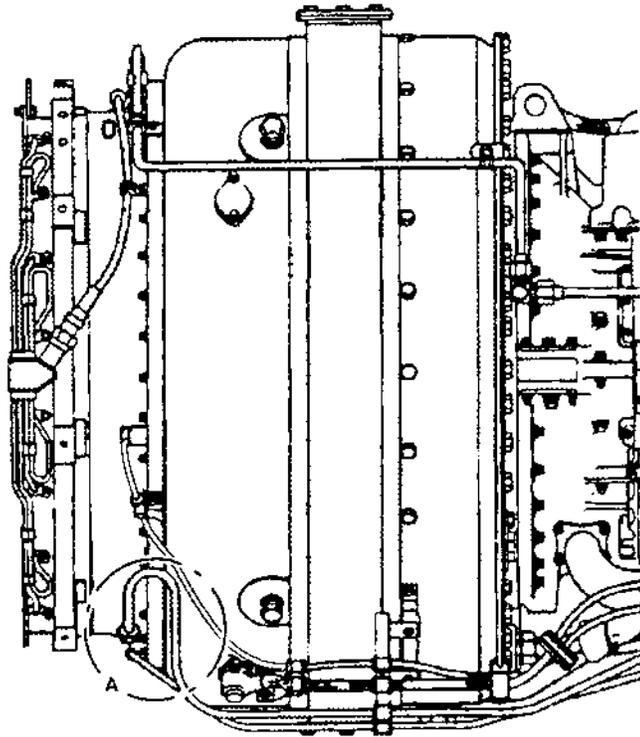
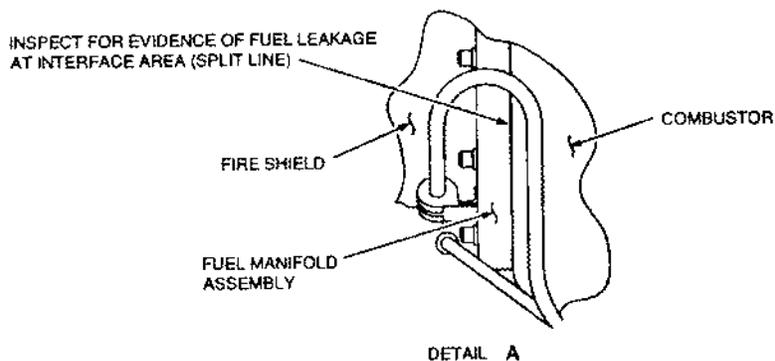
- (g) For fuel manifold assemblies, P/Ns 2-163-620-37 or 2-163-620-38, with 1,800 or more CSN or cycles-since-overhaul (CSO), inspect for leaks within 300 CIS after the effective date of this AD as follows:
- (1) Start engine and let stabilize at ground idle.
 - (2) With the engine operating, look for fuel leaking from the fuel manifold assembly to the fire shield interface area (see Figure 1 of this AD). No leaks allowed.
 - (3) If you find any leaks, shutdown the engine and replace the fuel manifold assembly with an FAA-approved serviceable assembly.
 - (4) Shut down engine.
 - (5) Look for fuel leaking from the fuel manifold assembly to the fire shield interface area (see Figure 1 of this AD). No leaks allowed.
 - (6) If you find any leaks, replace the fuel manifold assembly with an FAA-approved serviceable assembly.

(h) Thereafter, within 600 CSLI, inspect fuel manifold assemblies, P/Ns 2-163-620-37 and 2-163-620-38, for leaks as specified in paragraphs (g)(1) through (g)(6) of this AD.

(i) Replacing a fuel manifold assembly that has a P/N specified in paragraph (c) of this AD with a fuel manifold assembly, P/N 2-163-620-39, 2-163-620-40, 2-163-620-41, or 2-163-620-42, or an FAA-approved equivalent part, terminates the inspection requirement of this AD.
