Airworthiness Directive

AD No.: 2020-0201R2

M601/H80 engines

ATA 73 – Engine Fuel & Control – Fuel Control Unit – Replacement

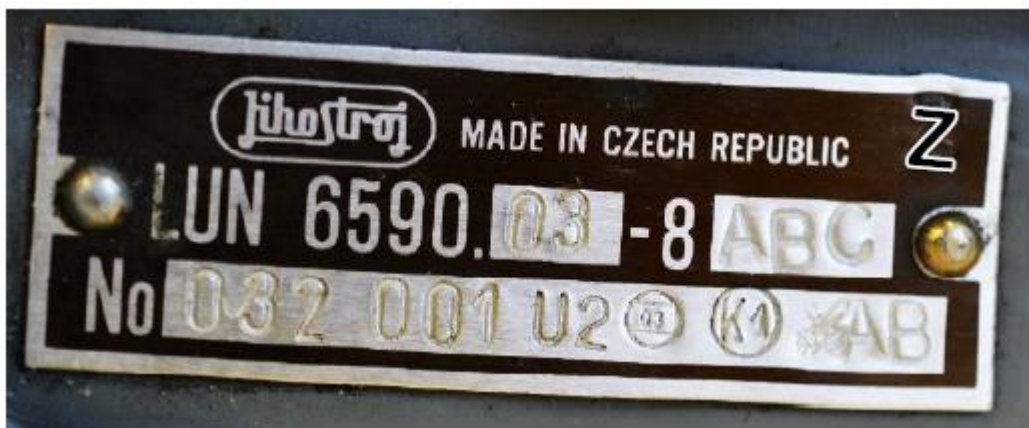
Figure 1 – Typical data plate for repaired FCU (see Note 2 of this AD)

Affected part: Fuel control units (FCU), having a Part Number (P/N) and serial number (s/n) as listed in Appendix 1 of this AD, except those marked with a 'Z' on the data plate; see Figure 1 in Appendix 1 of this AD.

Note 2: the 'Z' can be marked on different position in the data plate (e.g., on the left upper corner of the data plate).
