**AIRWORTHINESS DIRECTIVE**

**AlliedSignal (Lycoming) Turbine Engines - T53 Series****AD/T53/23****Combustion Chamber Housings****10/2009**

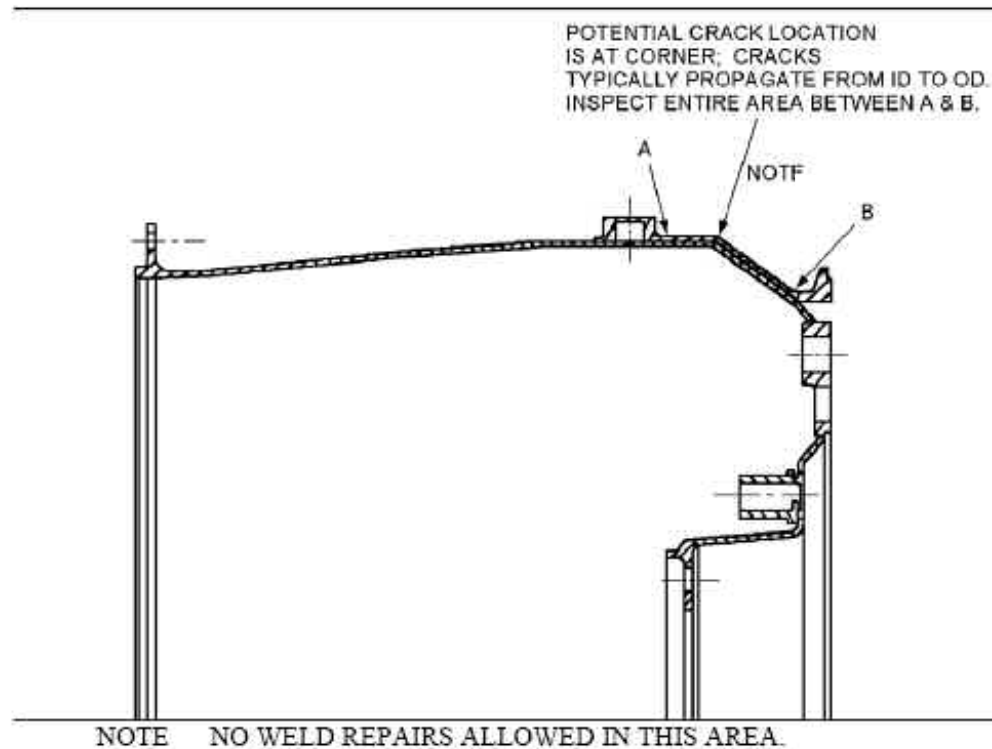
**Figure 1. Visual Inspection of CCH**

**Requirement:** 1. For CCH, P/N 1-130-610-05 and 1-130-610-12, inspect the area between points A and B around the entire housing circumference in Figure 1 of this AD for weld repairs and cracks.

3. For CCH, P/N 1-130-610-05 and 1-130-610-12, inspect the area between points A and B around the entire housing circumference in Figure 1 of this AD for cracks.

**Background:** This AD results from eight instances of cracks in CCHs. Two of the instances resulted in an engine shutdown during flight. The issuing of this AD is intended to detect cracks in the CCH, which could result in rupture of the CCH, leading to loss of engine power and damage to the helicopter.

a. Any cracks are found - replace the CCH.

b. If any weld repairs are found - replace the CCH.

4. If you find any cracks, replace the CCH.
