## AIRWORTHINESS DIRECTIVE

### Beechcraft 200 (Super King Air) Series Aeroplanes

**AD/BEECH 200/67  
Amdt 6**

**Fuselage Rear Pressure Bulkhead**

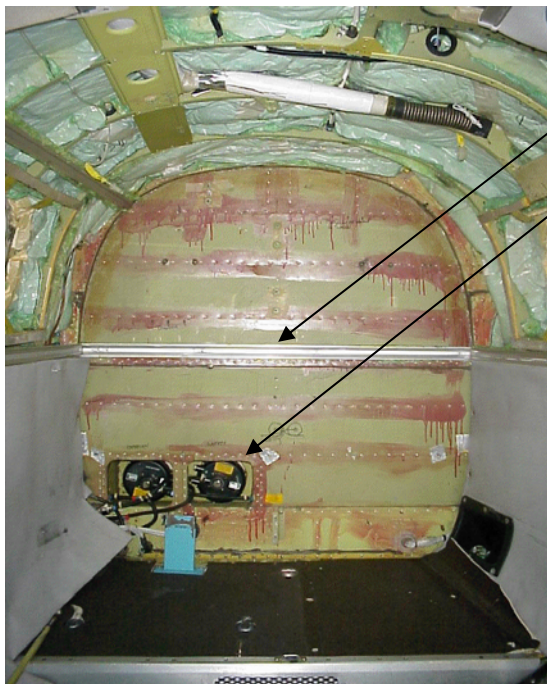
While doing the inspection, also note any damage such as sharp dents or punctures in the bulkhead and around the outflow and safety valve box. Damage such as this increases stress concentration and may develop into cracks at some stage in the future. Ensure that all damage is assessed, repaired if necessary and its cause rectified so it does not reoccur. See figure 1 below, which shows the front side inspection locations (aft side not shown).

**Remove this extruded upholstery rail if it covers the lower row of rivets in the lap joint. This will enable inspection for cracks along the rivet line.**

**Inspect around the Outflow Valve cutouts and box for damage to the bulkhead, including gouges, cracks and punctures.**

Background: Cracks and other damage have been found in the rear pressure bulkheads in several Australian aircraft. Undetected cracks or other damage may cause loss of pressurisation or, if large enough, catastrophic structural failure of the rear pressure bulkhead.

**Requirement:** Inspect the entire forward and aft side of the rear pressure bulkhead and the outflow and safety valve box for cracks and loose or missing rivets in accordance with Beech Super King Air 200 series maintenance manual, latest revision, Special Inspections, Section 5-20-05, Inspection item 51 “Aft fuselage area and rear pressure bulkhead”.

Compliance: Inspect initially at 10,000 cycles and then at 500 cycle intervals\*.
